SAFETY RECOMMENDATION No: 01/2017

01/2017: Grounding of B/C "St. Gregory"
(See the full Report [here.](#))

Grounding of B/C "St. Gregory"

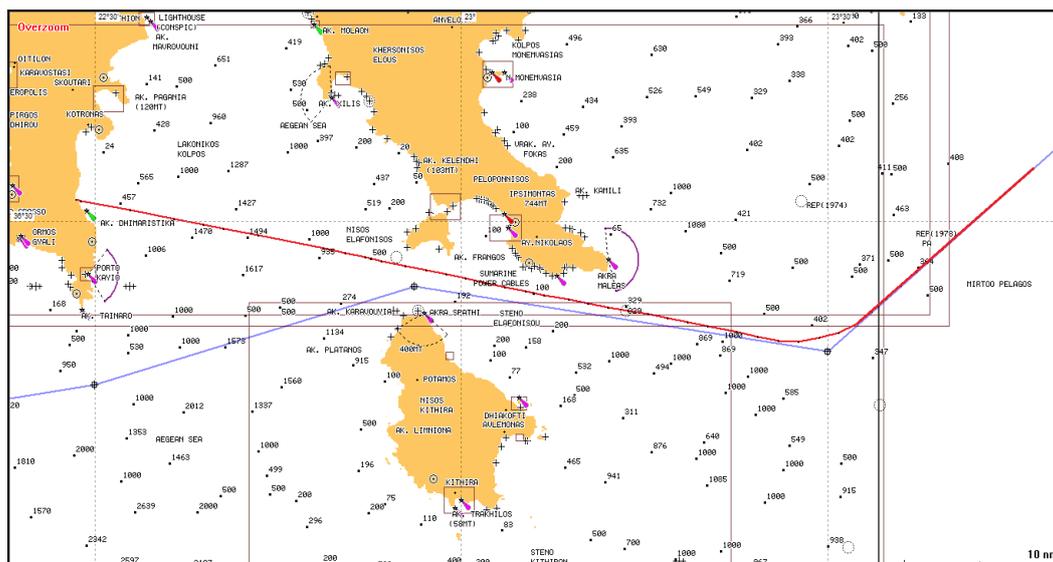
On the 7th of June 2017, at approximately 05:13 (L.T.), the B/C St. Gregory grounded on the rocky coastline at the South Coast of Peloponnese (Kokkala - Greece), in position lat: 36° 31' 40" N, long:022° 28' 29" E, after passing W.P.No.9 without altering her course. At the time of the marine casualty, weather conditions were reported to be with very good visibility, wind force ENE 5-6 bfrs, sea was moderate and it was still dark. None of the crew was injured and no pollution was reported.

Figure 1: The actual course of ST GREGORY (red line) until her grounding, in relation to the planned route (blue line)

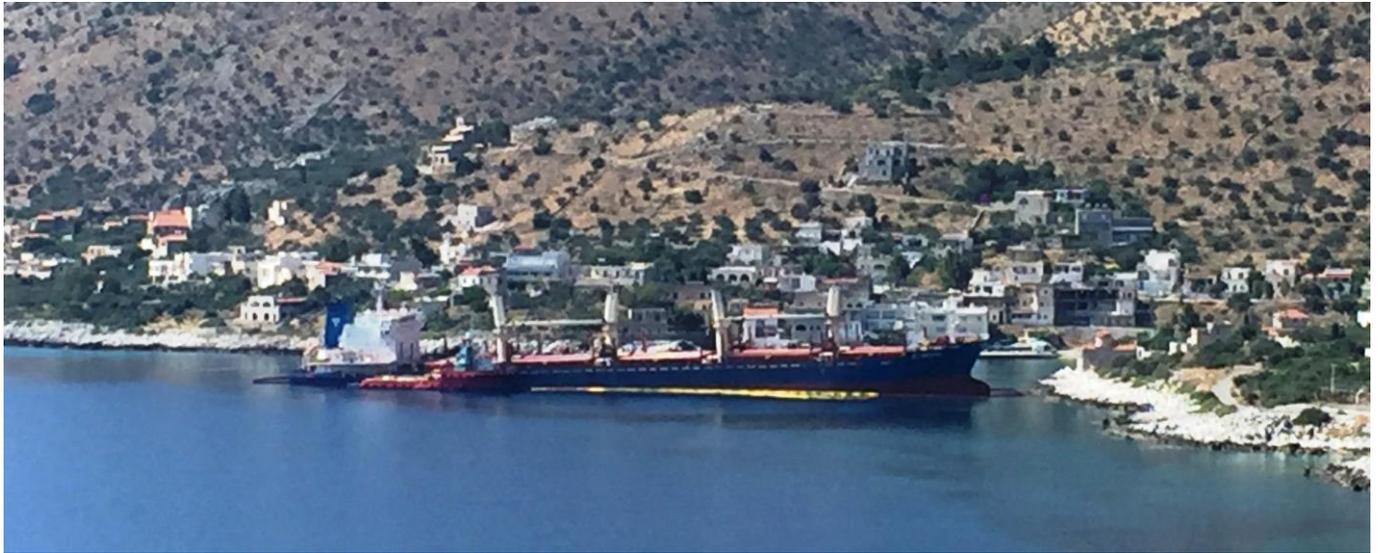
St. Gregory grounded on a bottom of sand and rocks by bow up to frame number 180. As a result of the grounding, there was damage to the hull with several dents and cracks near the bulkhead between the FPTK and WBT 1SB. More specifically there were 29 cracks observed in the WBT 1P & 1S, the FPTK and the Pipetunnel.

Figure 2: ST. GREGORY aground at Kokkala

St. Gregory re-floated on 20th June 2017, after off loading of her cargo and anchored with the assistance of two (02) Salvage Tugs, at Gytheio anchorage sea area. On 6th of September 2017 St. Gregory was escorted by a Salvage Tug to Chalkis Shipyard, Greece, in order to undergo permanent repairs.
