SAFETY RECOMMENDATION No: 50/2014

07/2014: **FATAL FALL OF BOSUN FROM THE DECK CRANE OF B/C «PANORIA»** Flag Greece IMO: 9480930

FATAL FALL OF BOSUN FROM THE DECK CRANE OF B/C «PANORIA»

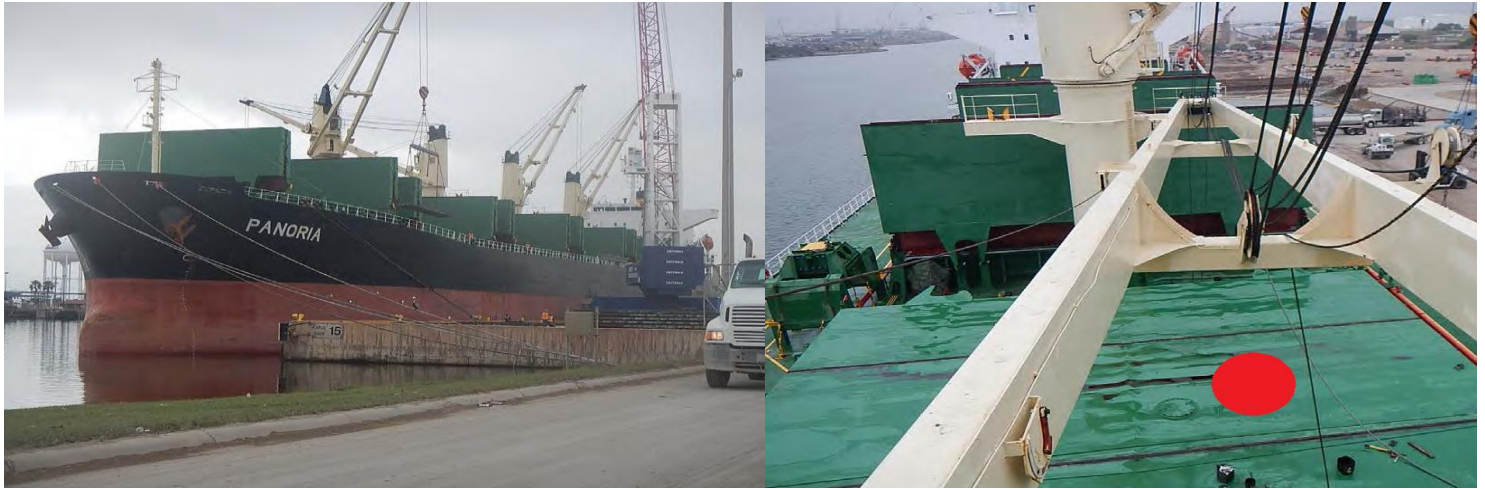
Vessel's berthing position at Brownsville, Texas, USA

The location where the Bosun fell on top of cargo hatch cover No.3
