SAFETY RECOMMENDATION No: 51/2014

07/2014: **FATAL FALL OF BOSUN FROM THE DECK CRANE OF B/C «PANORIA»** Flag Greece IMO: 9480930

Date of publication:

24/01/2017

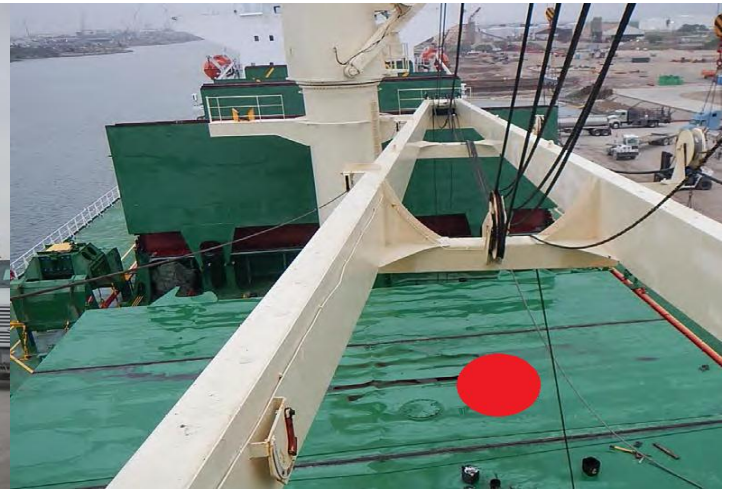
standing on the jib's cross section he lost his balance and fell from a height of 9.5 meters on the cargo hold's hatch cover. The safety harness did not prevent his fall as the old wire rope was not secured to any fixed point and was hanging free.

The location where the Bosun fell on top of cargo hatch cover No.3

Provide clarification concerning the “Working Aloft/Overside Permit” procedure, so that the tasks for which the Permit is valid are recorded and described in detail and are well understood by every involved crew member.
