SAFETY RECOMMENDATION No: 54/2014

07/2014: **FATAL FALL OF BOSUN FROM THE DECK CRANE OF B/C «PANORIA»** Flag Greece IMO: 9480930

FATAL FALL OF BOSUN FROM THE DECK CRANE OF B/C «PANORIA»

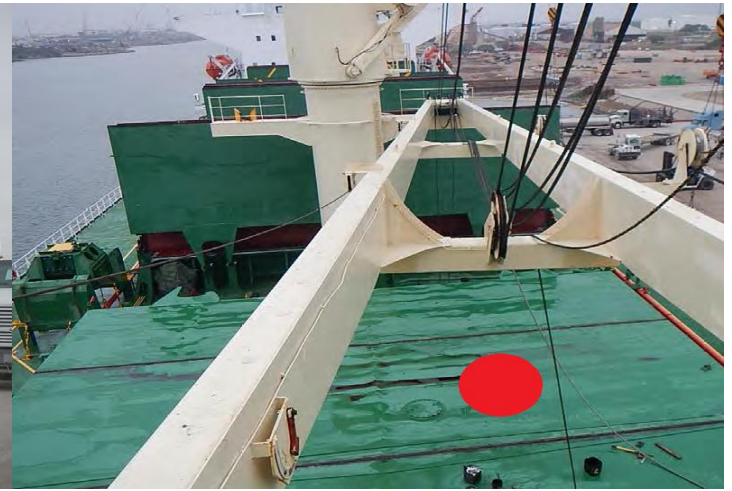
standing on the jib's cross section he lost his balance and fell from a height of 9.5 meters on the cargo hold's hatch cover. The safety harness did not prevent his fall as the old wire rope was not secured to any fixed point and was hanging free.

The location where the Bosun fell on top of cargo hatch cover No.3

Provide clear instructions to the crews for the safe access to the crane booms when it is deemed necessary.
