SAFETY RECOMMENDATION No: 59/2014

08/2014: Grounding of C/V “YUSUF CEPNIOGLU”
(See the full Report [here.](#))

Grounding of C/V “YUSUF CEPNIOGLU”

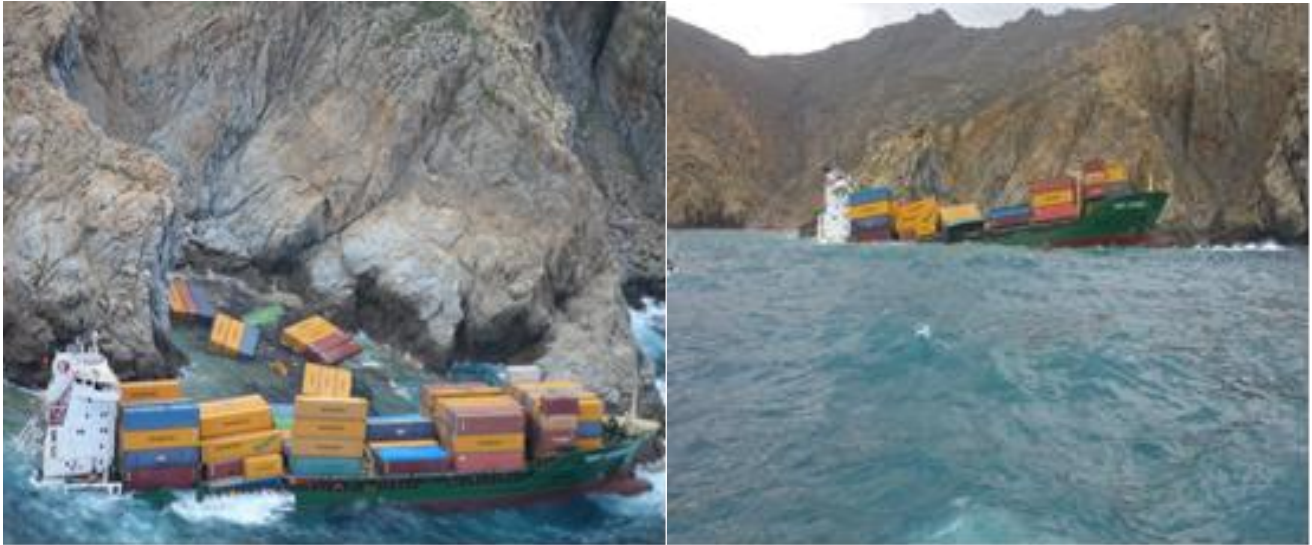
On the 8th of March 2014, at approximately 05:30, the Turkish registered Yusuf Cepnioglu grounded on the rocky coastline of Avlemonas bay at the North West part of Mykonos Island, in position lat: 37°29' 55" N, long:25°20'12" E. At the time of the marine casualty, weather conditions were reported to be good with medium visibility, wind force up to 4-5 Bft NE, moderate sea and it was still dark. At 04:00 on 08 March 2014, Chief Officer took over the navigational watch. His watch was quiet and no lookout watch was posted during his watch. At that time vessel was underway at central Aegean Sea heading towards her voyage next way point between Islands of Mykonos and Tinos. On the course of his watch Chief Officer fell asleep and missed the way-point where according to the vessel's passage plan he should had alter the course to starboard so as to follow a safe crossing between the islands. As a result vessel continued her passage unattended without the OOW performing watch duties, and at approximately 05:30 grounded with her bow on the rocky coast. Yusuf Cepnioglou listed to starboard and at approximately 1000 the Master ordered the abandonment of the vessel. Eleven crew members abandoned the vessel by a life raft and were recovered by a HCG patrol boat. Yusuf Ceptioglu's Chief Engineer did not board on the life raft and remained on the vessel until he was evacuated by the HCG patrol boat. Master and Chief Officer were the last to evacuate the vessel by a SAR helicopter.

Grounding point of Yusuf Cepnioglu at Mykonos Island.

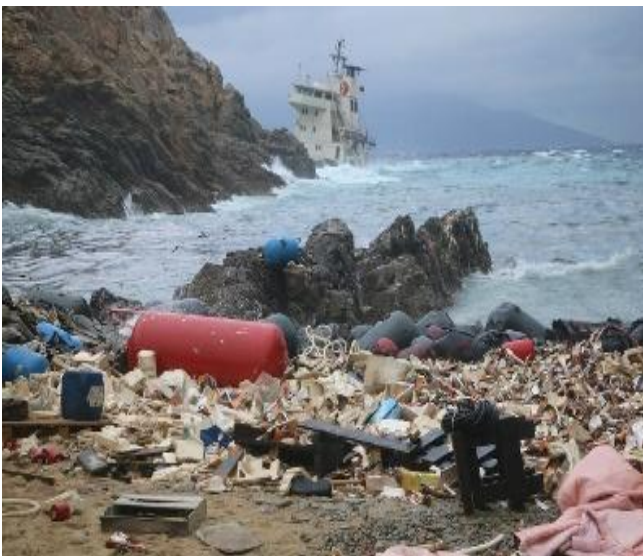
The hull of the vessel suffered multiple cracks and deformations on her bow and port side and several compartments including engine room, cargo holds and void spaces were flooded. Due to gale winds that prevailed on the same day several containers fell overboard. Pollution from vessel's bunkers as well as cargo from the containers was washed up to the shore. Salvage and clean up operations were commenced when permitted by weather conditions. Yusuf Cepnioglou was finally removed from the casualty area in two pieces.

Cargo debris washed up on the nearby coastline.

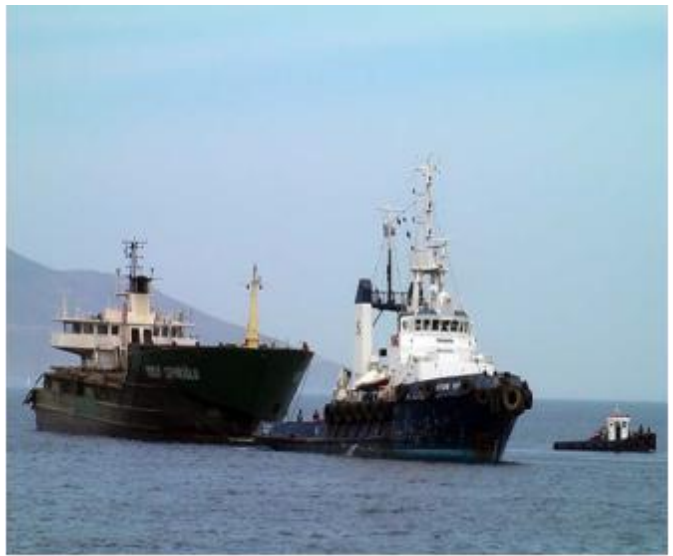
Yusuf Cepnioglu salvage operation
