SAFETY RECOMMENDATION No: 60/2013

09/2013: Impact of MSC Magnifica on Piraeus Port entrance breakwater.

Impact of MSC Magnifica on Piraeus Port entrance breakwater

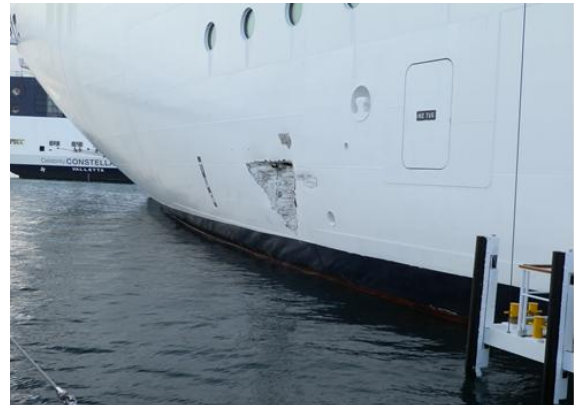
The cruise ship sustained a crack at the point of impact while her port underwater shell plating close to the waterline sustained deformations and intends lengthwise due the contact with the breakwater under the sea level. Her port stern quarter sustained an intend caused by port tug stem post during maneuvering to assist her.

1. structural damages :
 - crack on port bow section above the waterline
 - deformation and intends and scratches on port side shell plating lengthwise under the waterline
 - indent at port aft quarter close to stern post
2. Piraeus' port entrance breakwater
 - Port entrance breakwater's head damaged
 - concrete round-hut red light detached and collapsed into the sea

Figure 3: *The damaged port bow section of MSC Magnifica*

Repairs were carried out while in berth by a marine service company and following her Class inspection, she departed from the port at morning hours on the next day of her arrival and continued her planned cruise voyage.
