SAFETY RECOMMENDATION No: 84/2013

14/2013: Death of 3rd Engineer of M/V CAPTAIN PETROS H.
(See the full Report [here.](#))

Name of vessel: CAPTAIN PETROS H

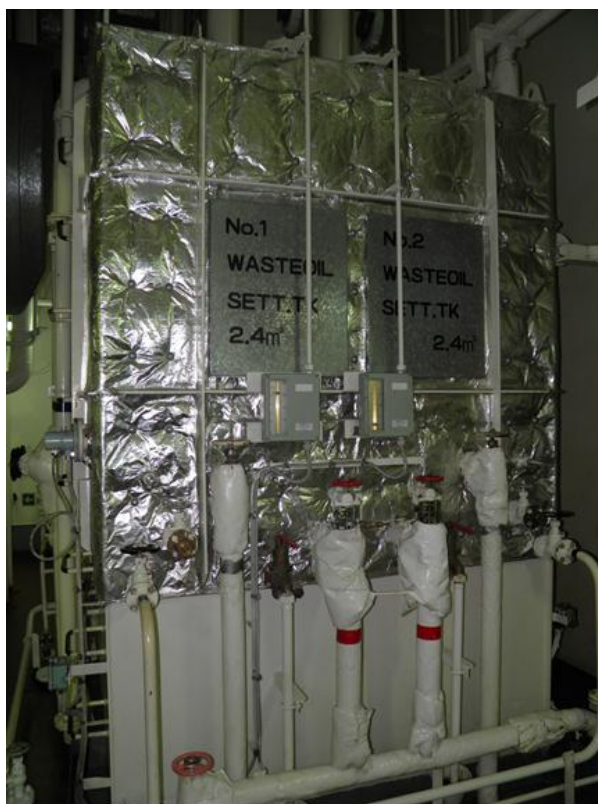
The Waste Oil Settling Tanks

- The accumulation of oil sludge mud to the bottom of the tank caused the jamming of the level gauge float and the clogging of the drain valves.
- The Waste Oil Settling tank was not fitted with sounding pipes, and the malfunctioned level gauge was the only available means for indicating the remaining quantity in the tank.

- The vessel's PMS did not provide guidelines for periodic routine maintenance/cleaning of the Waste oil Settling Tanks in order to remove the heavy oil residues and avoid the jamming of the level gauges.

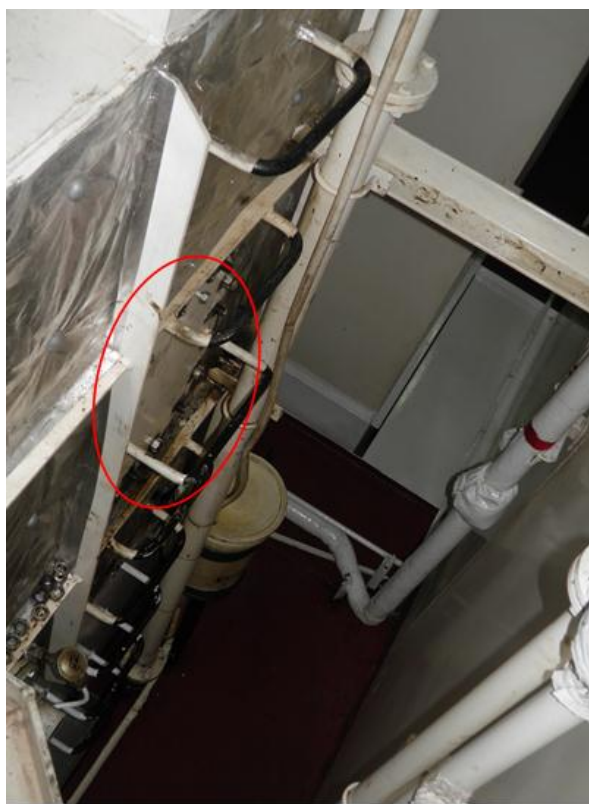
The manhole at the aft side of No2 W.O.S. Tank

- The 3rd Engineer did not apply the common practice for the safe opening of the manhole and didn't use the manhole's jackscrews.
- Potential hazards related to the remaining quantity in the tank and the faulty level gauge were not identified during the process of the Job Hazard Analysis.

- The remaining oil quantity was indirectly heated up to 86°C by the adjacently heated No 1 W.O.S.Tank.
- The overalls of the 3rd Engineer were the common type made of cotton fiber and did not protect his body from the splashing hot oil which caused serious burn injuries.

Consider providing the crew with heat/flame protective clothing (overalls) complying with the respective standards, for use at works or operations with burn injury hazards.

- Existing protective clothing do not provide full protection against steam and hot liquid. However the use of a heat/flame protective clothing complying with ISO 11612 could have provided better protection to the 3rd Engineer's body than his common cotton type overall that he was wearing at the time of the casualty.
