SAFETY RECOMMENDATION No: 85/2013

14/2013: Death of 3rd Engineer of M/V CAPTAIN PETROS H.
(See the full Report [here.](#))

CAPTAIN PETROS H Managers

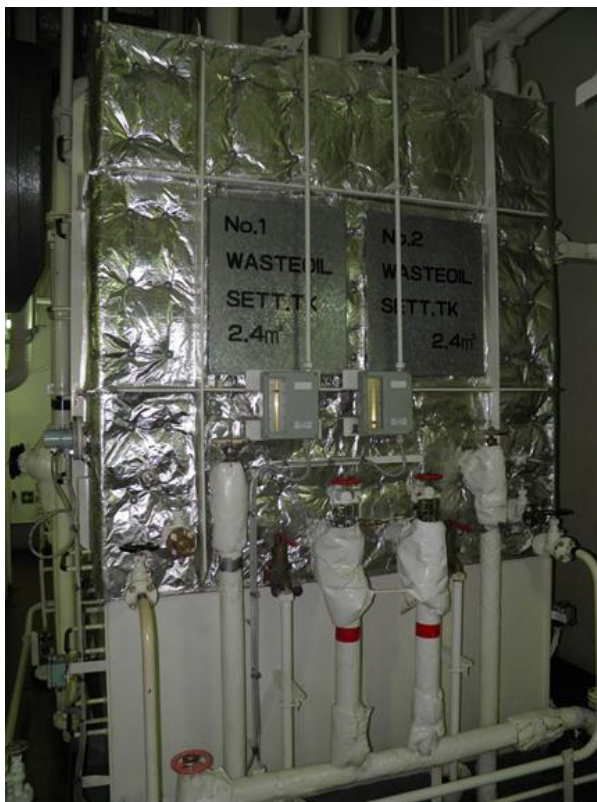
The Waste Oil Settling Tanks

- The accumulation of oil sludge mud to the bottom of the tank caused the jamming of the level gauge float and the clogging of the drain valves.
- The Waste Oil Settling tank was not fitted with sounding pipes, and the malfunctioned level gauge was the only available means for indicating the remaining quantity in the tank.

Highlight to the crews of their managed vessels the importance of applying precautionary measures during the opening of a tank when the remaining quantity is not provided by direct and credible means.

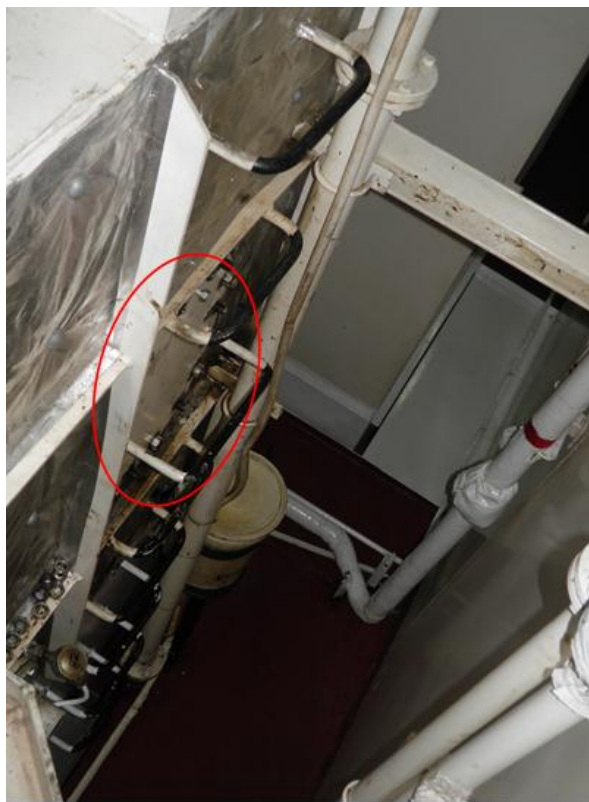
They opened the drain valves and when they presumed that the tank had emptied the 3rd Engineer begun to slack the nuts of the tank's manhole cover located at the mid-height of aft side of the tank. Having in mind that the tank had been emptied, the 3rd Engineer slacked all the nuts of the manhole cover except 4 nuts at the upper part of the cover which were slacked by half a turn. Then he pulled the manhole cover to open it; however when the cover detached from the cover seat hot sludges from the tank at a temperature of approximately 85°C splashed on to his body.

The manhole at the aft side of No2 W.O.S. Tank

- The 3rd Engineer did not apply the common practice for the safe opening of the manhole and didn't use the manhole's jackscrews.
- Potential hazards related to the remaining quantity in the tank and the faulty level gauge were not identified during the process of the Job Hazard Analysis.
