**HELLENIC BUREAU FOR MARINE
CASUALTIES INVESTIGATION
(HBMCI)**

MARINE ACCIDENT INVESTIGATION REPORT

04/2013

**FOUNDERING OF TUG BOAT “ARTEMIS V” DURING THE DEPARTURE PROCEDURE OF
M/V JSM**

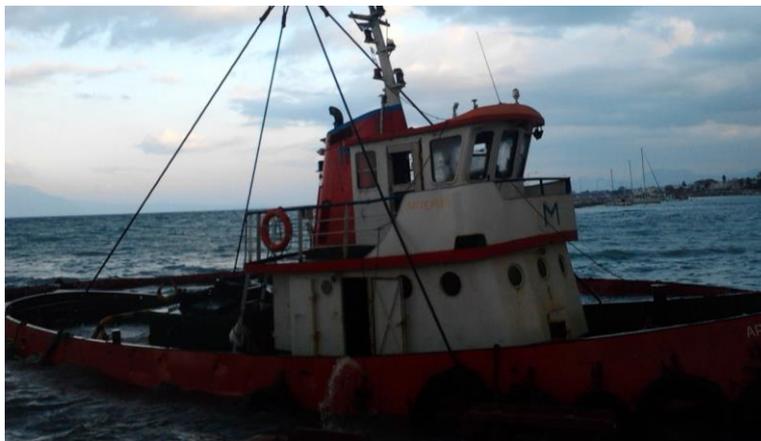
Figure 1: T/B “ARTEMIS V”, P.R.2001 During the refloating operation in Kiato Port.

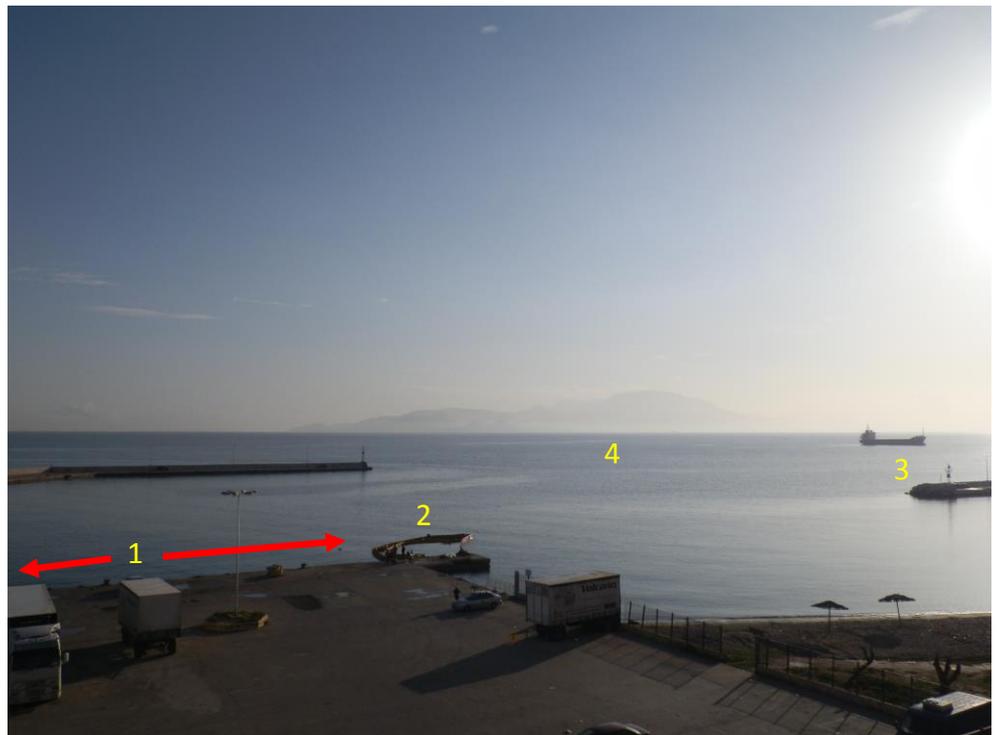
Figure 4: View of Kiato port.

- 1: Point of berthing of “JSM”
- 2: Point of sinking of T/B
- 3: End part of fishing vessel refuge
- 4: Port exit

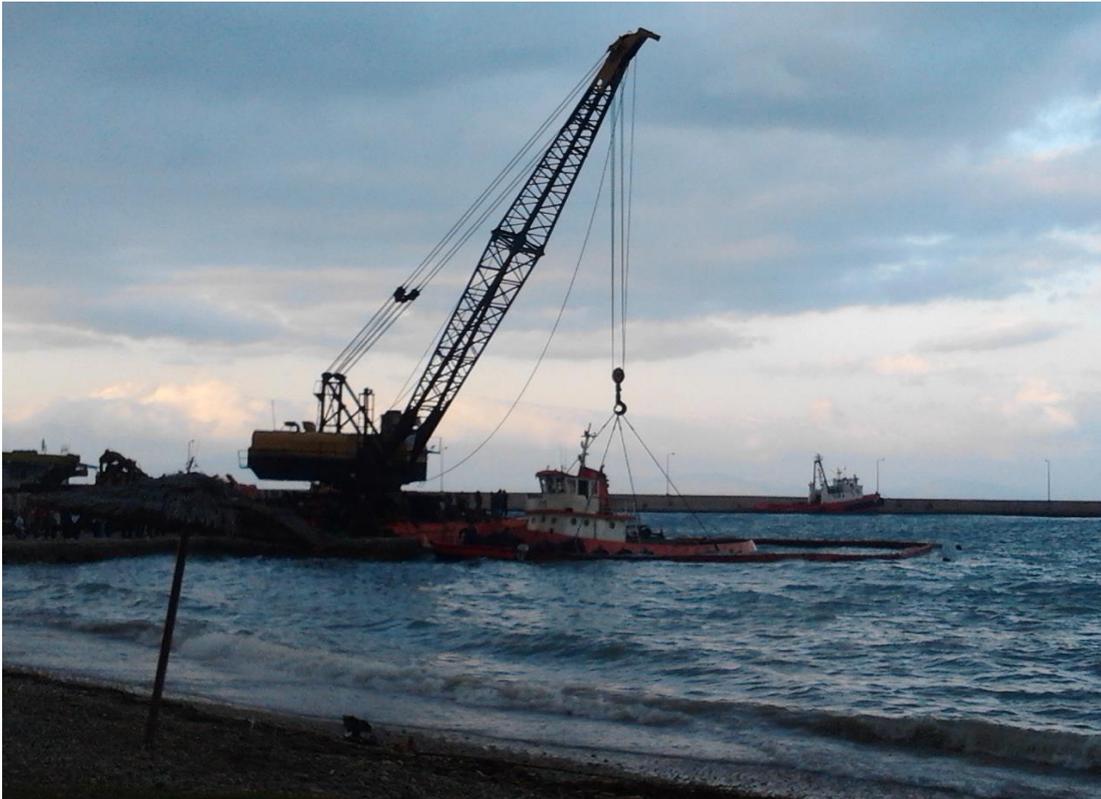
Figure 5: Refloating of T/B ARTEMIS V in Kiato Port, by a heavy lift barge.

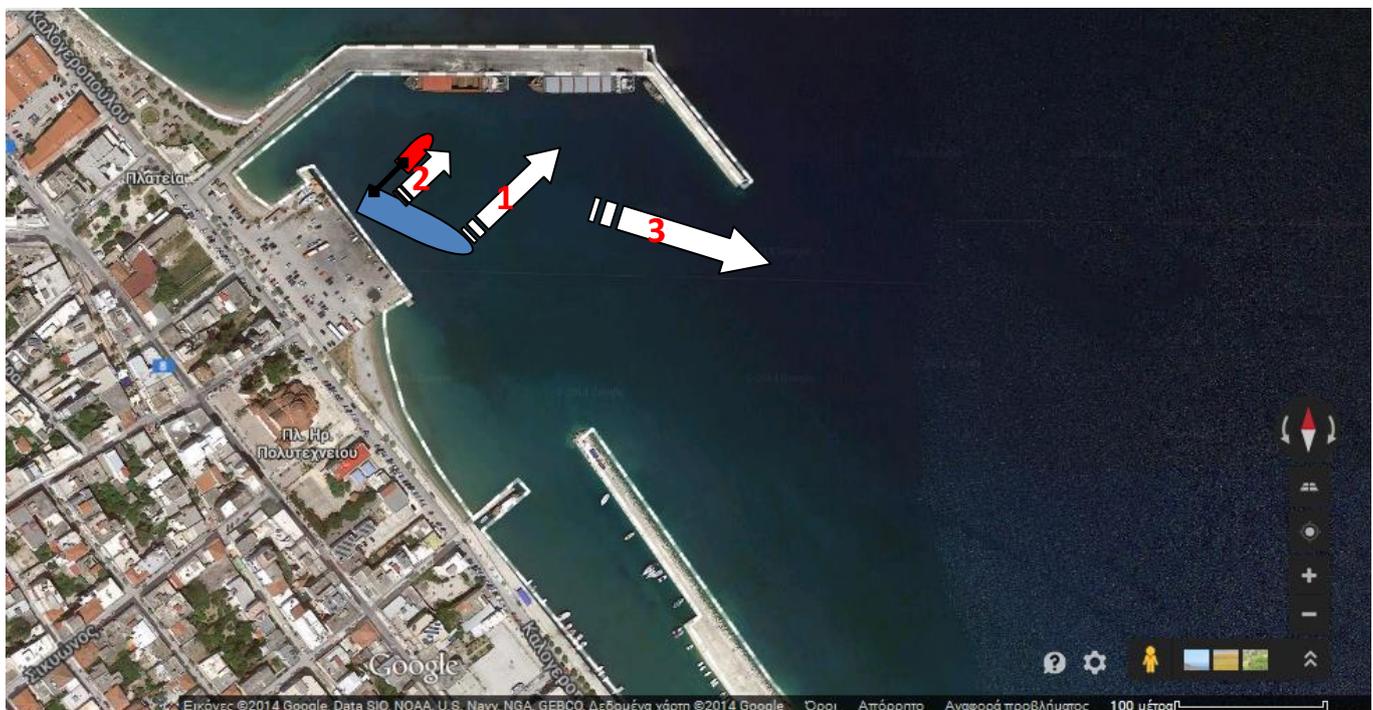
Figure 6: Schematic illustration of the maneuvering as planned by the Master of JSM (blue vessel):

- (1) casting the bow off the dock by vessel's lines,
- (2) sheering vessel's stern off the dock by ARTEMIS (red boat), so that JSM was able to bound to port exit,
- (3) JSM exit from the port with her means.

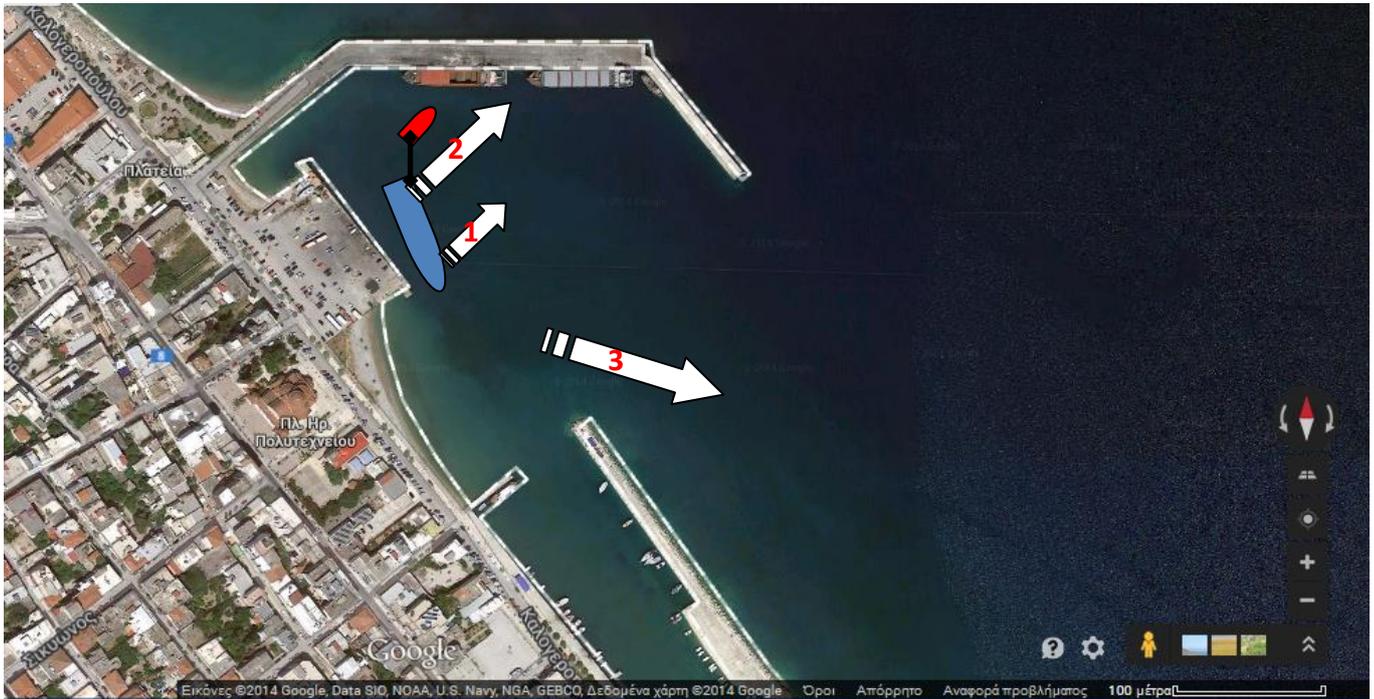
The actions that followed were not part of the Master's planning and could only be considered as instinctive counteract actions for the avoidance of the inherent risk of Ship's impact or grounding, which eventually led to the foundering of the ARTEMIS V.

Figure 7: Schematic illustration of the maneuvering of JSM (blue vessel):

- (1) casting JSM bow off the dock by vessel aft spring line,
 - (2) sheering JSM stern off the dock by ARTEMIS V (red boat), causing a rapid turn of JSM bow to starboard and towards the dock, rendering ship's position in a hazardous situation in relation to her safe exit from the port.
 - (3) JSM exit from the port with her means while pulling ARTEMIS V as she was being dragged on sea bed.
- (The dimensions of vessels and towline are not scaled. Map Source: Google Maps, <http://maps.google.com/>)

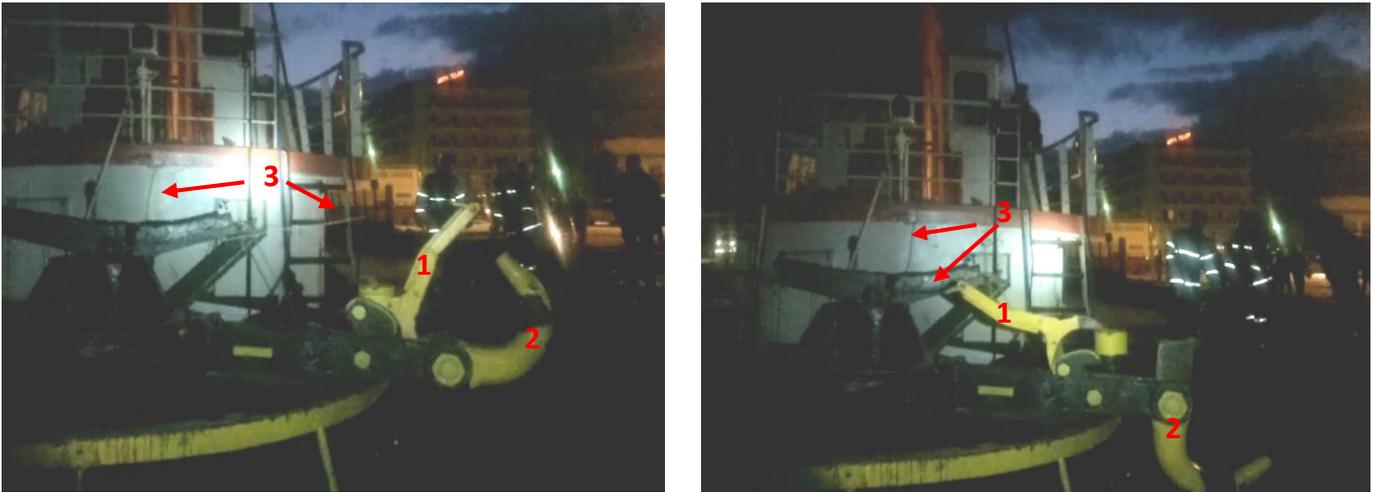
The arrangement and operation of the towline's quick release mechanism of ARTEMIS V is mechanical and provides only one mode of activation. More specifically, it consists of a jointed arm coupled to the base of the towing hook which is connected with a wire that passes through two metal buckles towards the bridge where it enters through a simple hole on the superstructure and ends to a handle mounted above the aft port window of the bridge of the Tugboat. (fig. No 8 and 9).

The handle is not supported by a permanent arrangement and simply remains hanging by the wire, practically as a pendulum, next to the port aft window of the bridge superstructure.

Fig. 8: Arrangement of the quick release mechanism of ARTEMIS V. The releasing phases prior to activation (on the left) and past activation (on the right). 1: Hook fastening arm, 2: Towing hook, 3: Release wire from the coupled jointed arm to the bridge.

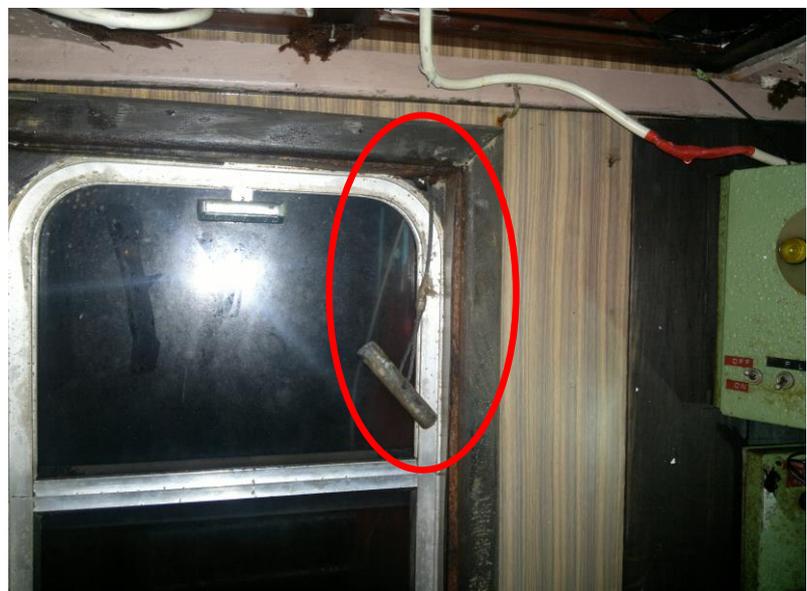
The release handle arrangement was not ergonomically designed and mounted so that the Skipper is able to immediately operate it, particularly in emergency situations of heeling or listing. The release handle's mounting was almost two meters away from the maneuvering position and the engine's lever controller which was actually the position of the Skipper during the towing and maneuvering procedure. Aforementioned arrangement may be described as a simple construction with no specific technical safety standards for its sufficient operation at all potential dangerous situations due to heeling such as the one in which the ARTEMIS V got into. Additionally said arrangement could not

Fig. 9: The quick release activation handle inside the bridge of ARTEMIS V.

facilitate the direct and prompt activation from the navigating position.

The operation of the quick release mechanism was inspected after the salvage of ARTEMIS V and it was found to be functioning adequately. However the testing was not performed with the towing hook under tension due to the condition of the Tugboat.

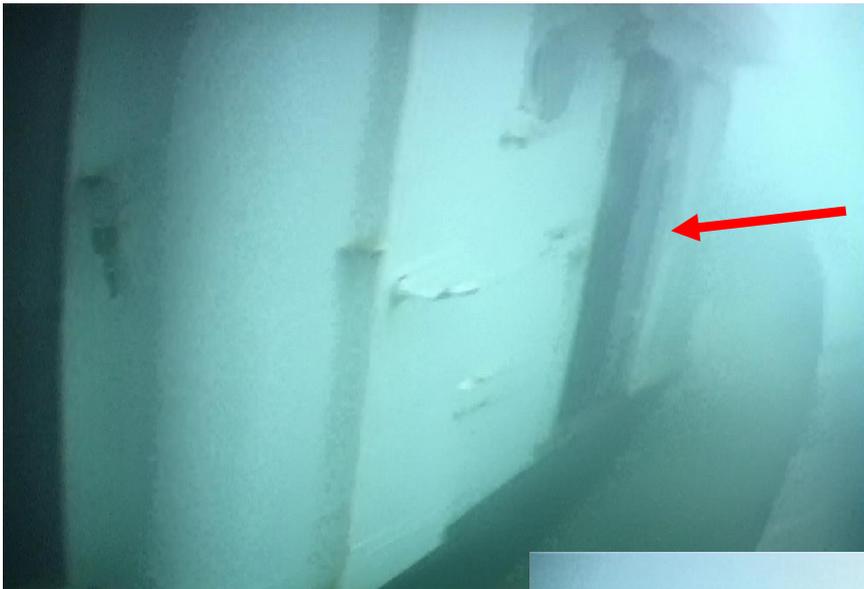
The watertight and weathertight openings of a Tugboat must be closed operations to ensure its watertight integrity. The investigation process found that the watertight and weathertight openings of ARTEMIS V ie skylights and superstructure's doors were open during the towing (Fig. 10 and 11).

Fig. 10 (port): picture of the sunk Tugboat. The starboard watertight door (red arrow) provided access to the engine room through a staircase was found in open position.

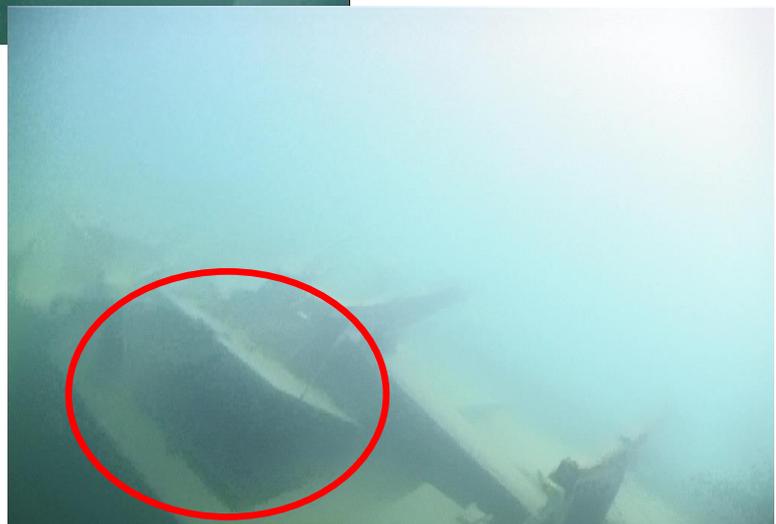
The ongoing tension applied by the towline to the Tug via its towing hook, caused a rapid and increasing list until the submersion of the deck edge. From that point onwards, given the inflow of seawater by the openings as mentioned above, there was a rapid change of the displacement and therefore a shift of the center of gravity of the Tug, which resulted to the loss of her stability and her foundering.

Fig. 11 (starboard): The Tugboat ARTEMIS V submerged. The starboard weathertight openings on top of the engine room (skylight) were found in the open position (inside red circle).
