HELLENIC BUREAU FOR MARINE CASUALTIES INVESTIGATION

MARINE CASUALTY SAFETY INVESTIGATION REPORT
08/2014

GROUNDING OF YUSUF CEPNIOGLU
ON MYKONOS ISLAND ON 08-03-2014

May 2017

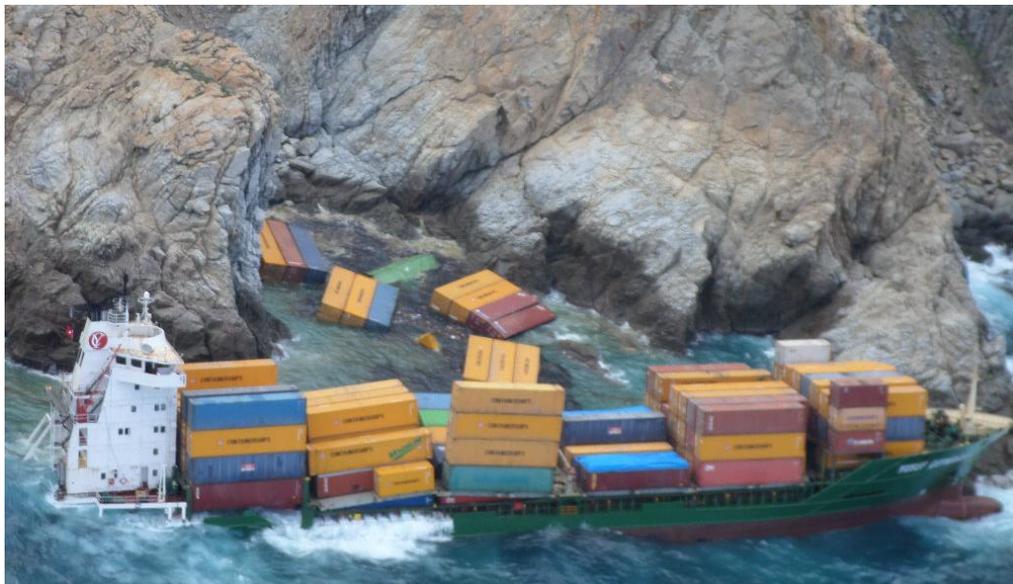
Figure 1: YusuF Cepnioglu grounded at Mykonos Island.

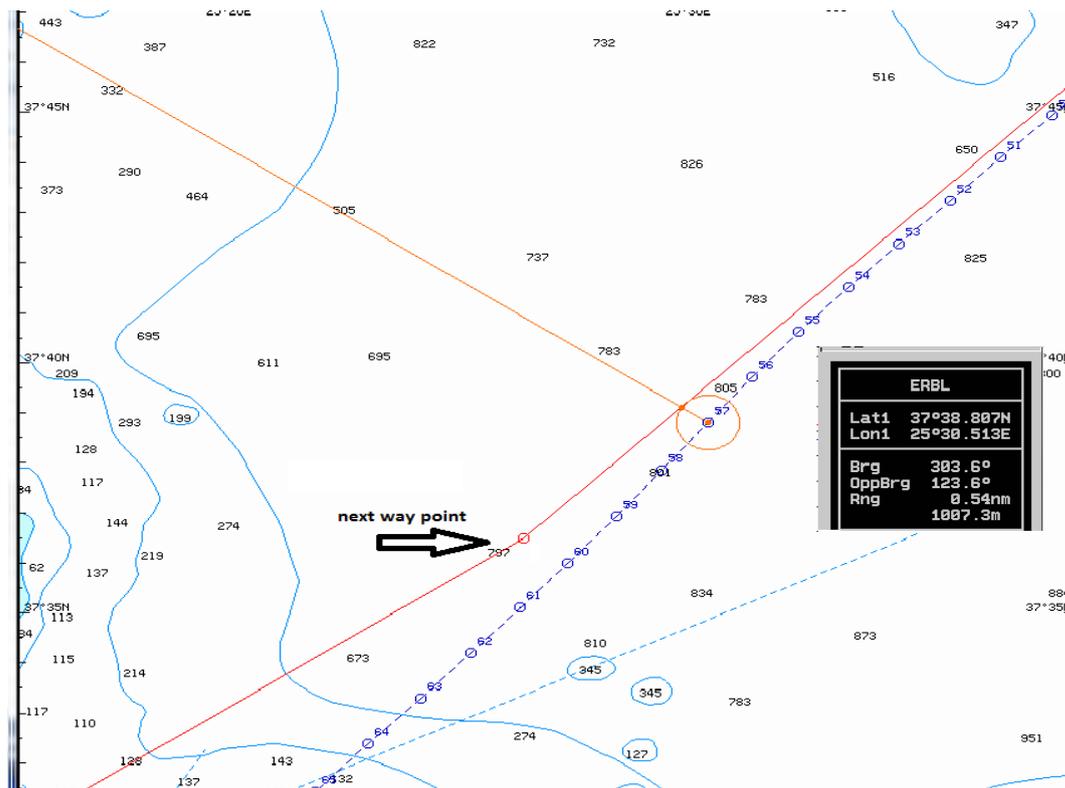
Figure

Furthermore, it was reported that at around 04:30, Yusuf Cepnioglu course, position and track were observed and she was found to be at a 16 to 18 nm distance, almost an hour and 30 min, far from the next way point where course should be altered for crossing the area between Tinos and Mykonos. However, said distance from the next way point was not confirmed as according to AIS data extracted from available sources, at that time Yusuf Cepnioglu was underway approximately 4 nm from the next waypoint, sailing with a speed of 12 knots. More specifically at 04:27:25 she was at position Lat. 37° 39' 43" Long. 25° 31' 28" sailing with COG of 221° and a speed of 12 Knots while at 04:33:26 she was at position Lat. 37° 38' 48" Long. 25° 30' 31" sailing with COG of 219° and the same speed. Moreover, the vessel's position was slightly off course that is 0.54 nm to port (Figure 6). However, the Chief Officer did not make any correction to the course and he sat on a chair next to the radar where he fell asleep. Consequently the vessel proceeded with the same heading towards the north coast of Mykonos.

6. Ship's position at 04:30, (position 57). VRM (Variable Range Marker) shows the extend of drifting to port.

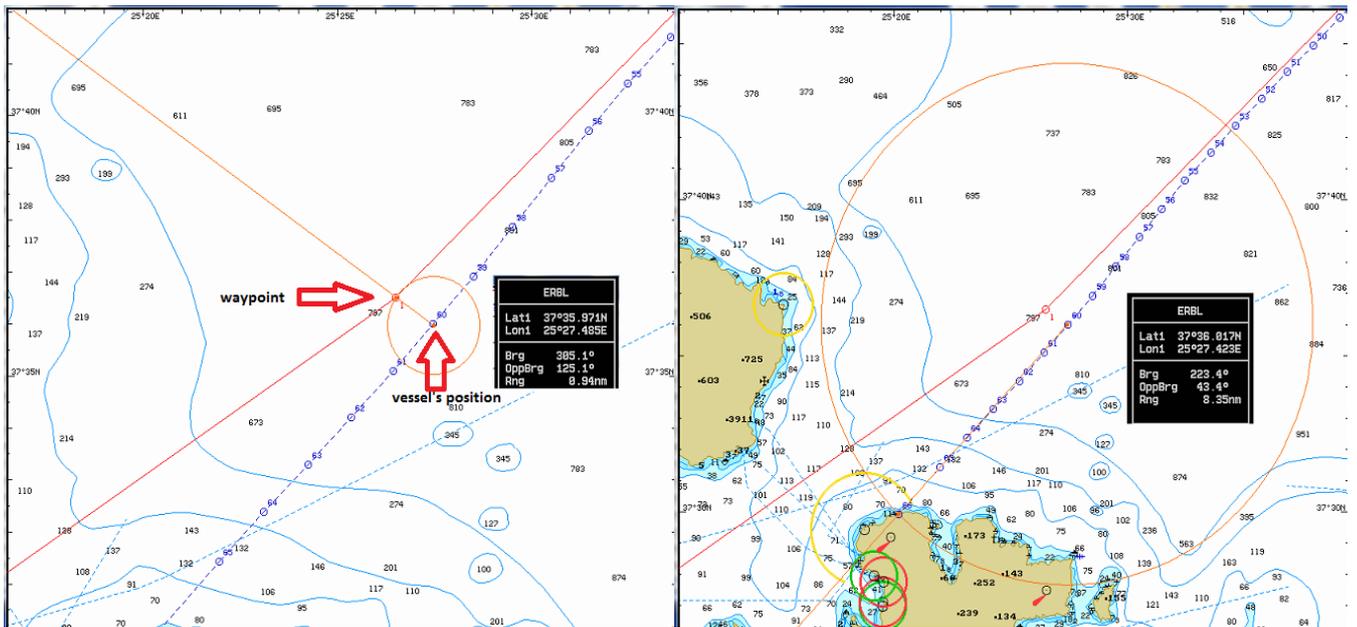
At approximately 04:51, Yusuf Cepnioglu was almost 1 nm southeast from the next waypoint sailing at a speed of 12.3 Knots and her COG was recorded at 222°, that is 14° to port from the course of 236° which was planned for the crossing the area between the two islands. Moreover the vessel's position was at a distance of 8.35 nm from the

grounding position. Nonetheless, the C/O was asleep and did not make any alteration to the course (Figure 7).

Figure 7: Ship's position at 04:51. VRM (Variable Range Marker) shows the extend of drifting to port and distance from the grounding point.

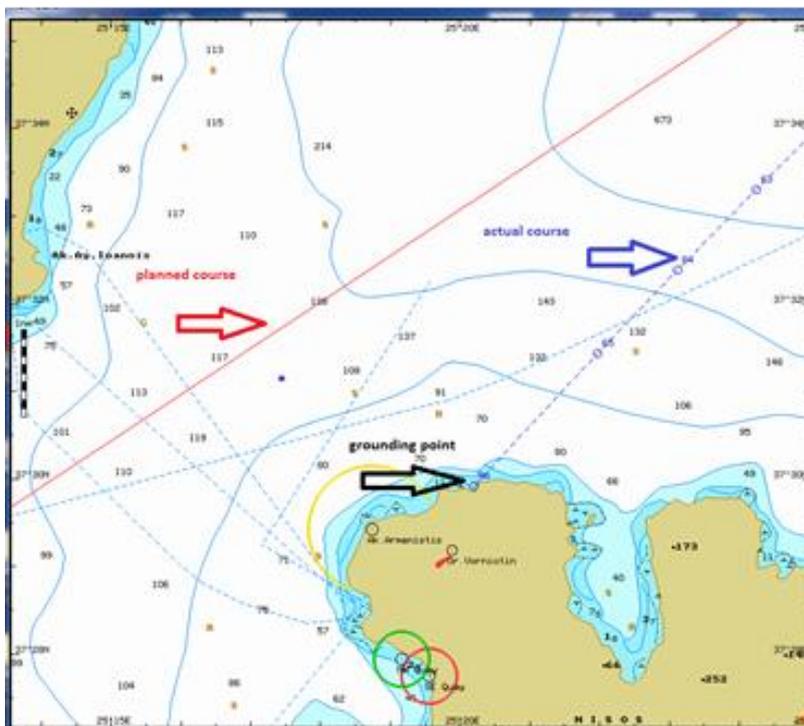
As the C/O who was the only one on the bridge fell asleep on the chair next to the radar shortly after 04:30, Yusuf Cepnioglu kept sailing with an unattended bridge, maintaining her course towards the rocky shoal at the north coastline of Mykonos where she grounded with her fore section at 05:30 with a speed of 12.2 knots (Figure 8).

Figure 8: Vessel's course towards the grounding point while bridge was unattended at 05:10, 05:16 and 05:22.

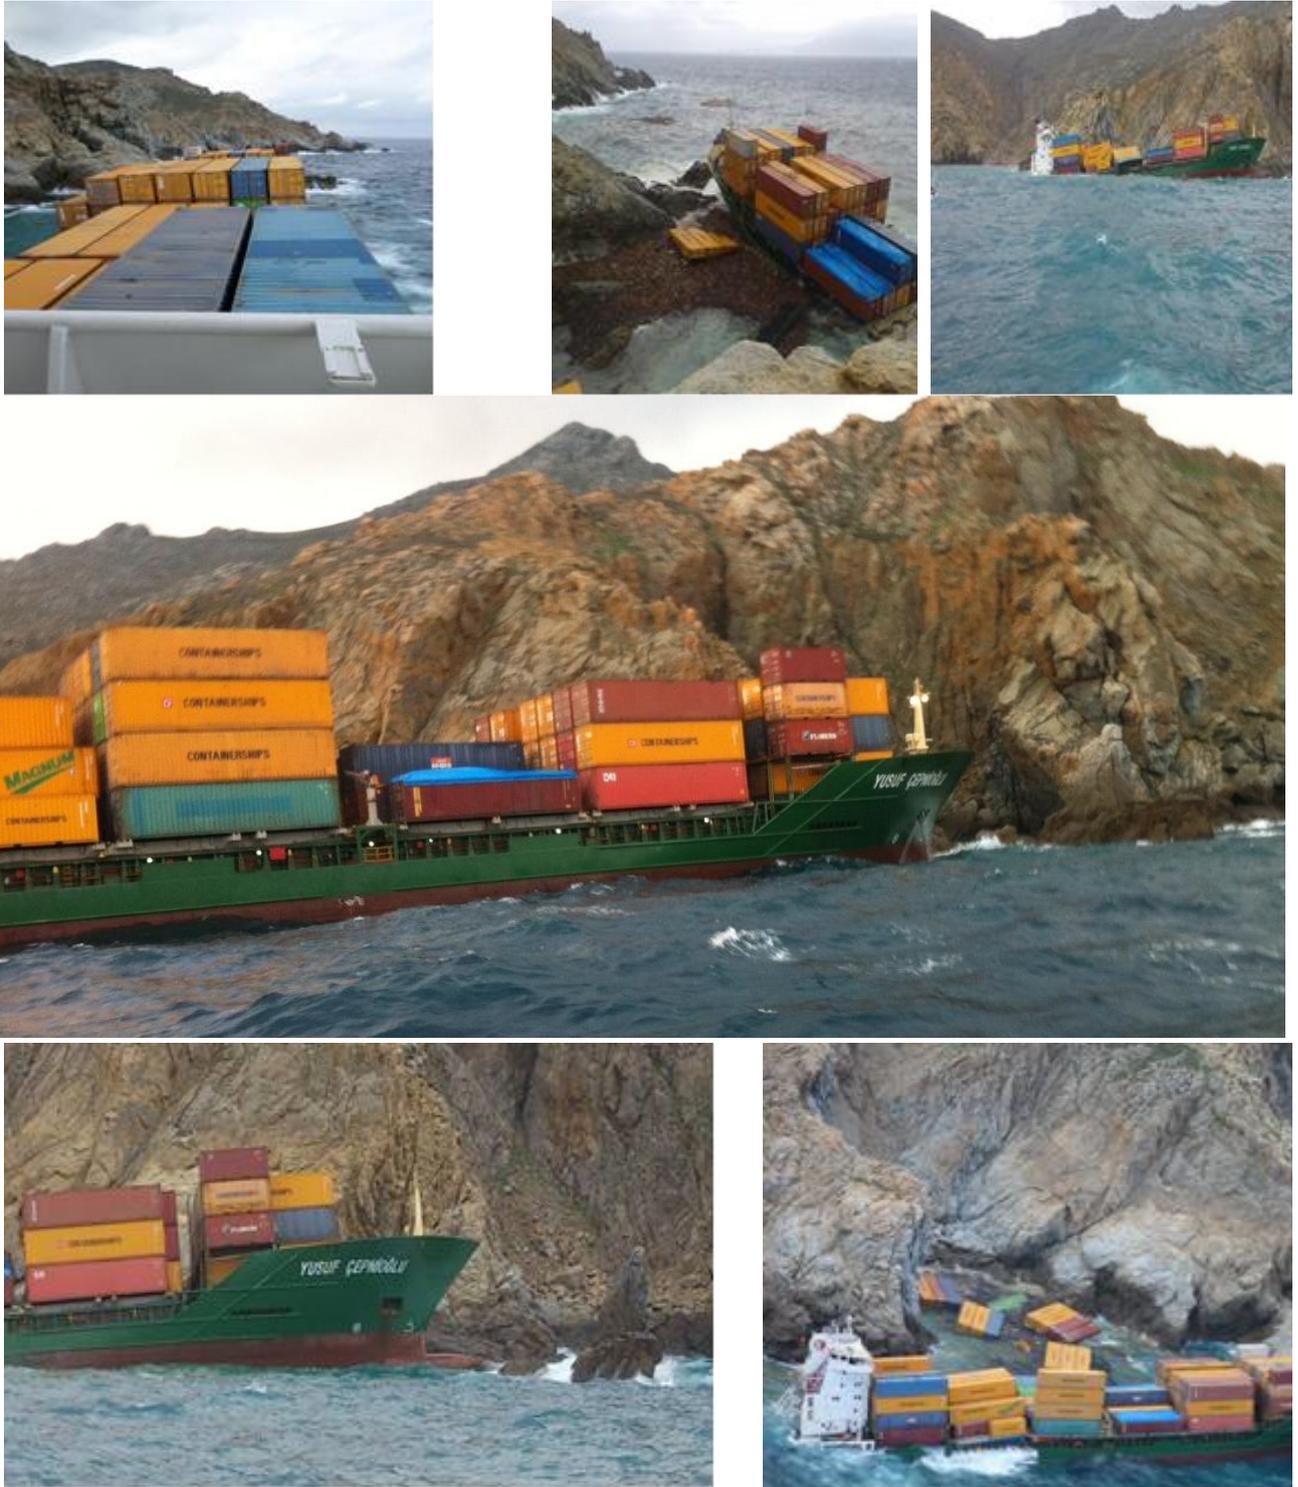
Figure 9: Photos from the vessel grounded at the north coast of Mykonos Island.

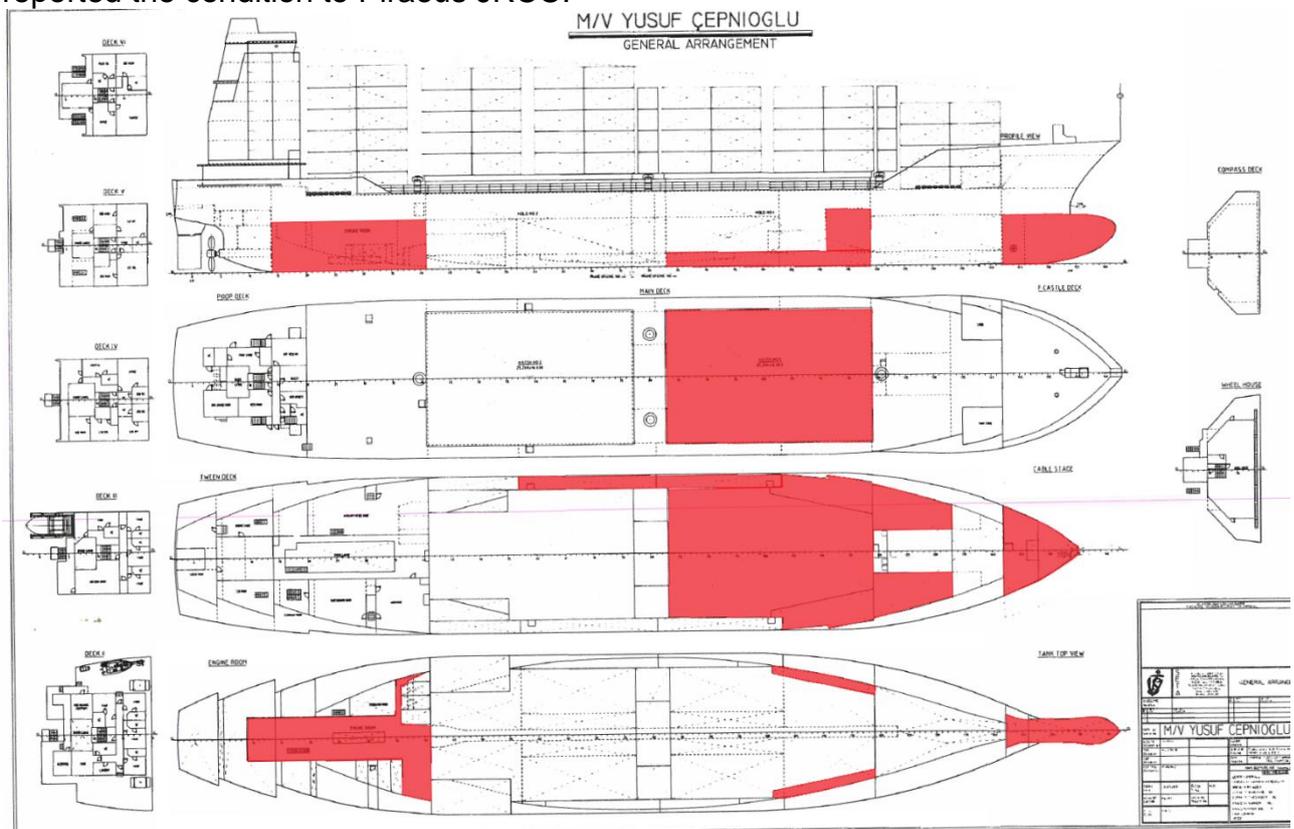
The vessel suffered extensive cracks and indentations on her foresection and port side, mostly lengthwise, and more specifically at Forepeak Tank, Collision Bulkhead and No. 1 Cargo Hold. Port and starboard side Wing Ballast Tanks and Deep Tank were also affected and breached due to the heavy contact with the rocky seabed. Several compartments including engine room and cargo holds were flooded and pollution from bunkers was reported. None of the crew was injured.

The Master also visited the forecastle, together with the Chief Officer, to check the damages and evaluate the situation. From the visual inspection and sounding of the forepeak tank it was reported that forepeak level had increased from 40mt before grounding to 110mt. In addition, the water level in the vessel's deep tank had increased from 500mt to 600 mt and inside the wings tanks from 0 mt to 100 mt. Moreover, the watertight bulkhead of cargo hold No.1 had bended and cracked and water was leaking inside the hold at a low flow rate of approximately 2-3 liters per minute. No damages to Cargo hold No.2 and no pollution to the sea were reported (Figure 10). At approximately 08:25, the crew had completed the evaluation of the vessel's damages and the Master reported the condition to Piraeus JRCC.

Figure 10: Indicative depiction of damaged areas of Yusuf Cepnioglu

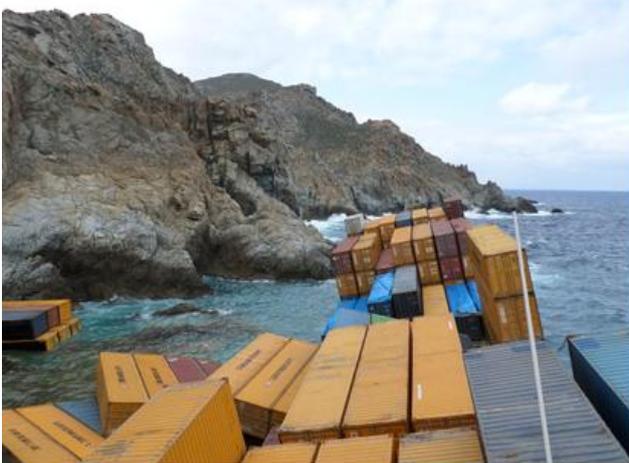
Due to the deterioration of the weather conditions, from 4-5 bf NE to 6-7 bf N, the ship kept hitting harder against the rocks alongside her port side. As a result the water ingress inside vessel's tanks increased and the vessel listed around 5° to port. Shortly before 09:30 and after a strong hit on the rocks, the Chief Engineer informed the Master that the engine room had suddenly flooded, bilge well level was quickly rising up and fuel tanks were almost full. The vessel's list had increased to 20° portside and some containers toppled into the sea at the port side between the vessel and the rocky coast. At the same time the vessel's bunkers started to leak into the sea and an oil spill was observed.

Figure 11:
Yusuf Cepnioglu listed to portside with some containers toppled into the sea.

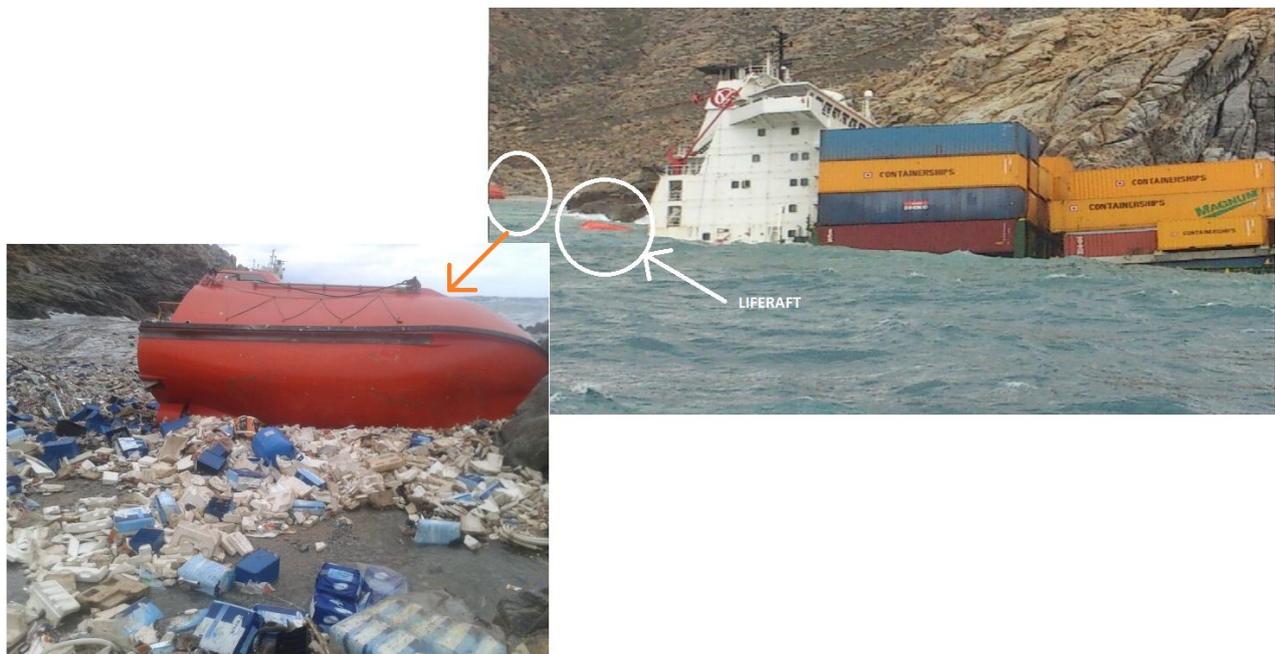
Then they attempted to abandon the vessel by launching the rescue boat and the life raft located at the vessel's port side, but due to the close proximity of Yusuf Cepnioglu to the rocks and the heavy rolling of the ship, the rescue boat was capsized and smashed into the rocks, while the life raft had drifted and later was casted ashore.

Figure 12: Yusuf's Cepnioglu lifeboat casted ashore and life raft as was found after the evacuation procedure

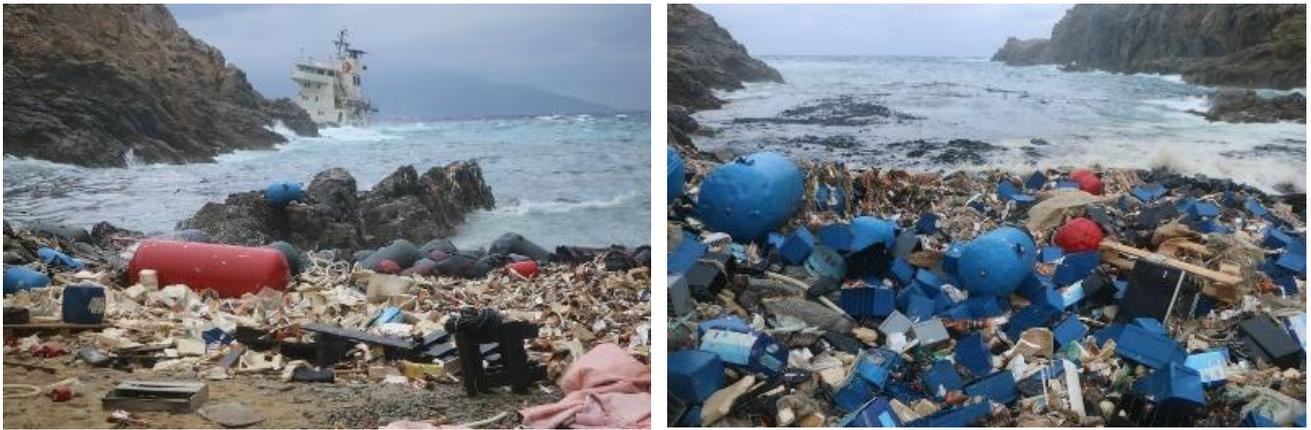
Substantial quantities of debris were washed up to the nearby area of "Korfos bay" as well as the nearby islands and other inlets. More specifically at the nearby local area of "Armenistis bay" cargo debris covered with fuel oil residues were washed ashore in an area of approximately 1,000 m², as well as in the sea area forward of the vessel's bow estimated to approximately 1,000m². The cleanup operation lasted several weeks and over 500m³ of debris were collected with the assistance of volunteers. Oil booms were positioned around the vessel as well as near the local power and desalination plants to prevent any further pollution.

Figure 13: Cargo debris washed up on the nearby coastline.

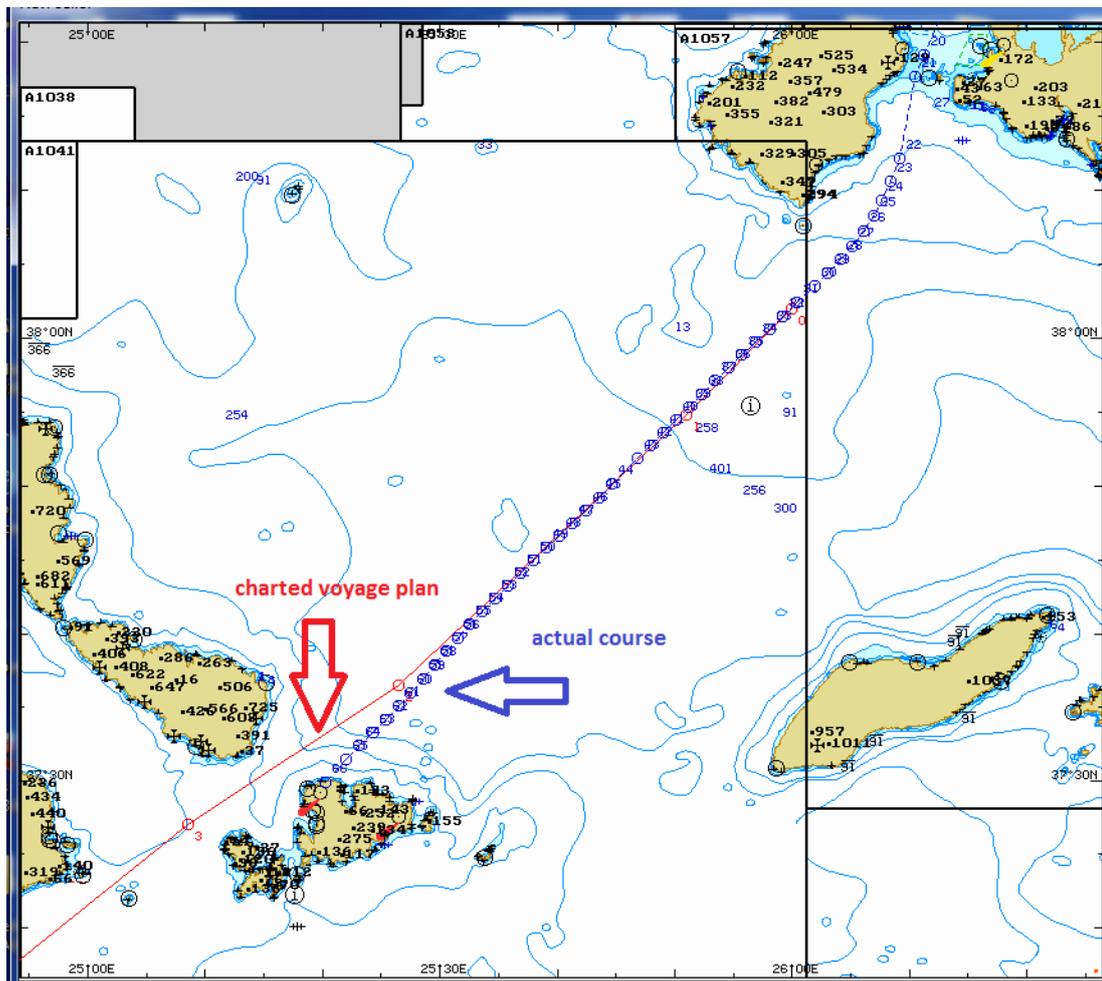
Based on the aforementioned data, the course of the casualty vessel was projected on an electronic chart, in order to reconstruct the passage leading to her grounding. An overview of the plotted positions is presented in figure 14, in contrast to Yusuf Cepnioglu’s planned course, as recorded at the navigational chart.

Figure 14.: Yusuf Cepnioglu voyage plan and positioning data as plotted on electronic chart.

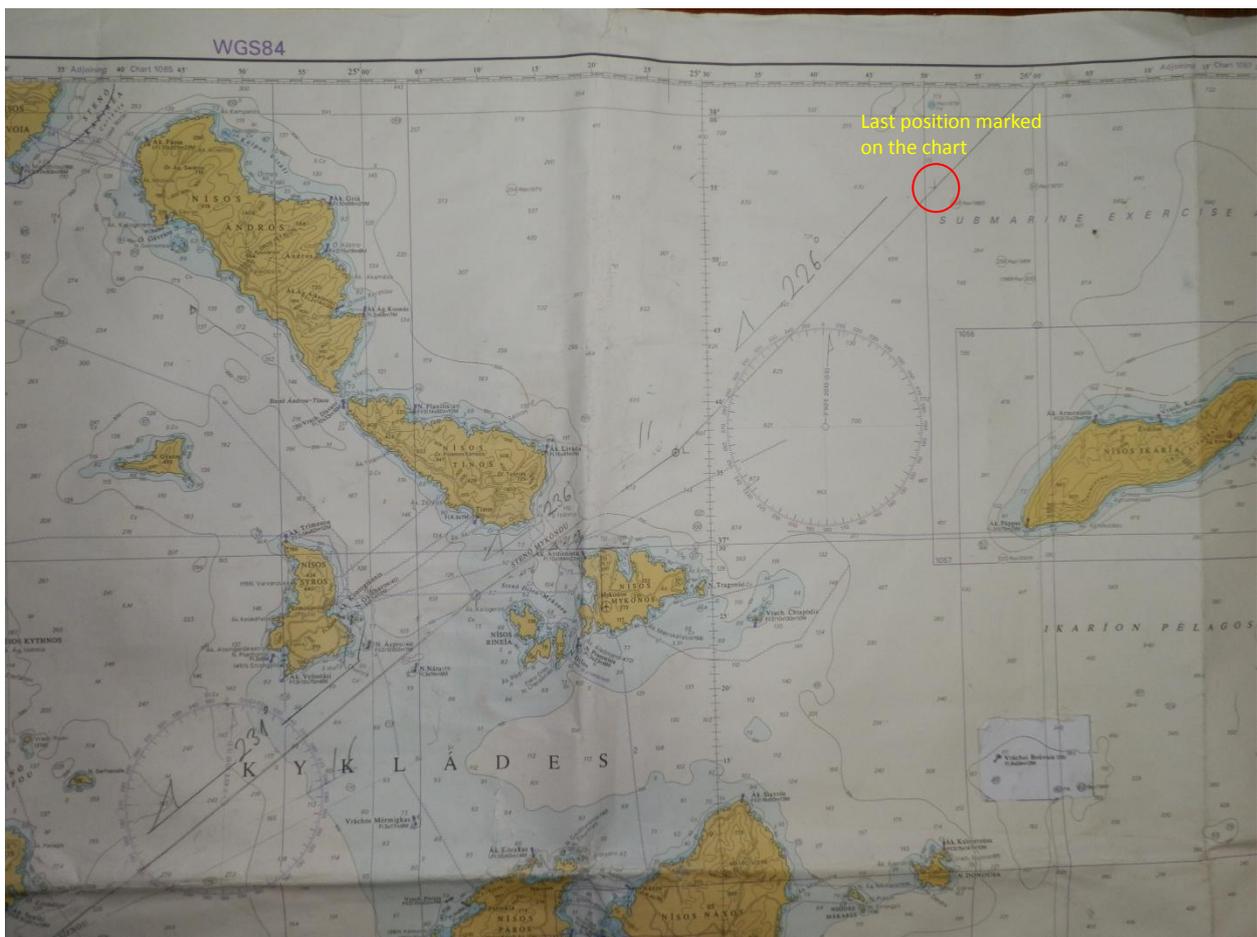
Examination of the used paper chart showed that the vessel's positions, prior to the casualty were not recorded on an hourly basis, and the last one was recorded at 02:40 almost three hours before her grounding. It is noted that at 04:00 when the C/O relieved the 2nd Officer and took over the watch the vessel's position was not marked on the chart as well. This indicates a systematic disregard by the OOWs to standard navigational procedures concerning the monitoring phase of the passage planning which allows the OOW to remain inactive for a period of time and it increases the potential for him to fall asleep.

Figure 20: The last position recorded on the chart by the OOW
