**HELLENIC REPUBLIC
HELLENIC BUREAU FOR MARINE CASUALTIES INVESTIGATION**

**MARINE CASUALTY SAFETY INVESTIGATION REPORT
10/2013**

Within the aforementioned framework HBMCI has been examining the fatal injury of a track trailer driver, occurred on board ROPAX Sorrento following her departure from the port of Igoumenitsa-Greece, on the 10th of July 2013.

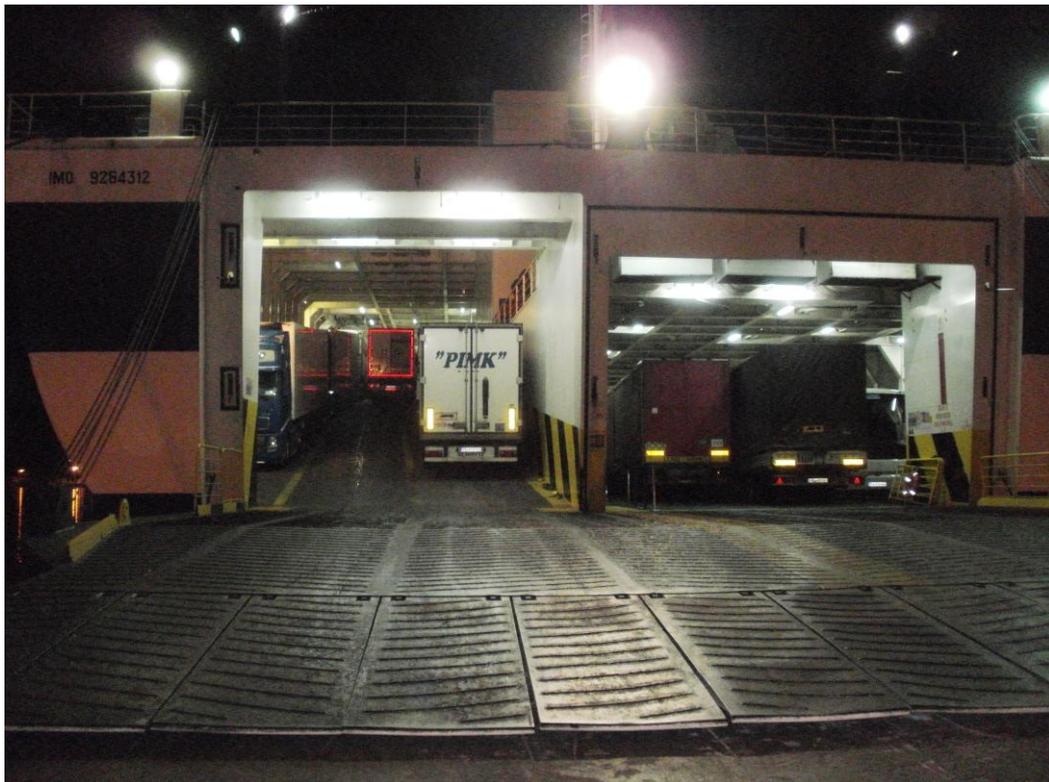
The permanent ramp was loaded with 09 tractor semi-trailers which were the last trucks to enter Sorrento before her departure from Igoumenitsa, as vehicle deck No 4 had already been fully loaded (figure 8).

Figure 8. The arrangement of the parked tractor semi-trailers post to the marine casualty. Shifted truck and parked truck at Lane no 2 have been unloaded.

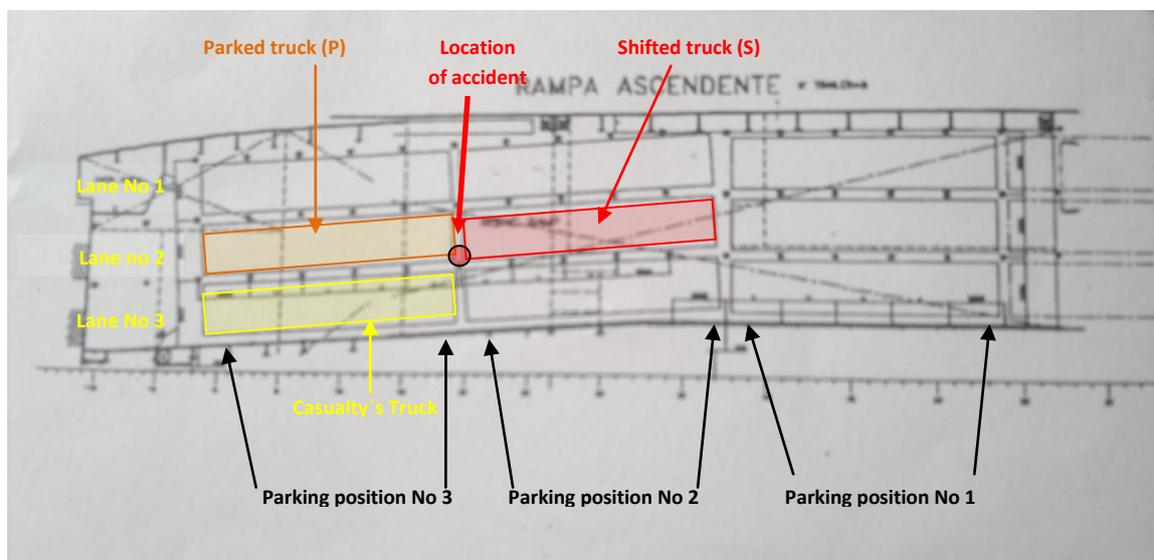
- The tractor semi-trailer S (*S stands for shifting*) entered the loading ramp and was guided by Sorrento's deck crew to parking position no 2 of Lane no 2.
- The tractor semi-trailer P (*P stands for parked*) entered the loading ramp and was guided by Sorrento's deck crew to parking position no 3 of Lane no 2.
- The casualty's tractor semi-trailer entered the loading ramp and was guided by Sorrento's deck crew to parking position no 3 of Lane no 3 (figure 10).

Figure 9. Sketch of the tractor semi-trailers arrangement prior to the casualty. Parking lanes and parking positions also marked.

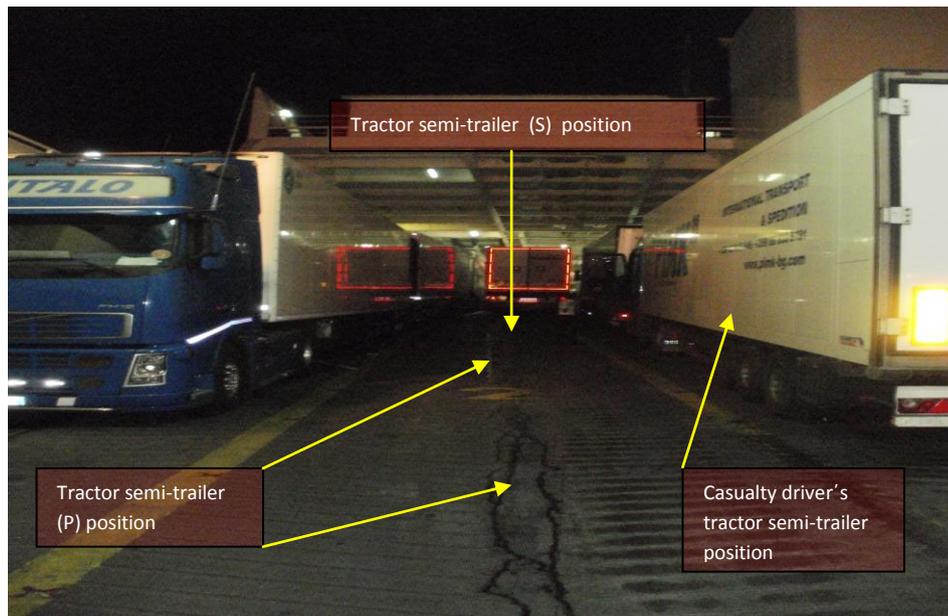
Figure 10. View of the permanent ramp with the tractor semi- trailers arrangement post to the occurrence.

Furthermore taking under consideration the location of the occurrence, it could be presumed that the casualty driver, having the intention to walk the accessible space between the front of tractor semi-trailer (P), that was parked beside his tractor semi-trailer and the rear of tractor semi-trailer (S), was probably on his way to the cabin of tractor semi-trailer (S), seemingly to its driver's door to meet his colleague-driver, that had parked on the front left of his truck, as shown in figures 9, 10 & 13.

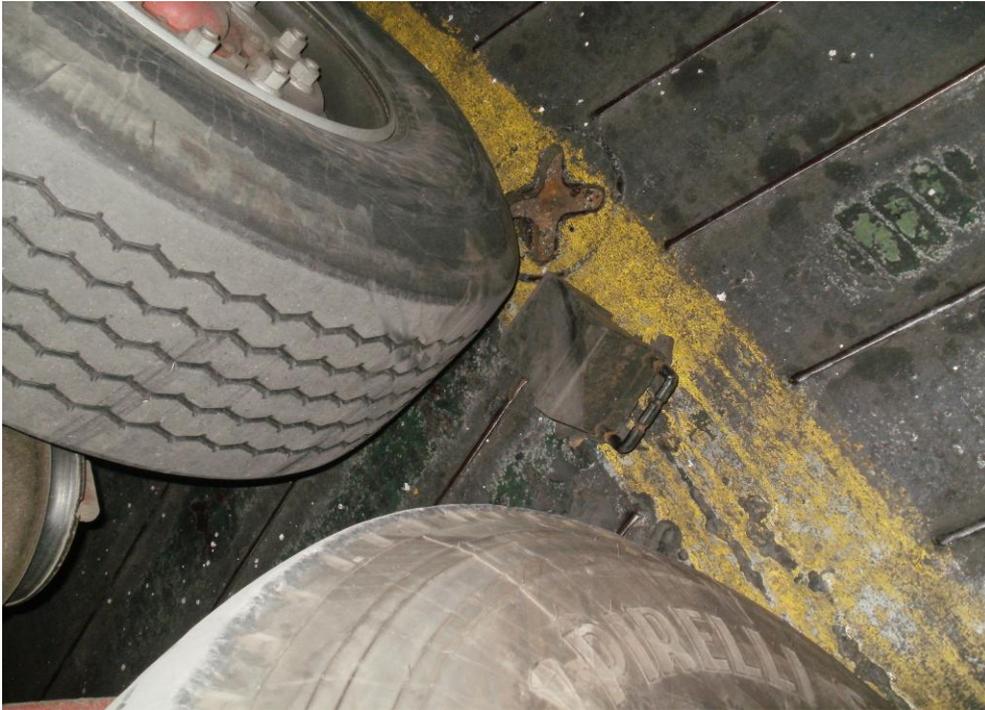
The driver of Truck (S) had parked shortly before at no 2 parking position of Lane no 2 of the permanent ramp. The AB that was securing the trucks placed two rubber wheel chocks at its rear no 2 axle wheels (figure 12). It was reported that

Figure 12. One of the chocks that were placed to secure the truck (S).

It is noted that chocks could be capable of restraining a freight vehicle from shifting at first, following its parking on deck, primarily on flat vehicle decks. It is underlined that chock securing is a supplementary restraining system to parking brake engagement and to the lashing arrangement while said methods are capable of securing a road transport unit and withstand the forces likely to be encountered while at sea.

Following consultation on said matter with tractor semi-trailers operators, truck drivers and ro-ro operators it was noted that the outcome of tests has shown that the restraining capacity of chocks placed on wheels of a transport unit significantly decreases mainly in relation to the increase of the sloping gradient and the weight of the freight vehicle.

transport unit from rolling and if deemed necessary, replace existing chocks in order to reinforce the restraining capacity.

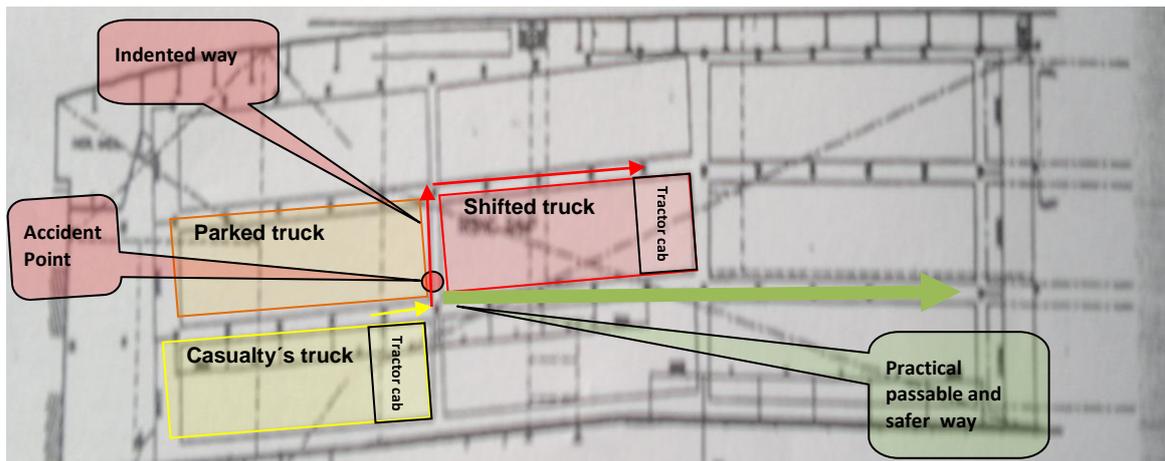
Figure 13. Sketch of the tractor semi-trailers arrangement prior to the casualty. Parking lanes and parking positions are also marked.

The truck driver that was attempting to pass between the two trucks was run over and stomped by the shifted tractor semi-trailer and was actually pinned between the rear of truck trailer (S) and the cab truck (P), parked at the end of the ramp (figure 13).

His colleagues (drivers) and the AB having heard the noise of the crash, ran to the scene and saw that the truck driver was trapped unconscious between the right side of cab truck (P) and the right side of the rear of the truck trailer (S), with his head and hands hanging motionless (figures 13, 14 & 15).

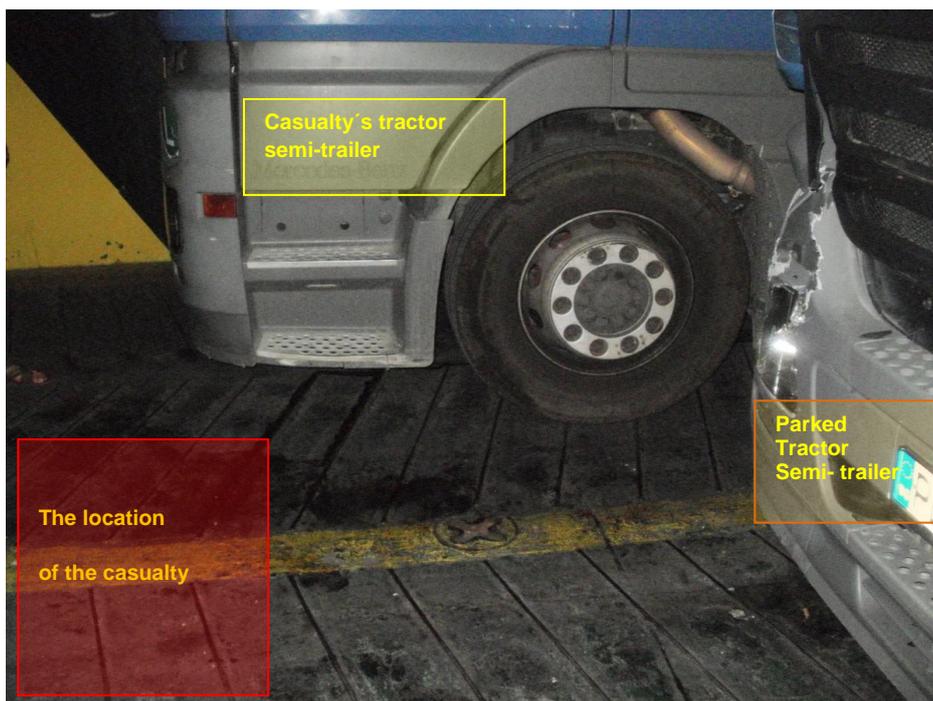
Figure 14. The location of the casualty post to the occurrence.

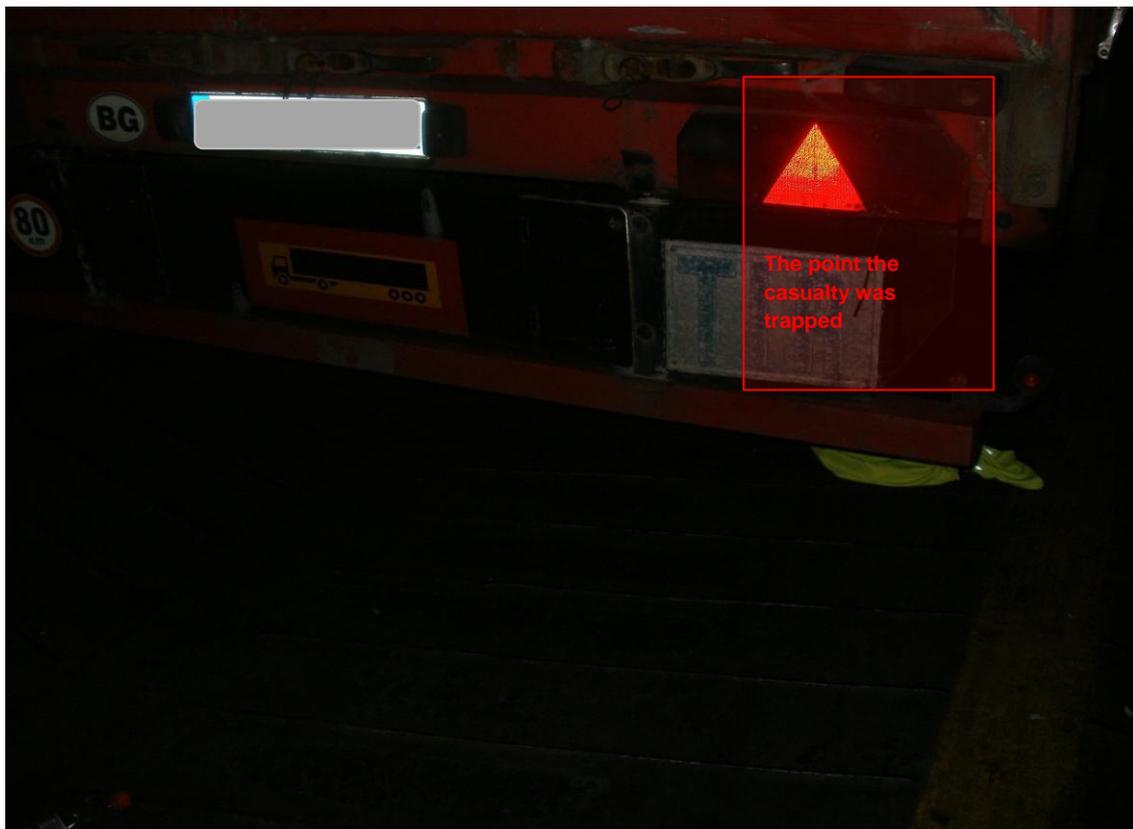
Figure 15. The rear of tractor semi-trailer (S) marked at the point the casualty was trapped.

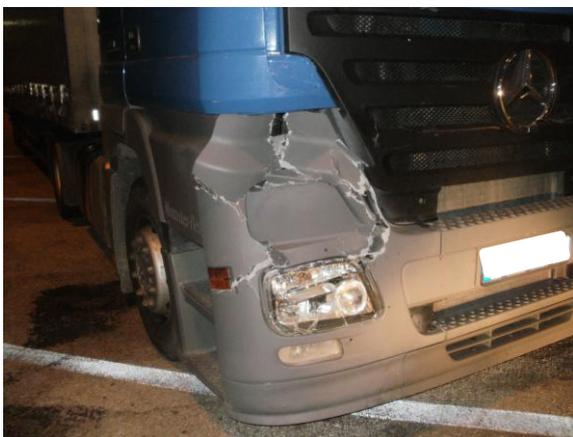
Figure 16. The damaged front right side of the tractor (P).

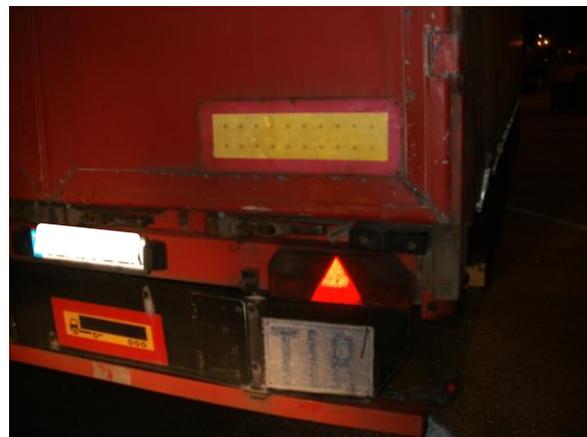
According to the results of the inspection the tractor semi-trailer (S) had a serious problem on its braking system at no 1 and no 3 axles while its braking system at no 2 axles was in good condition.

Figure 17. The right rear of semi-trailer (S).

- the truck was in general good condition and apart from the problem on its steering system, the hand brake mechanism and the braking system were functioning correctly.
- the trailer was found to have a serious problem with its braking application system, lopsided braking at no 1 and no 3 axles but the general condition

was reported as good, despite the aforementioned deficiencies. The condition of the truck as described above taking under consideration the evolution of events leading to the occurrence, is not alleged to have been a contributing factor to the accident, as referred problem is likely to contribute to road accidents yet not in the investigated case.

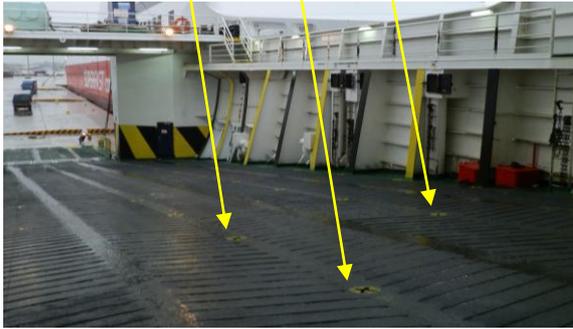
- (1) According to Sorrento’s Cargo Securing Manual the permanent sloped ramp from Deck No 3 to Deck No 4 was fitted with 33 securing points marked with yellow color for the lashing of loaded freight vehicles (figure 18).

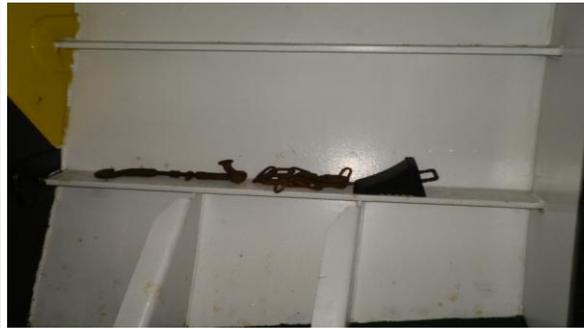
The permanent ramp was designed for the stowage of cargo transport units such as tractor semi-trailers with no structural restrictions and was equipped with chain lashings and rubber chocks (figure 19).

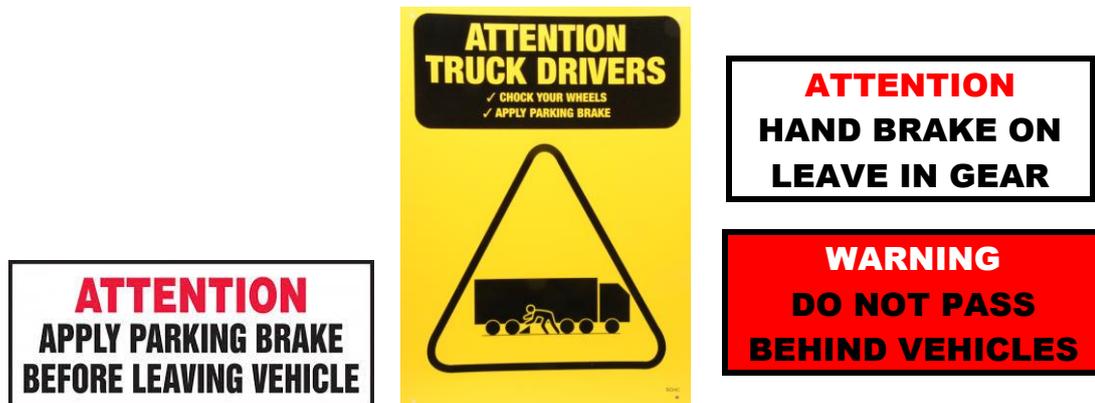
Similar marine casualties occurred, after trucks were shifted while ro-ro ships were underway, have highlighted that truck drivers may sometimes neglect to adequately apply the parking brakes before leaving their trucks and for this reason have to be reminded therein by the deck crew, as reported in paragraph 4.4.2 & 4.4.3.

Figure 20. Indicative signs that could be used in car decks

Based on the above many Operators of ro-ro ships have taken measures in order to draw the attention to drivers to apply the hand brake and engage gear once parked on a car deck and not to walk behind vehicles or transport units by warning signs, labels, posters and hand-held by crew instruction boards. Such methods are indicatively shown in figure 20.
