INTERIM REPORT

MARINE CASUALTY SAFETY INVESTIGATION

Death of one seafarer, one stevedore and serious injury of one stevedore

M/V IONIC

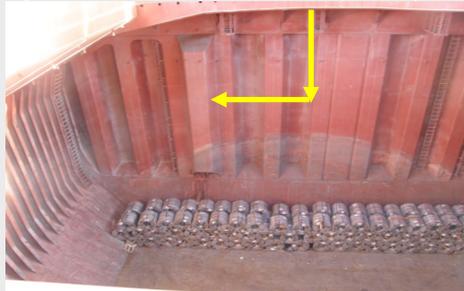
Cargo Hold No 1 showed from fore section. Duct is pointed in yellow.

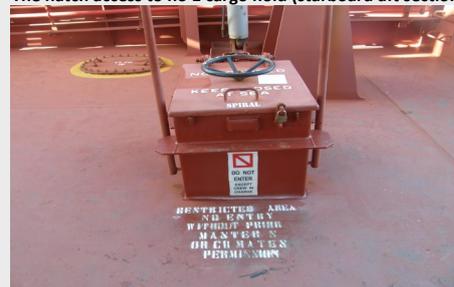
The hatch access to no 1 cargo hold (starboard aft section)

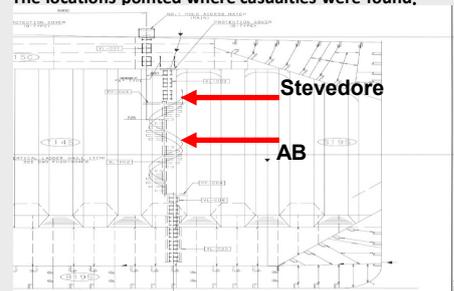
The locations pointed where casualties were found.
