Panama Maritime Authority
Directorate General of Merchant Marine
Maritime Affairs Investigation Department

M/V “NEW DIAMOND”

R-023-2021-DIAM

“EXPLOSION IN ENGINE ROOM”

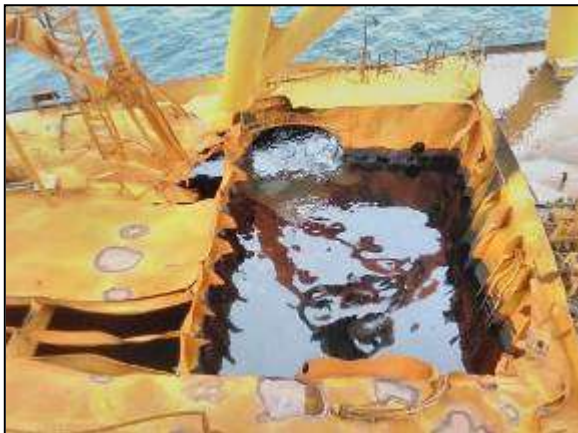
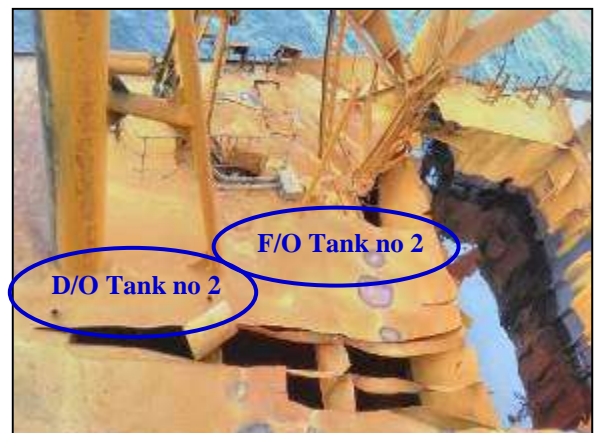
Port side F/O no 1, 2 and D/O tank plates blown off

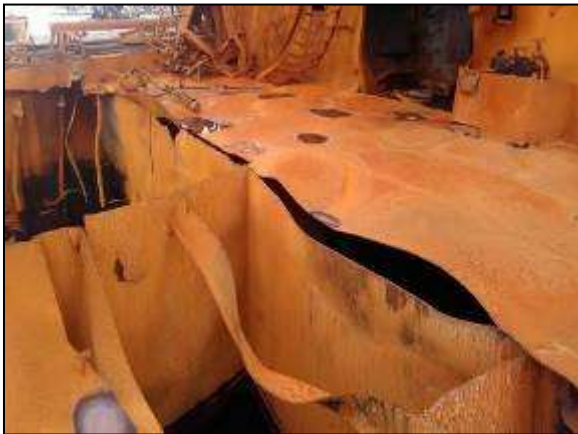
**Port Side F/O service & settling
tank in E/R**

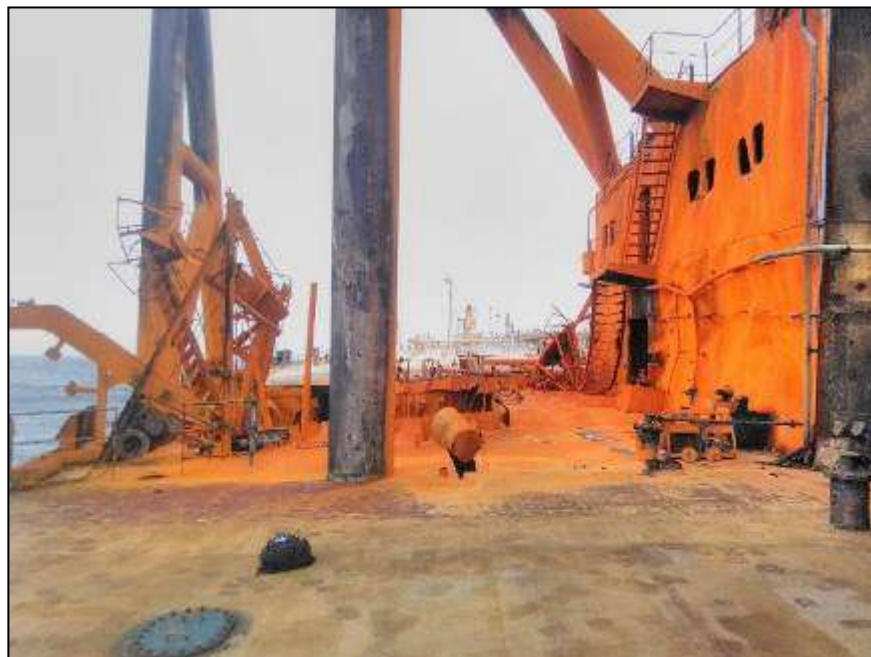
Aft of D/O tank no. 2 deck and in way of aft WB tank appears intact

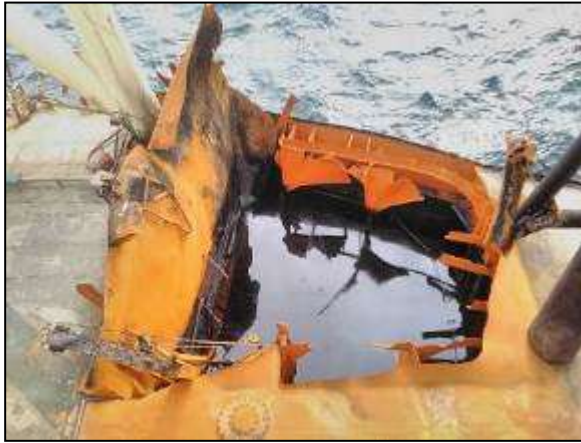
STBD side F/O tank blown off

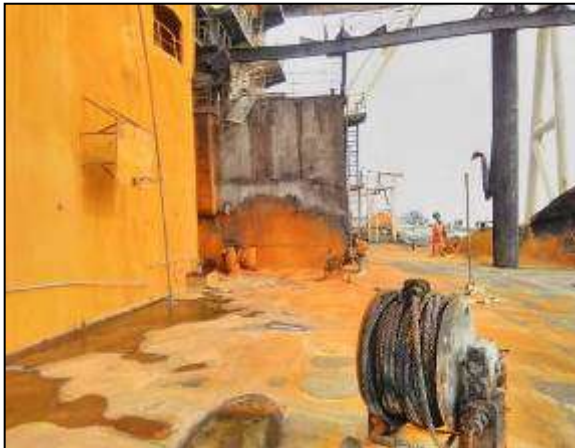
**Area between engine room and
accommodation aft**

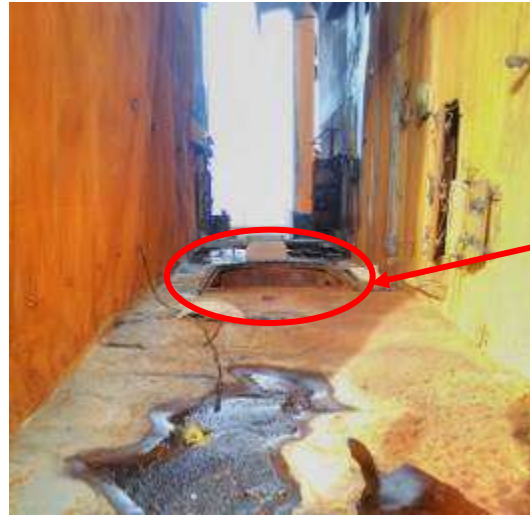
Between Engine room and accommodation

Sky light blown off

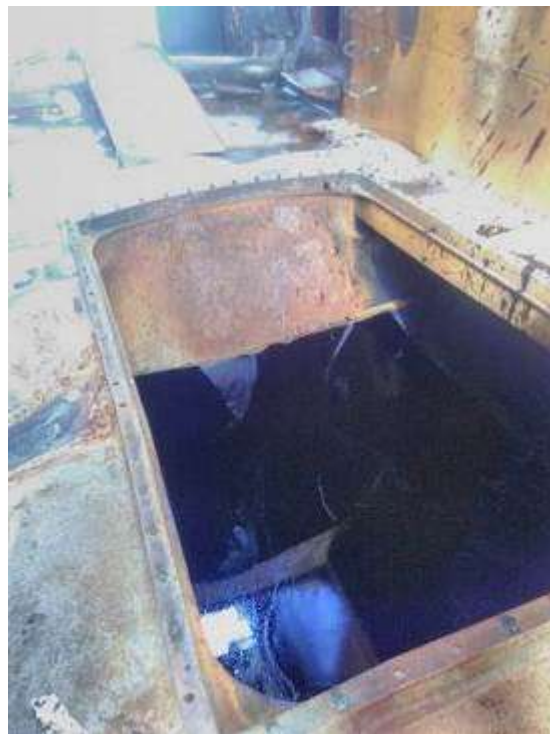
Closer view of sky light which was later used to rig scaffolding stage for access into engine room

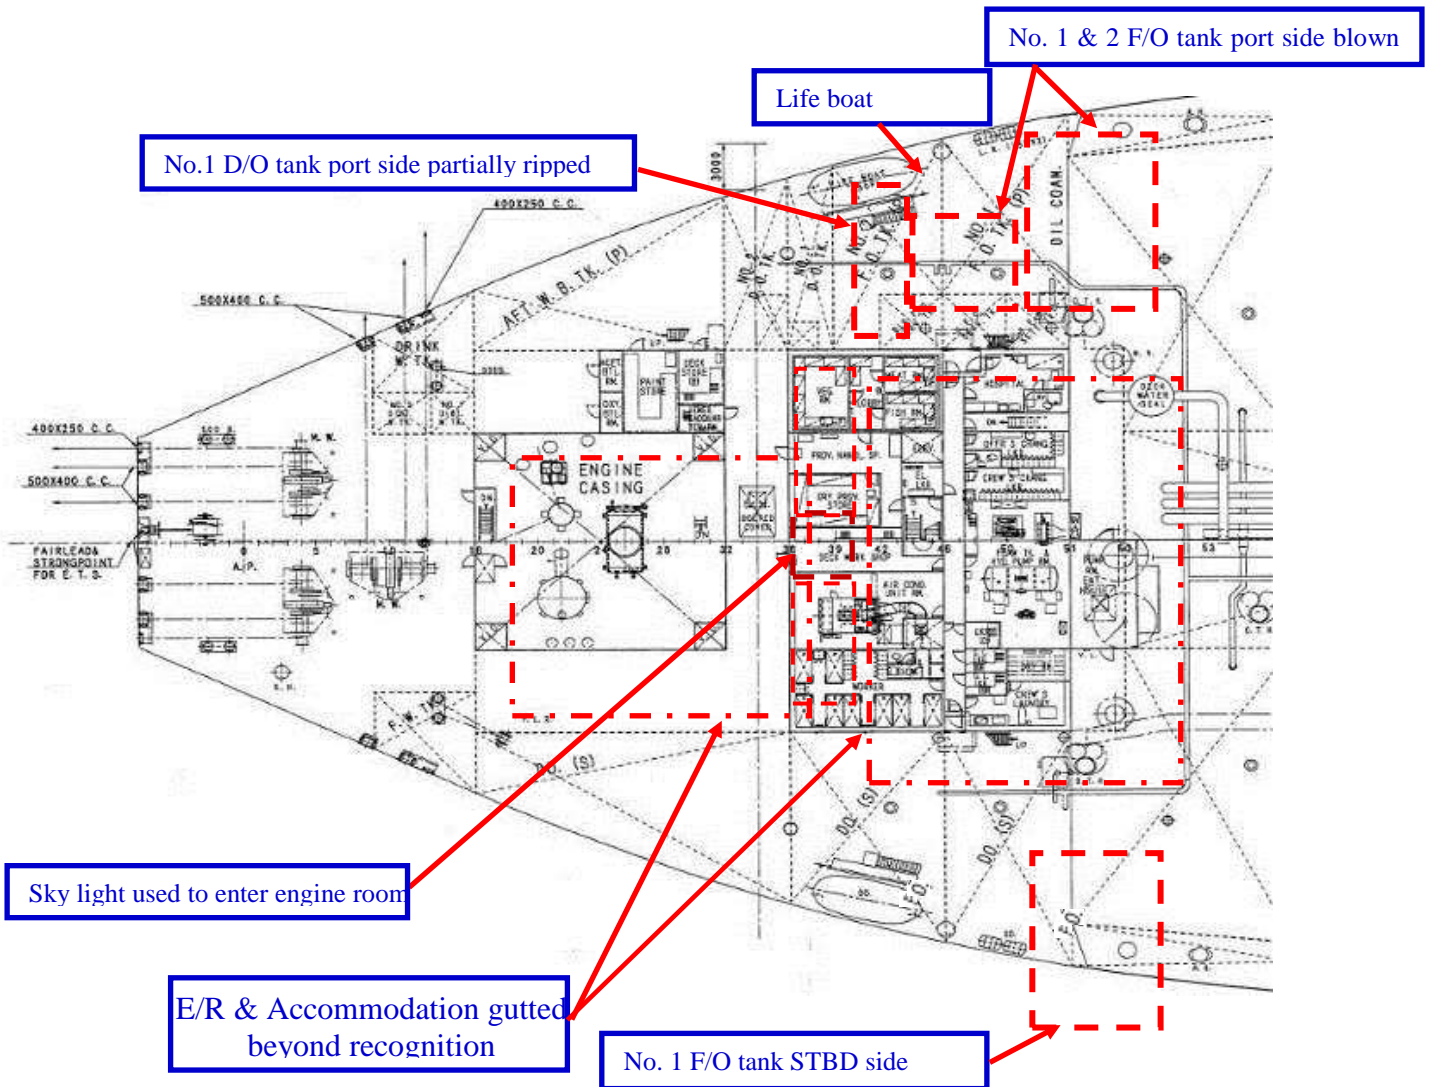
UPPER DECK LAYOUT

showing damages

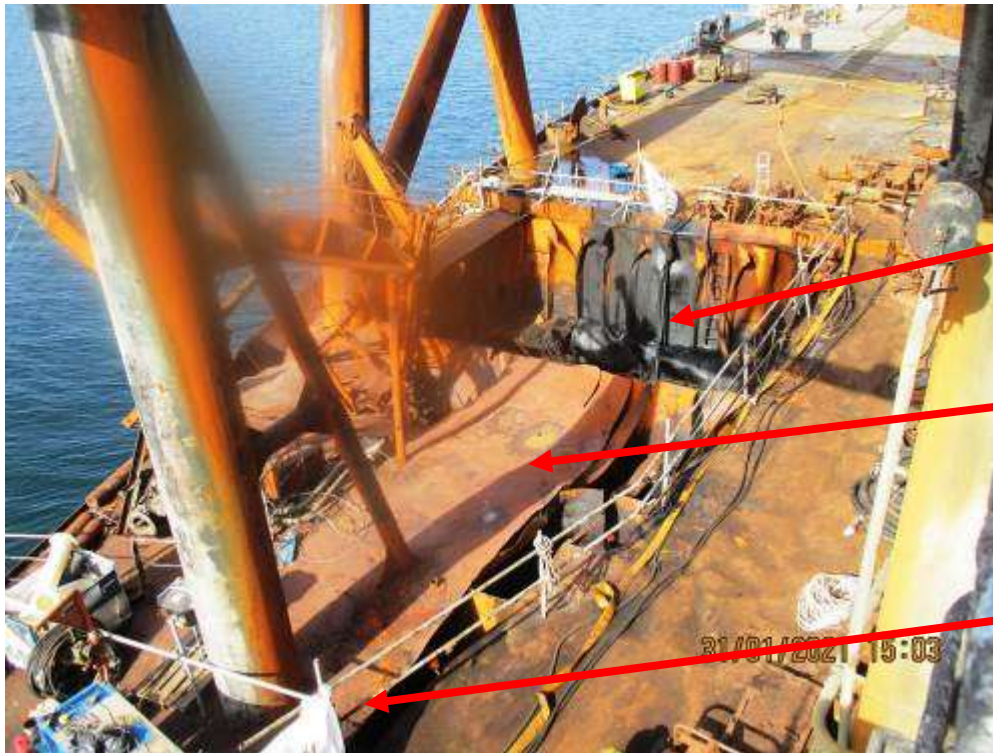
NO. 1 F/O Tank P

F/O Tank NO. 2 P

NO. 1 D/O Tank P

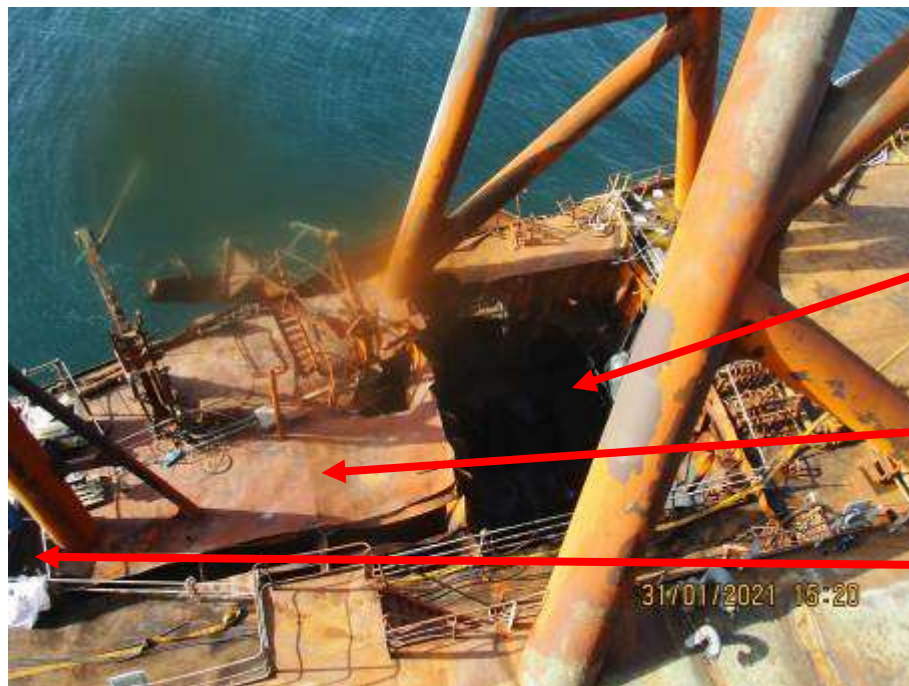
View from port side bridge wing

F/O Tank NO. 1

F/O Tank NO. 2

D/O Tank NO. 1

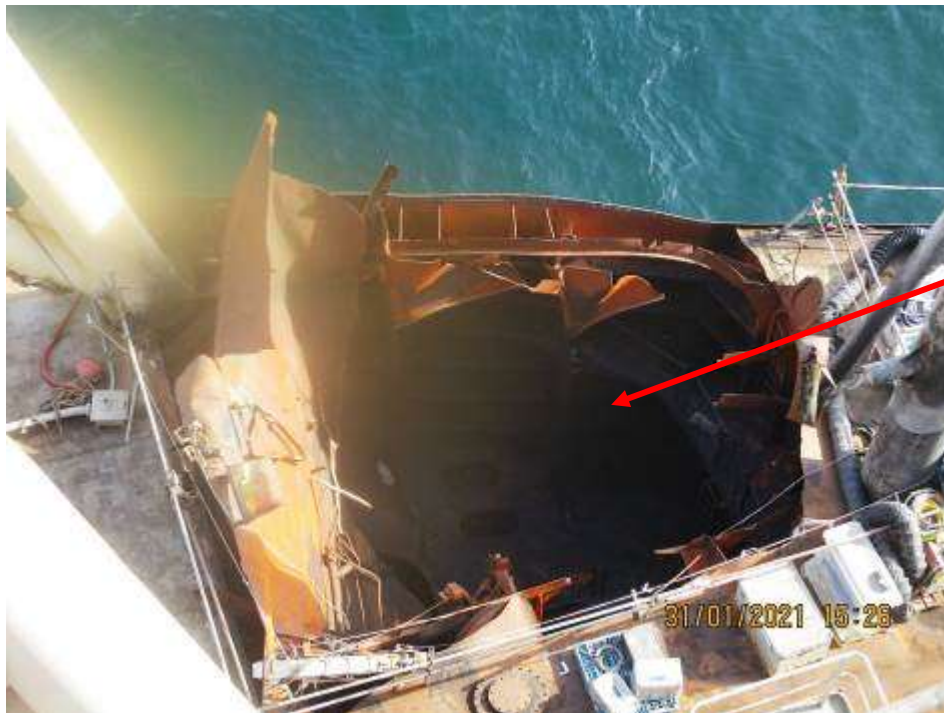
STBD no. 1 F/O
Tank

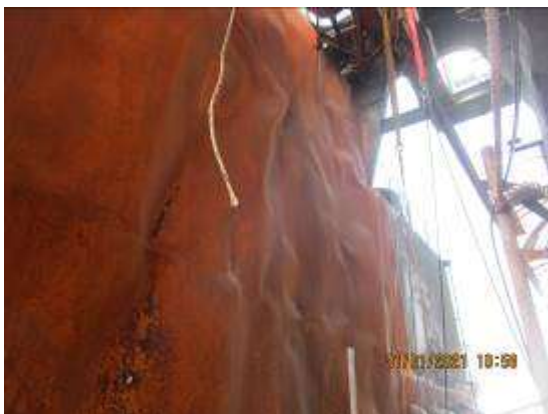
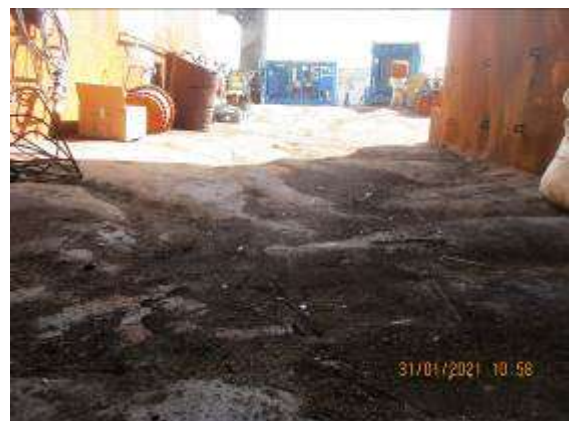
Bulged & deformed engine room casing bulkhead and upper deck

Broken and burnt out port holes on accommodation aft bulkhead and area around gantry crane above E/R sky light

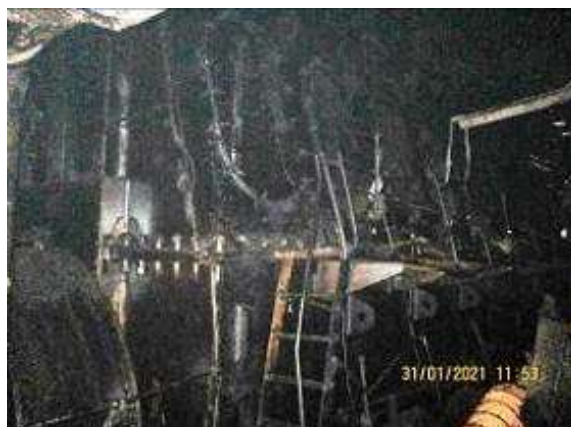
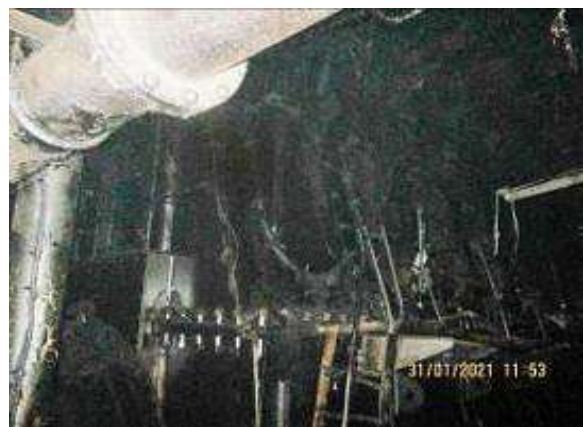
M/E crankcase and area around it

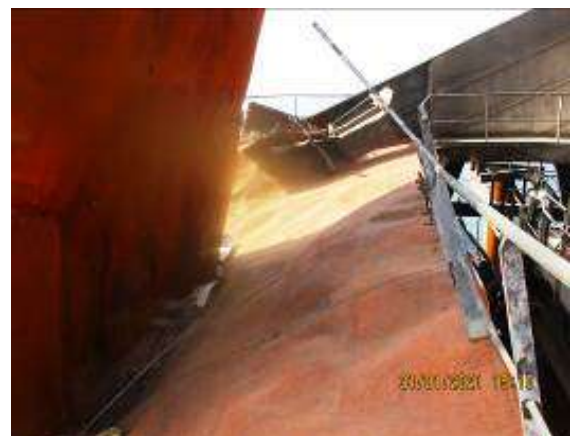
Engine room casing and funnel deck badly buckled, tilted forward due to fire heat

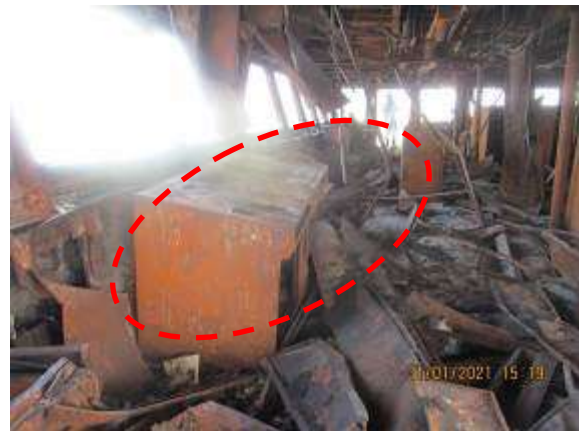
View from Port to STBD side
Maneuvering console with burnt out control and engine telegraph

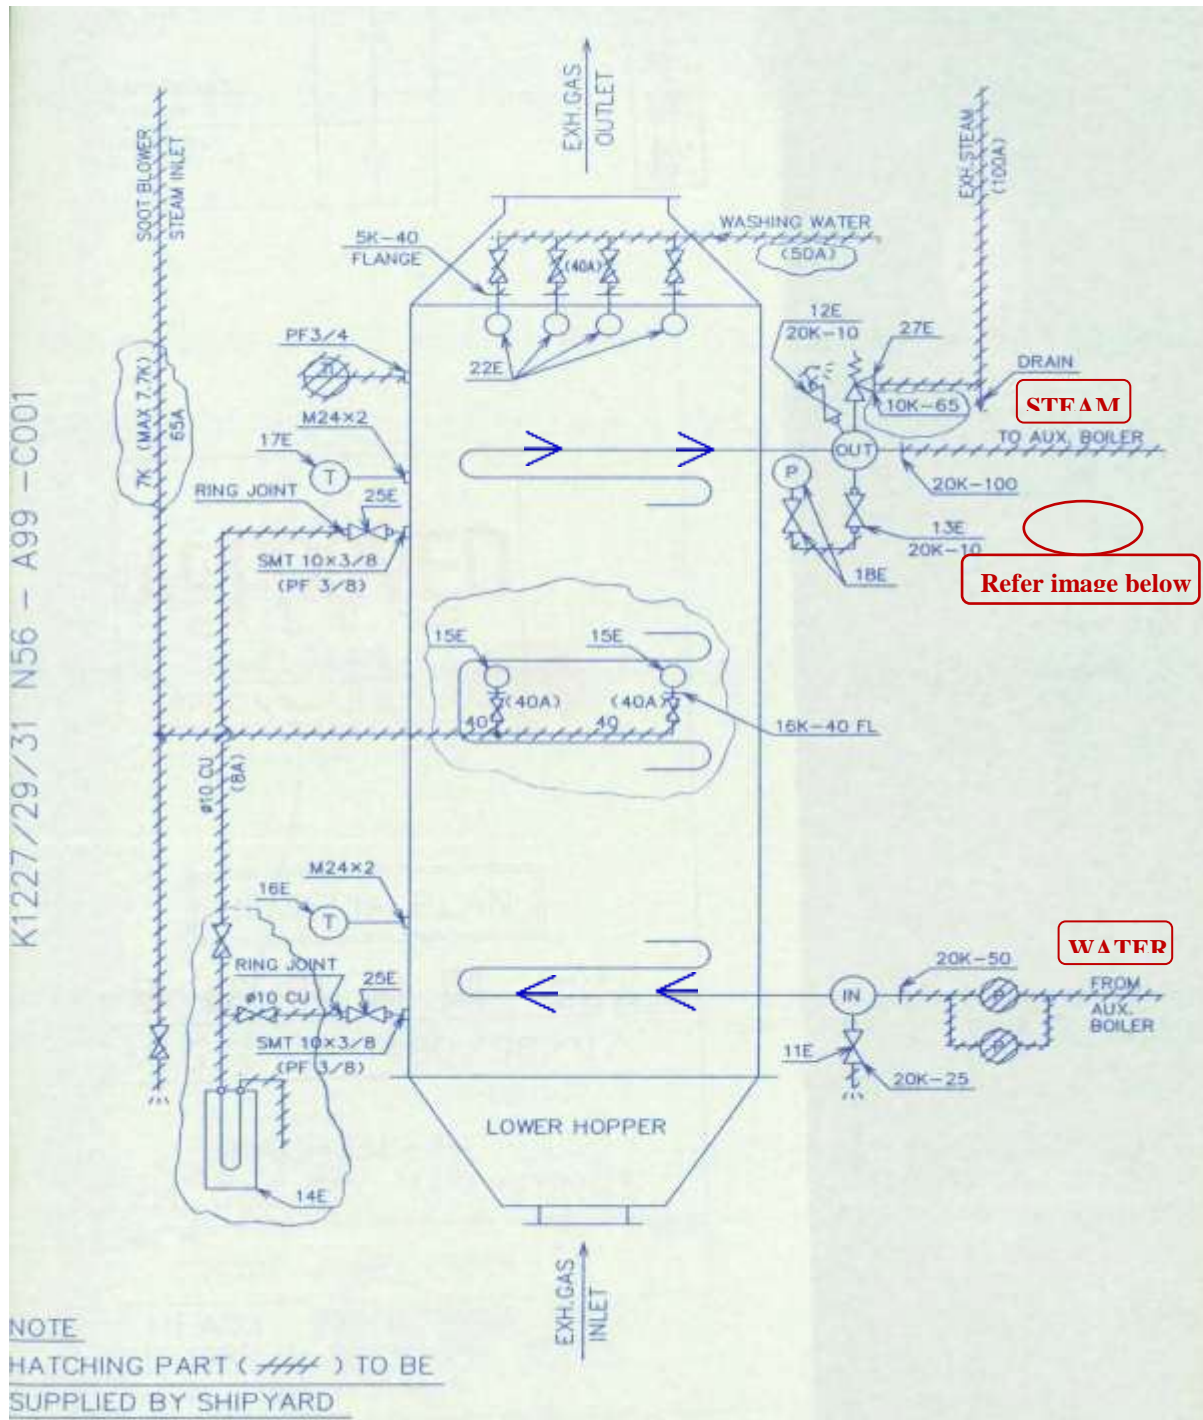
ILLUSTRATION NO 01 – STEAM OUTLET CONNECTION FROM ECONOMIZER TO AUX BOILER

Based on the available information it seems that the cause behind such catastrophic explosion is starting of a soot fire in Main Engine Exhaust gas trunk around economizer region which got aggravated to Hydrogen fire and resulted in rupture of large sized steam-water drum of auxiliary boiler having large amount of steam and water at high pressure. This probably happened due to rupture of some economizer tubes at soot fire stage or presence of water vapors due to improper combustion along with soot fire. The soot fire aggravated to Hydrogen /Iron fire which caused sudden and uncontrolled rise of pressure inside steam header which is connected to Auxiliary Boiler Steam-water drum via economizer steam outlet pipe. Therefore, pressure surged inside Auxiliary Boiler Steam-water drum which was the common drum for steam generated by Auxiliary Boiler as well as Exhaust gas economizer. Boiler drum pressure in this situation would have risen very rapidly beyond the drum design pressure of 22 Kg/Cm² and beyond capacity of Safety valves.

- Soot should not be allowed to accumulate as it may catch fire. Therefore, regular soot blowing is recommended with installed soot blowing arrangements.

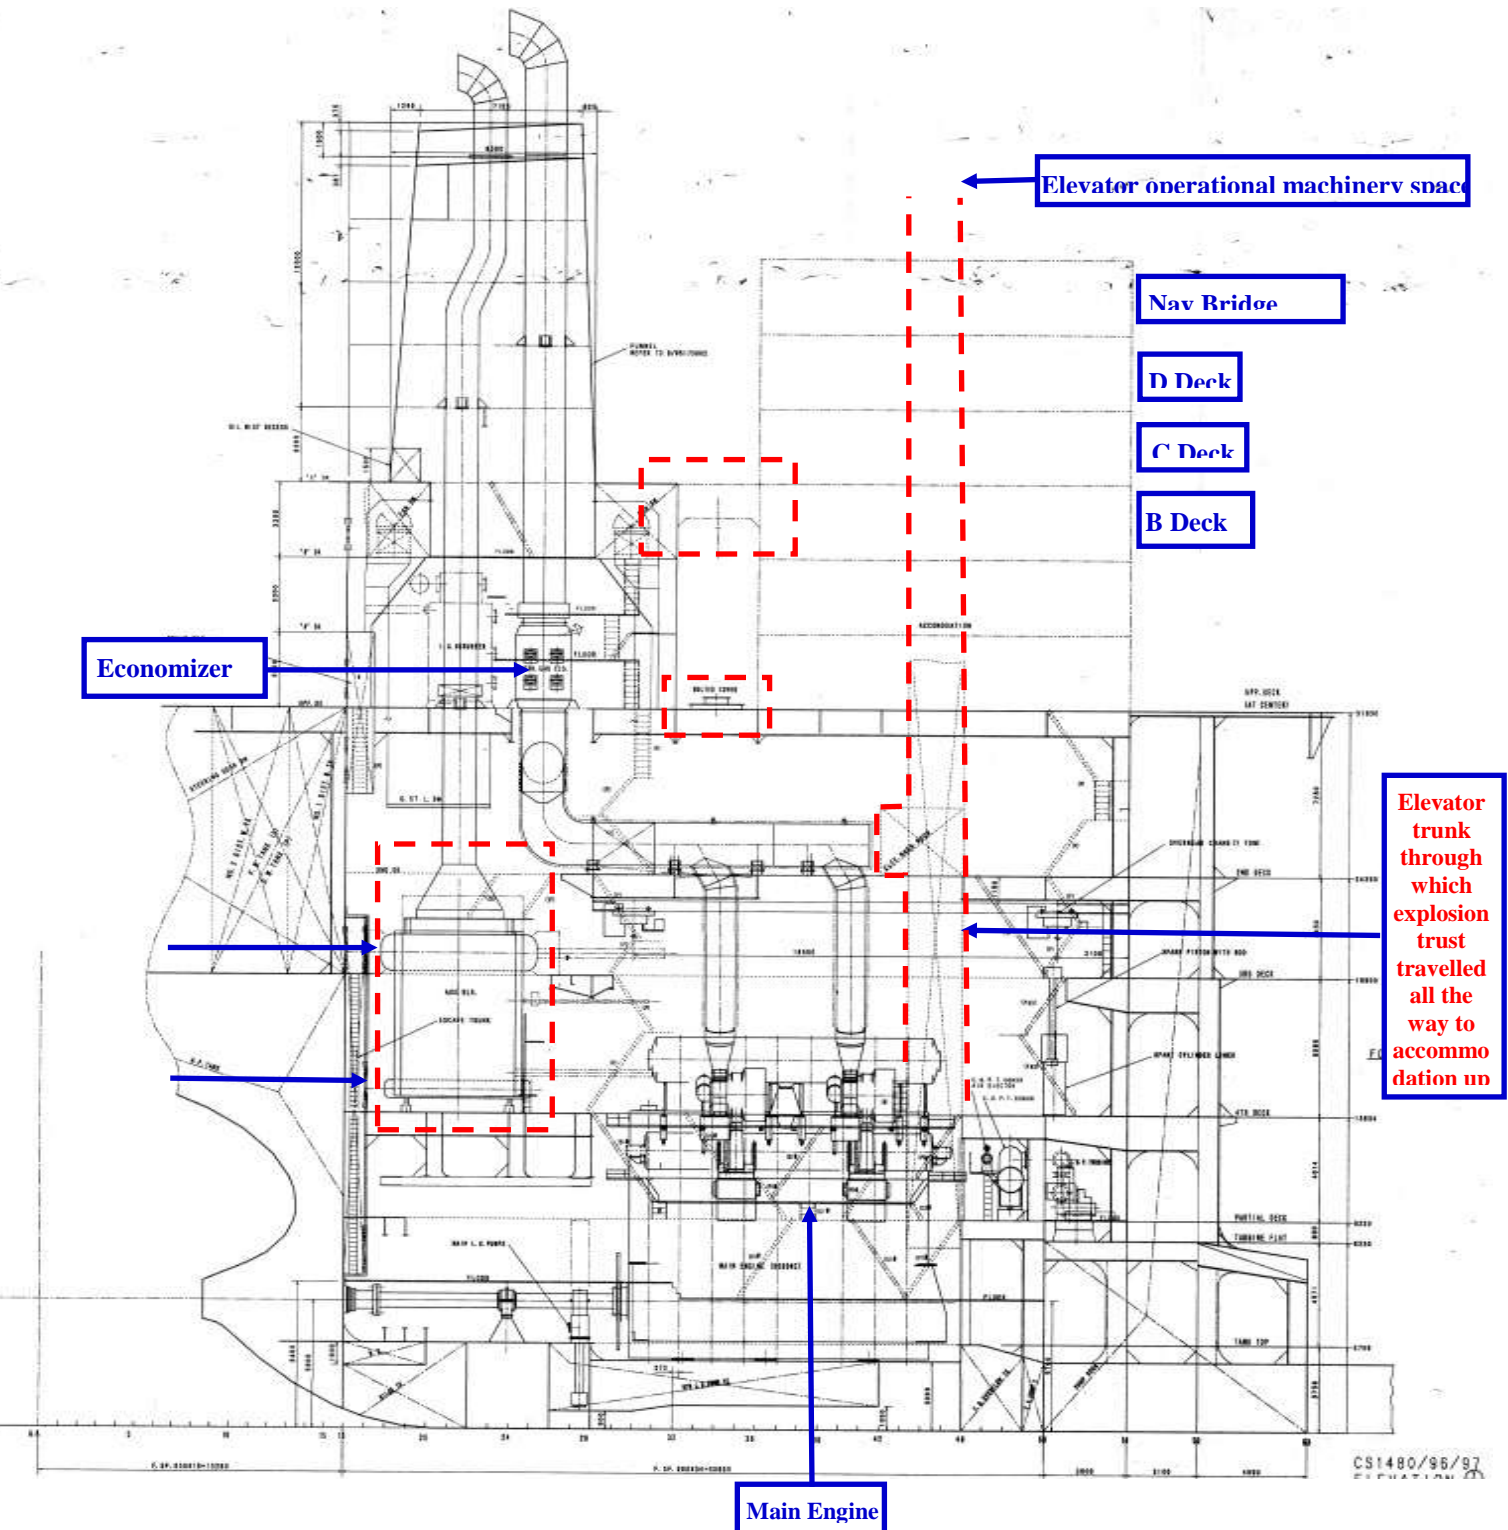
ILLUSTRATION NO 3

- Also, the ripples of force generating during explosion travelled through metal structure of engine room casing connected to crew accommodation superstructure at “C” deck level. For this reason, impact of the explosion was maximum on this deck also near to Third Engineer’s Cabin as elevator trunk also passes near to his cabin. The impact relatively reduced gradually on other decks. However, impact of damage was right up to Bridge Deck level and bridge door had collapsed.

- Damage was concentrated more on Port Side and branching of exhaust uptake for IG line /Deck seal etc. is also on Port side.
- Since the original damage was relatively less on lower decks of accommodation (many crew members were in mess room area located on A and B deck at the time of explosion and fortunately didn’t suffer much injury) crankcase explosion is less likely as primary source of explosion was against Boiler explosion.

RED DOTTED LINES SURROUNDING THE PATH OF EXPLOSION ENERGY

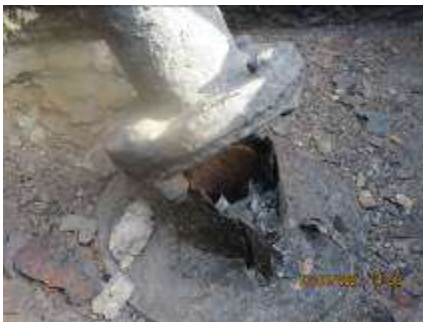
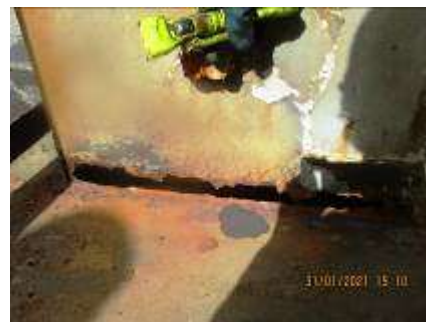
During on-site investigation it was also found that fitting out site the engine room had material loss wherein sub-standard repairs being undertaken on board such as airpipe and main engine starboard side exhaust trunk.
