Fatal fall from height on board DSM Capella Kalamata, Greece 20 January 2024

BMSR ID Safety
Investigation Report 1/2024

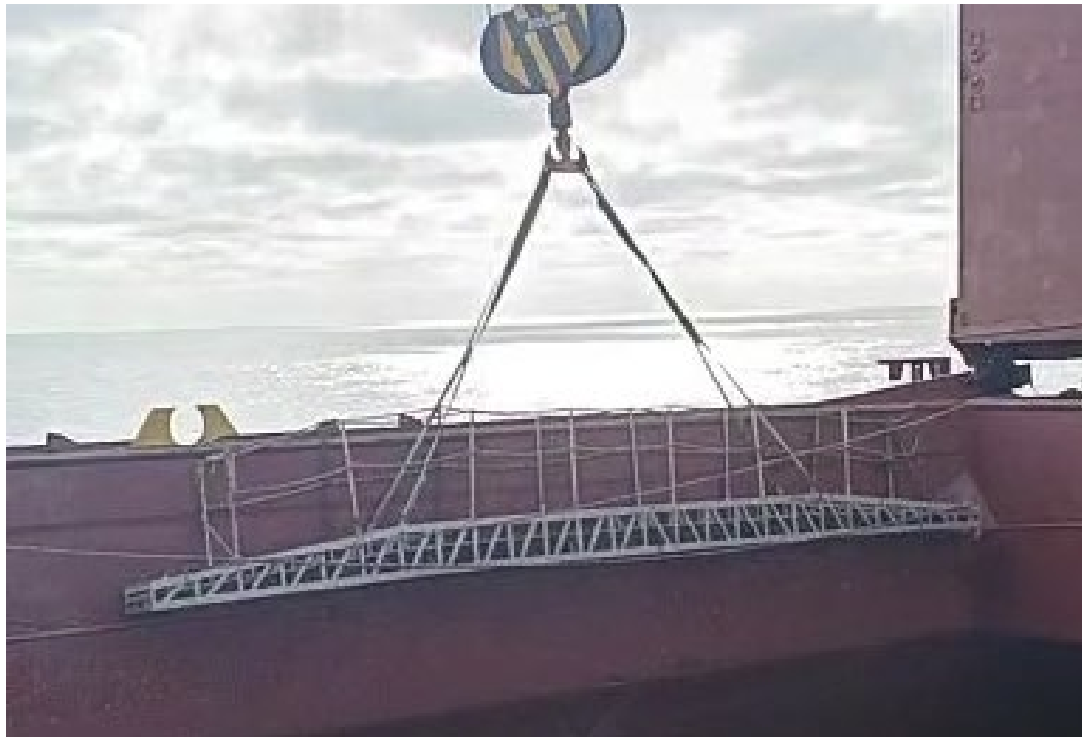
Figure 3 – Reconstruction showing the initial position of the portable gangway in hold No.5

Shortly after, AB1 and AB2 finished chipping and painting the hatch coaming inside hold No.6. The two deckhands returned to the deck and were told by the bosun to now chip and paint the inner hatch coaming of hold No.5. To facilitate this, AB1 and AB2 climbed on to the main deck from the portable gangway, which was then moved by the bosun from the upper section of hold No.6 to the starboard side aft of hold No.5 (**Figure 3**) using crane No.3.

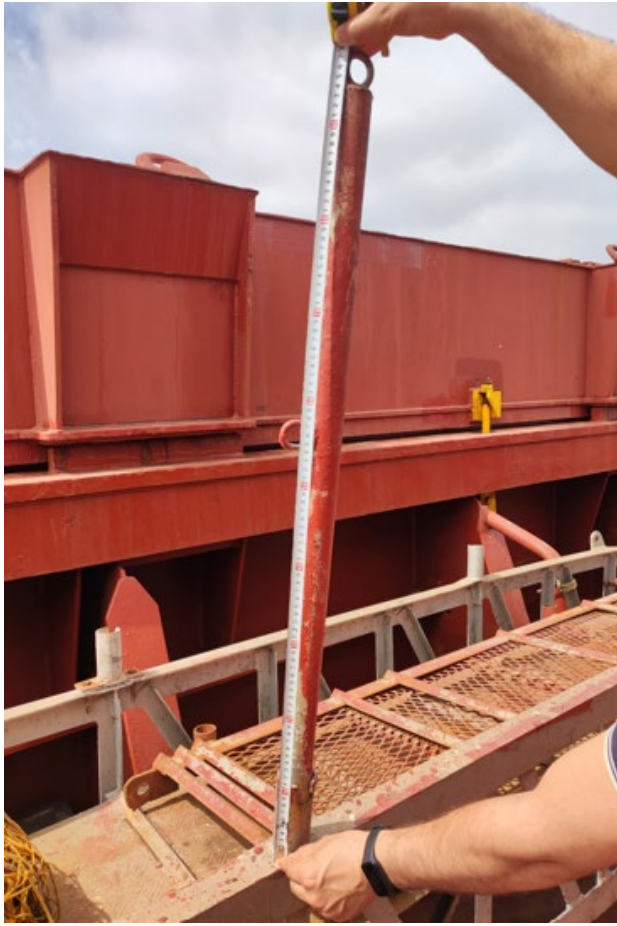
Figure 4 – Potable gangway (stanchion and guardrail heights)

The portable gangway (**Figure 3 and Figure 4**) was made of aluminium and was 10m in length and 70cm wide with thirty steps, 34cm apart. It weighed 250Kg and eight stanchions of about 1m in height were fitted on each side of the gangway at intervals of 1.2m. Rope was rove at the top and mid-levels of the stanchions to form all-round guardrails. The distance from the upper rope securing point at the top of each stanchion to the mid-stanchion rope securing point was 40cm. The distance between the mid-stanchion rope securing point and the base of each stanchion on the gangway's metal structure was 56cm. The gangway's metal framework was 24cm above the walkway (**Figure 5**) but decreased towards its ends.

To have fallen off the section of portable gangway that was enclosed by the rope guardrails, AB1 must have fallen over, through or under the ropes on the inboard side of the gangway. The height of the vertical stanchions above the walkway on which AB1 was standing was at least 1m, and therefore as advised in the COSWP. However, although the gaps between the upper and mid-level rope guardrails, and between the mid-level guardrail and the gangway's metal framework were 40cm and 56cm respectively, and the distance between the supporting stanchions was 1.2m, the effectiveness of the stanchions and the rope guardrails as a fall prevention system was reliant on the rope guardrails being taut.

- The deceased either fell over, through or under the rope guardrails fitted to the portable gangway.
- The effectiveness of the rope guardrails fitted around the portable gangway was possibly reduced due to insufficient tension.

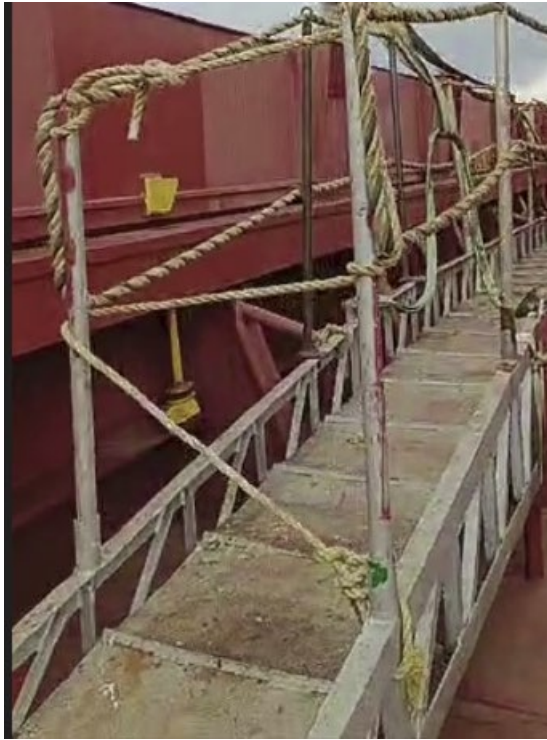
Figure 6 - Portable gangway (end-on)

The stanchions at the gangway's extremities were inset by about 1m. To rig the gangway for use as a painting stage, the rope guardrails were tied off across these stanchions thereby enclosing 8m of the gangway's length. The outer 1m at each end of the gangway were not enclosed by the rope guardrails (**Figure 6**).

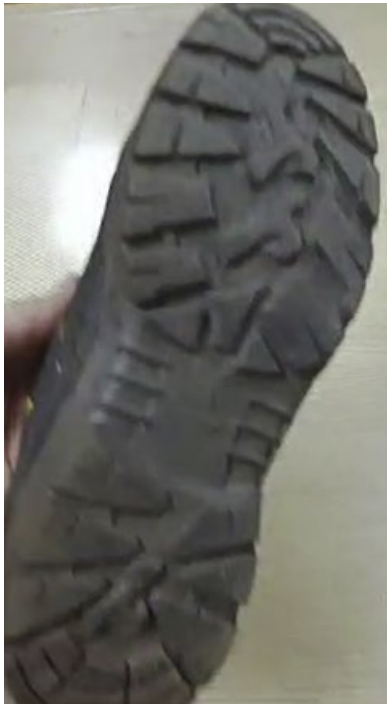
Figure 7 – The sole of one of the safety shoes worn by AB1

The personnel protective equipment (PPE) on board *DSM Capella* was provided by Diamond Ship Management. At the time AB1 fell, he was wearing safety shoes (**Figure 7**), a safety helmet, gloves, goggles, overalls, and a safety belt or harness with a single 1.5m fall arrest lanyard (**Figure 8**). The tread on the safety shoes, and the safety helmet were in good condition, and the spring hooks at either end of the lanyard were in working order.

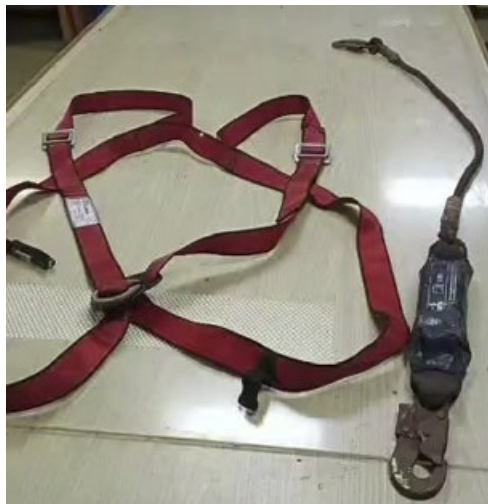
Figure 8 – Safety belt and lanyard worn by AB1

AB1 was wearing a safety harness with a 1.5m lanyard attached. However, it is evident from his landing on the hold bottom and the correct functioning of the spring hook when checked after the accident, that the lanyard was either not secured, or not secured effectively, to the portable gangway structure when AB1 fell over or through the rope guardrails.

- AB1 was wearing a safety belt and lanyard when he fell, but the lanyard was not attached to the gangway structure or crane slings and therefore his fall was not arrested.
