HELLENIC BUREAU FOR MARINE CASUALTIES INVESTIGATION

February 2018

Under the above framework HBMCI has been examining the grounding of Bulk Carrier St. Gregory, which occurred on the 7th of June 2017, in the South Coast of Peloponnese (Kokkala), in Greece. This report is mainly based on information and evidence that have been derived from vessel's Voyage Data Recorder (VDR), the Hellenic Coast Guard AIS Monitoring system and the interview process.

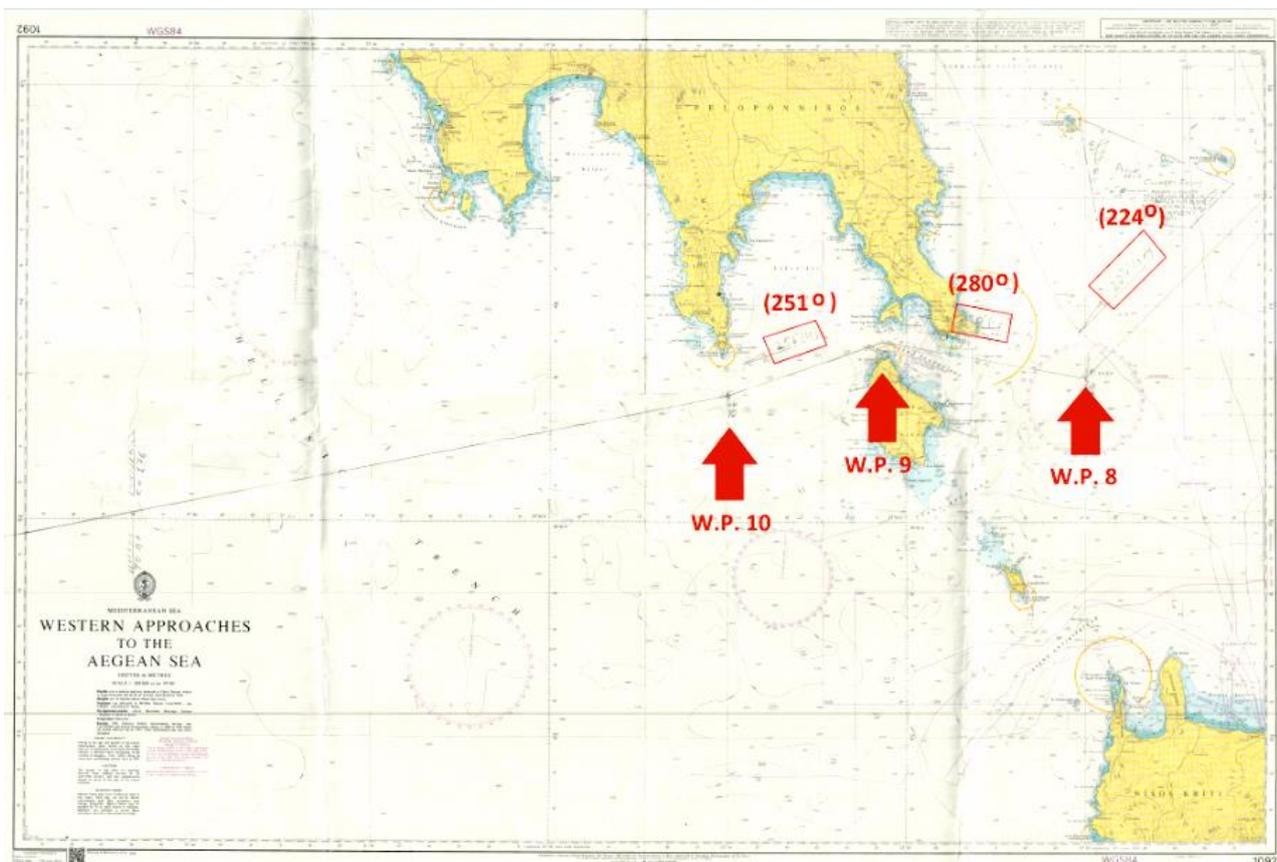
Figure 3.4 / 1: The planned route according to the Voyage Plan at the casualty sea area (the handmade notes by the OOW are highlighted in red).

After the 2/O altered the vessel's course to 284°, at approximately 00:37, the vessel continued with a steady course (see **Figure 3.4/2**). No course alteration was made by the 2/O at the planned W.P.

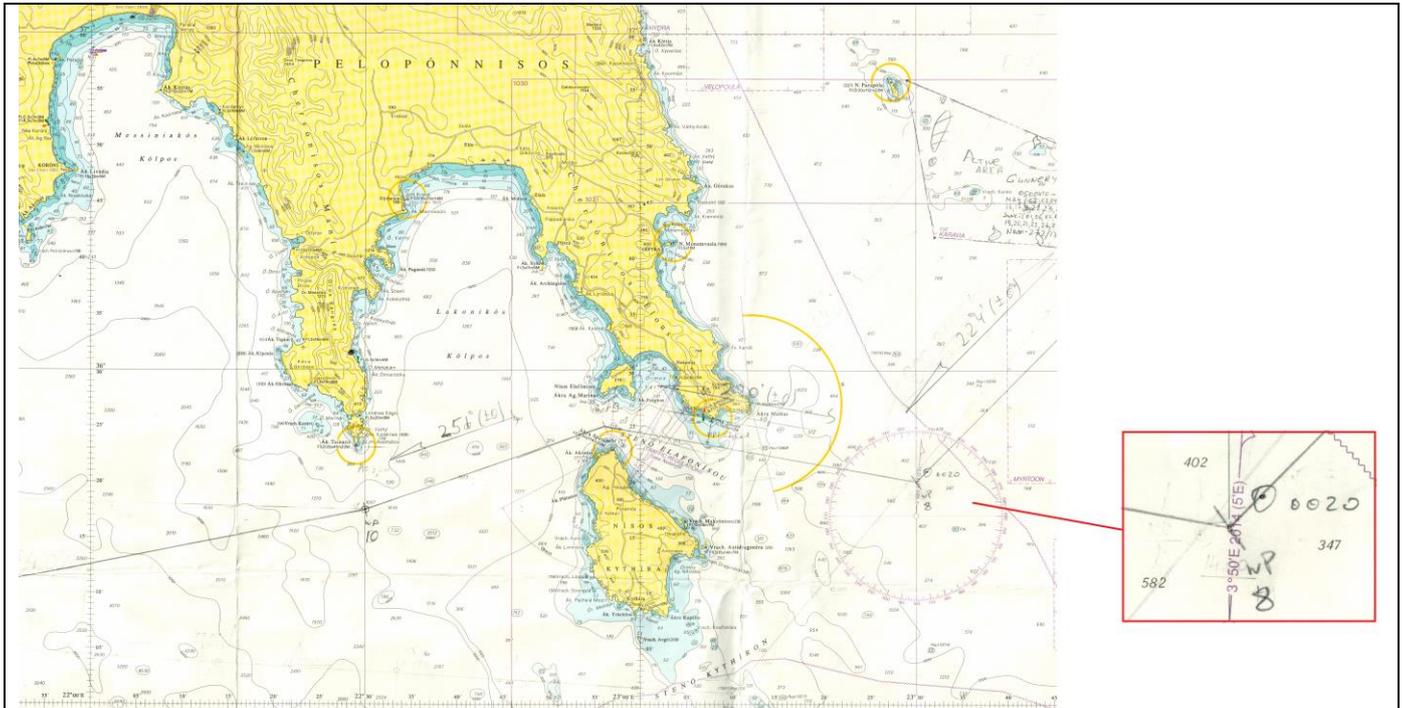
Examination of ship's paper chart showed that positions were marked every hour, except from the time period from 00:20 to 04:13 (**Figure 4.4.1/1**) during which no positions were plotted until vessel's grounding. Taking into account that the ship's course was not altered until the vessel grounded and the fact that from the vessel's VDR no activity was recorded inside the bridge, it can be deduced that, the 2/0 was not monitoring the vessel's course for almost 4 hours according to the voyage plan as plotted on the respective chart.

Figure 4.4.1. / 1: Abstract from the Nautical chart used on board St. Gregory during the passage from “Steno of Elafonisos”. The last plotted position (magnified part of the chart) was the one near WP 8 at 00:20 (Ship’s time)

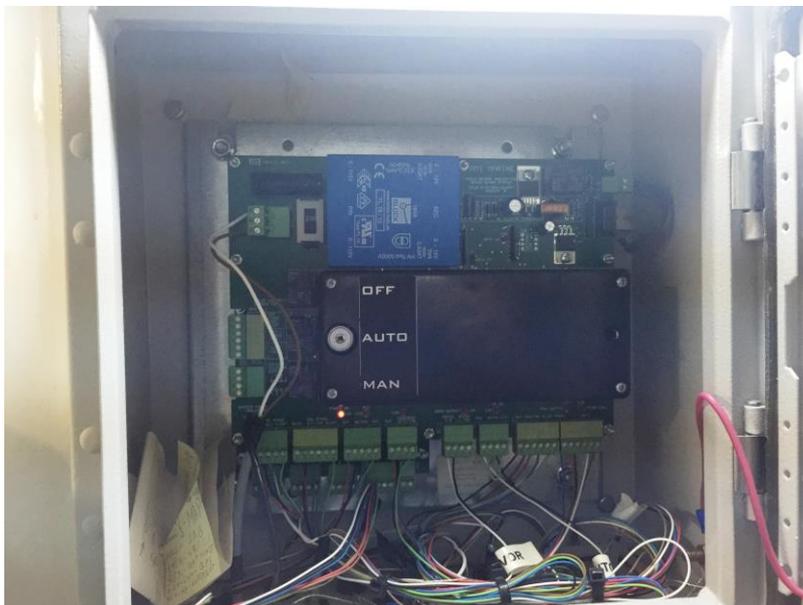
Figures 4.4.4.3/3: The Main Electronics Unit (MEU) of St. Gregory's BNWAS as found on the day the HBMCI Investigation Team boarded the vessel.

Following vessel's grounding and after HBMCI's request, the BNWAS working condition was inspected by its service providing Company and found in good working condition, at all stages (OFF, AUTO, MANUAL). According to the service report, in all positions the system would be automatically activated when the autopilot was activated, therefore the BNWAS could not be overridden.

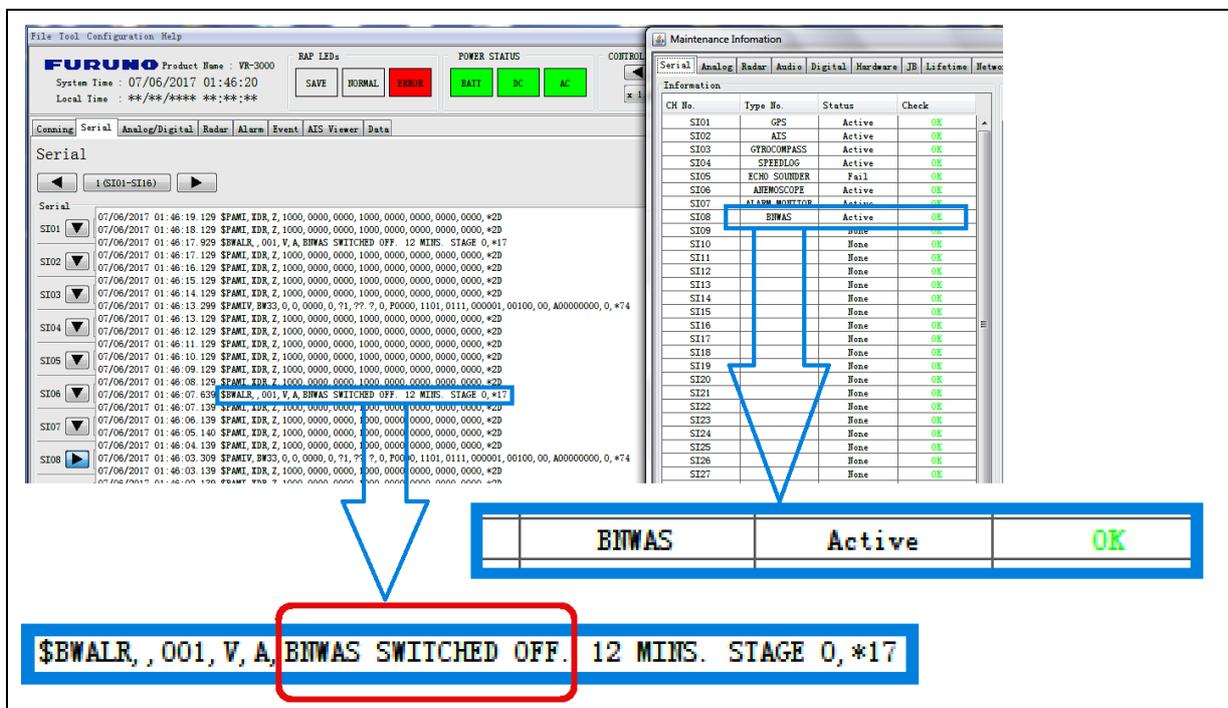
However it was verified through the analysis of VDR recordings, that on the night of the marine casualty no audible alarm was sounded from BNWAS before the grounding. Additionally from the BNWAS data as recorded by the VDR it was revealed that the system was set to OFF mode, so the BNWAS was deactivated, despite the fact that the Autopilot was engaged. (see Figure 4.4.4.3/4). These information were verified after clarifications provided by the manufacture company of said BNWAS system, AMI MARINE (UK) LTD.

Figures 4.4.4.3/4: BNWAS data as extracted from VDR analysis, showing that the BNWAS was properly connected to the VDR (BNWAS "Active"), however it was set to "OFF" Mode (BNWAS "SWITCHED OFF").

Moreover it can be deduced that no specific procedure during navigational watch handover concerning the operation of BNWAS was provided and therefore it was not required for the OsOW to check the system when taking over the navigational watch.
