**HELLENIC REPUBLIC  
HELLENIC BUREAU FOR MARINE CASUALTIES INVESTIGATION**

**MARINE CASUALTY SAFETY INVESTIGATION REPORT  
02/2020**

**July 2024**

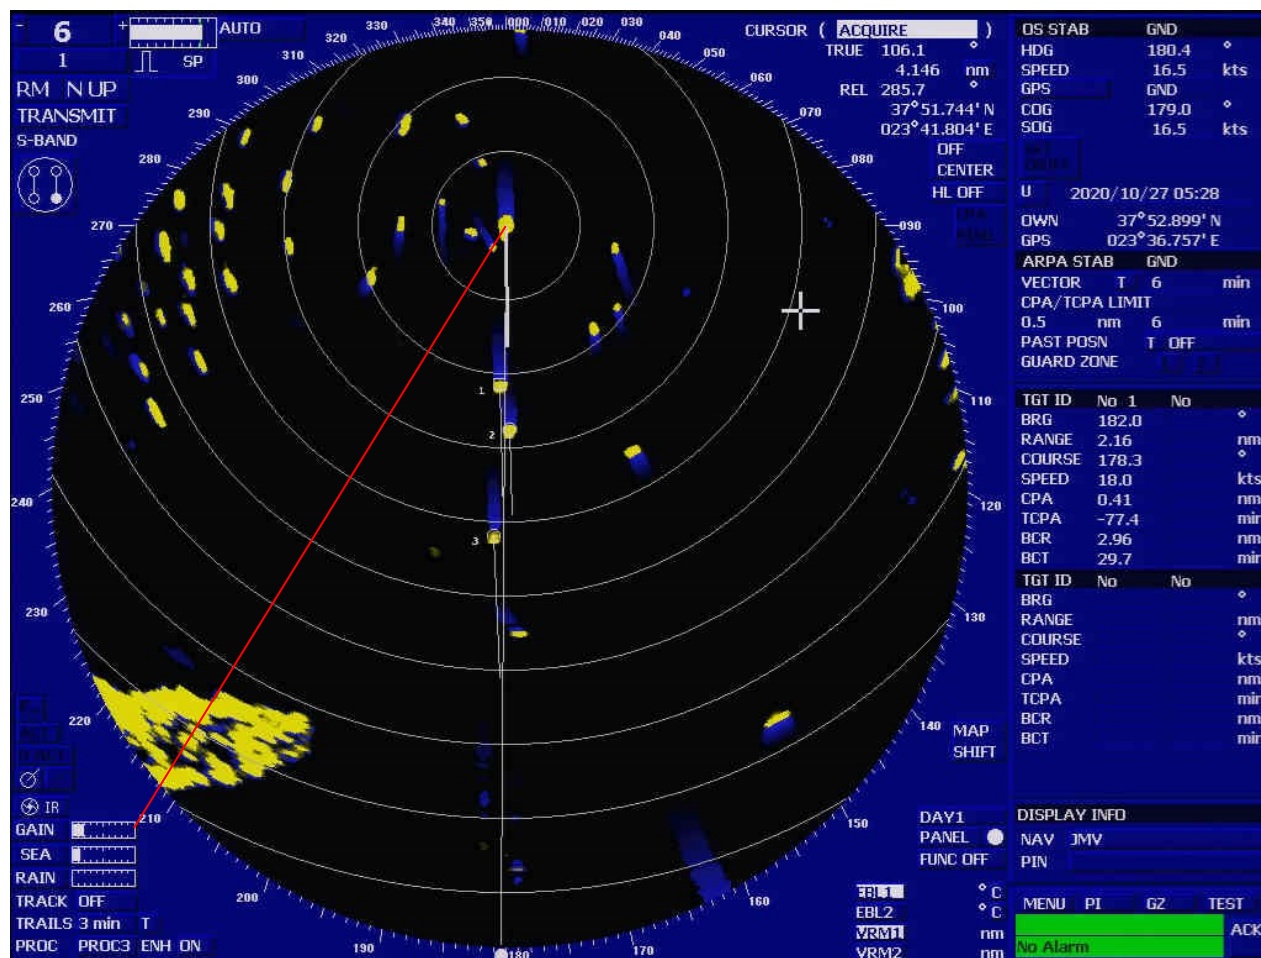
Figure 15. Depiction of MAERSK LAUNCESTON S Band radar at time 07:28:21.

At 07:28:19 both vessels were navigating at the sea area north of the Piraeus TSS. HS KALLISTO had passed from the stern of M/T ATLAS and according to data extracted from her GPS was steaming with a COG of 149,4° and SOG of 11 knots, while MAERSK LAUNCESTON was navigating with a COG of 179° and a SOG of 16,5 Knots. The distance between the two vessels was less than 0.4 nm and HS KALLISTO was at a bearing of approximately 212° (Figure 15).

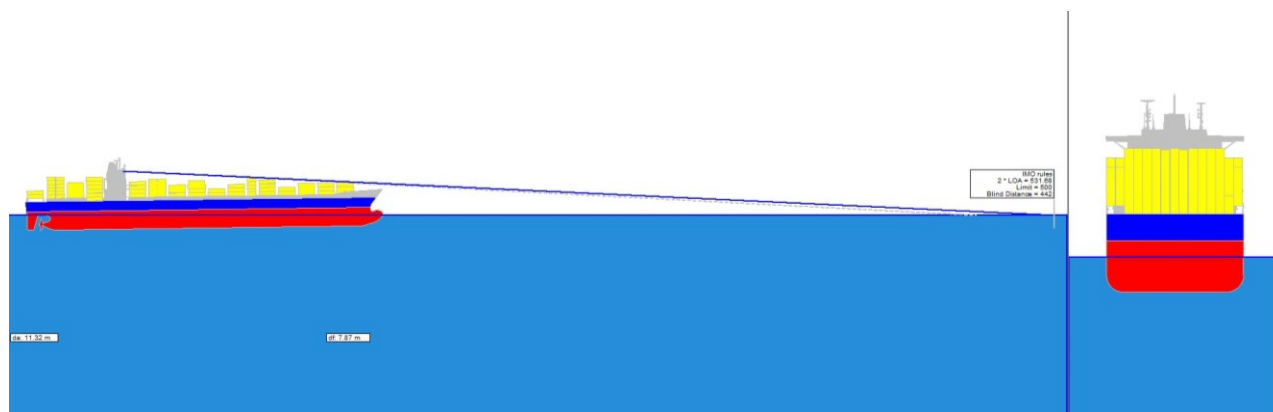
**Figure 16.** MAERSK LAUNCESTON's blind sector for the loaded condition of departure Piraeus Port.

At 07:29:59 the Master of MAERSK LAUNCESTON sounded a short blast with the vessel's whistle for two seconds; however, it is suggested that at time he could not have visual contact with HS KALLISTO as the war vessel was still within the blind sector of the bridge (Figure 16).

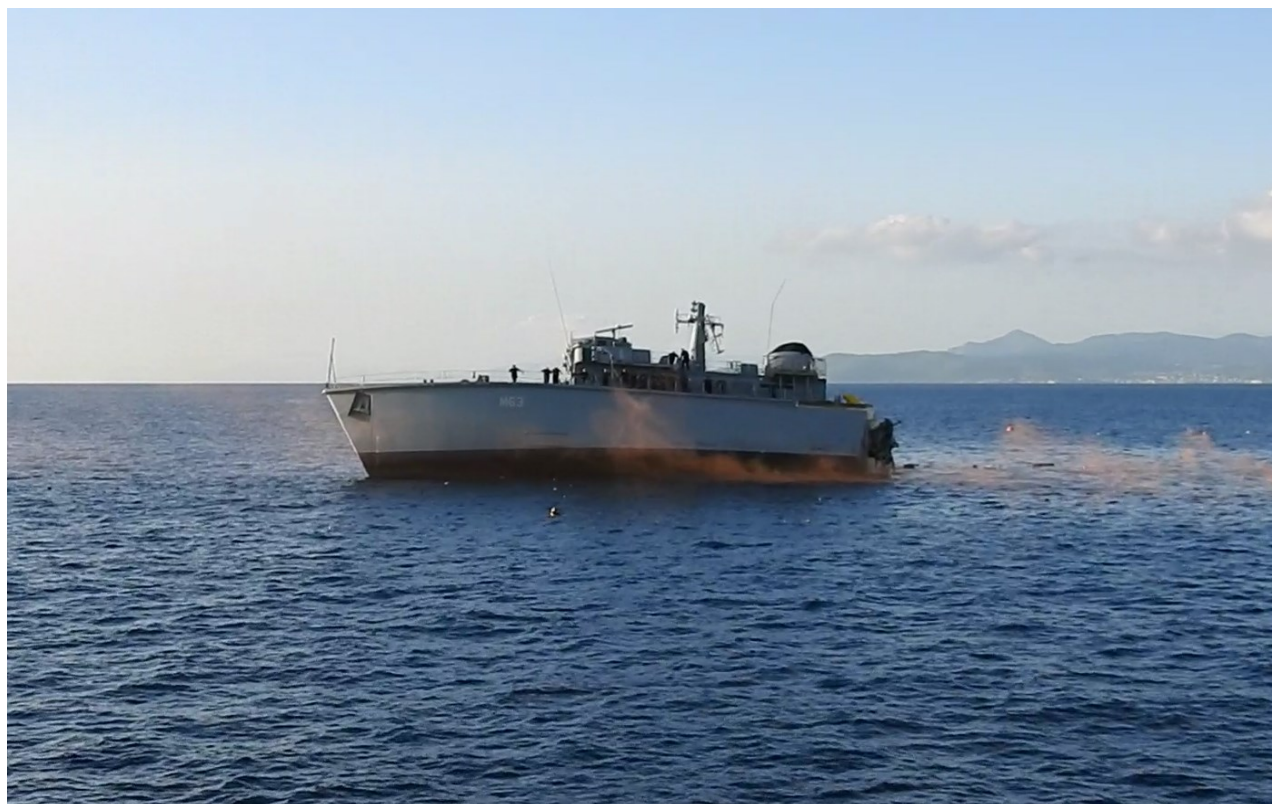
The fore part of HS KALLISTO sustained rapidly an approximately 60° list to her starboard side and all the remaining crew mustered at her port side (Figure 17). Immediately the Commander ordered the counting of the crew and it was found that everyone was on board apart from the 4 crew members that were in the sea.

**Figure 17.** The fore part of HS KALLISTO listed to her starboard side.

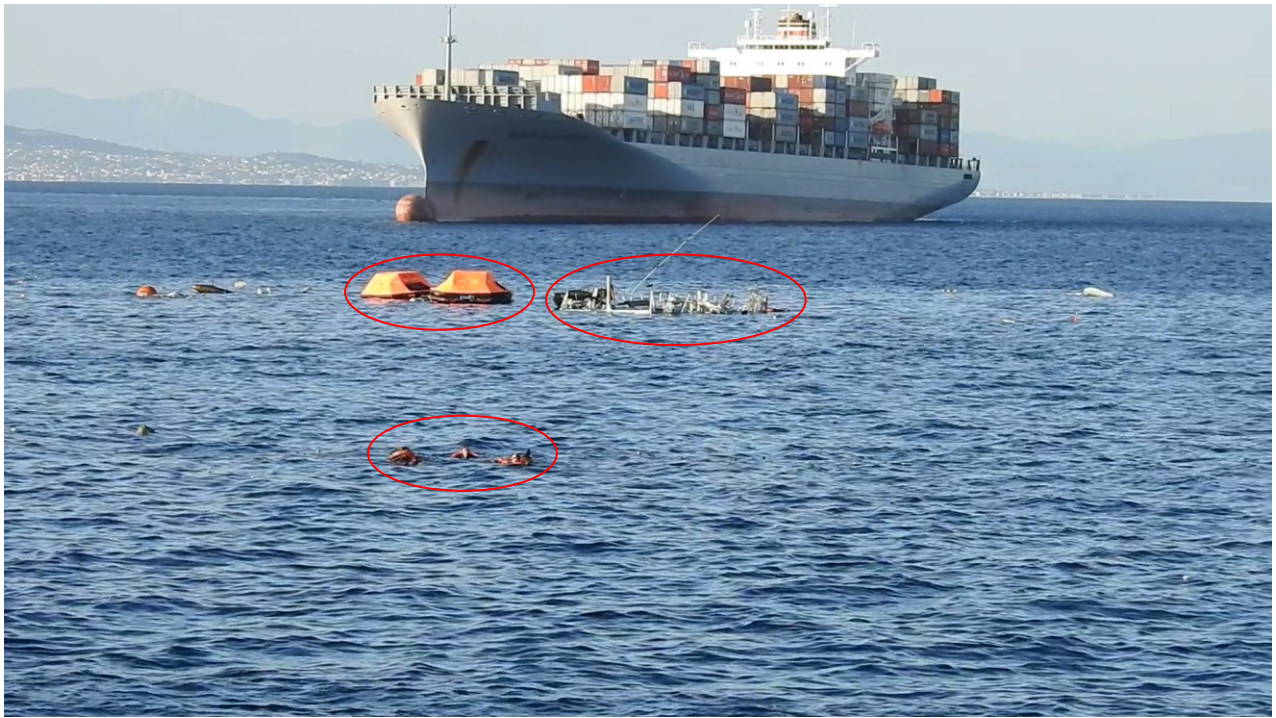
The aft part of HS KALLISTO sank rapidly. Only the canopy remained afloat which had detached from the aft part. The two liferafts that were stowed on top of the canopy were released automatically and inflated; however, they were not used by the crew members who fell into the sea as they were not in close distance and they had already managed to hold onto the life rings (Figure 18).

**Figure 18.** The canopy of the aft part of HS KALLISTO, the two liferafts and the four crew members holding on to the liferings.

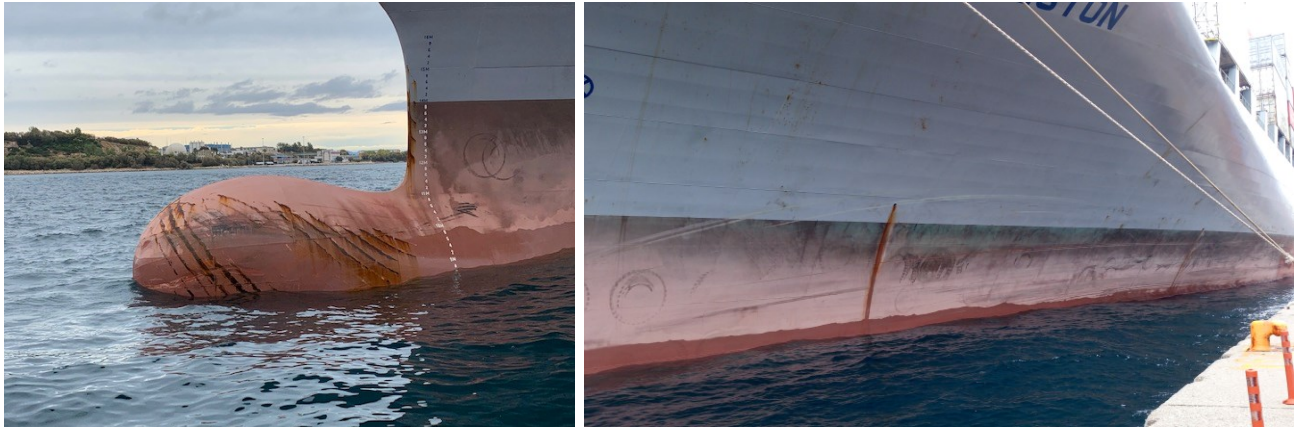
Due to the collision, MAERSK LAUNCESTON sustained only minor scratches at the bulbous and her port bow area. She was inspected by her Class on 28-10-2022 at Piraeus Port where “*no damage was found at the forward part of the vessel*” and so the vessel maintained her class and was allowed to continue voyages as per her statutory certificates (Figure 20, 21).

**Figures 20,21.** The minor scratches to MAERSK LAUNCESTON's fore area.

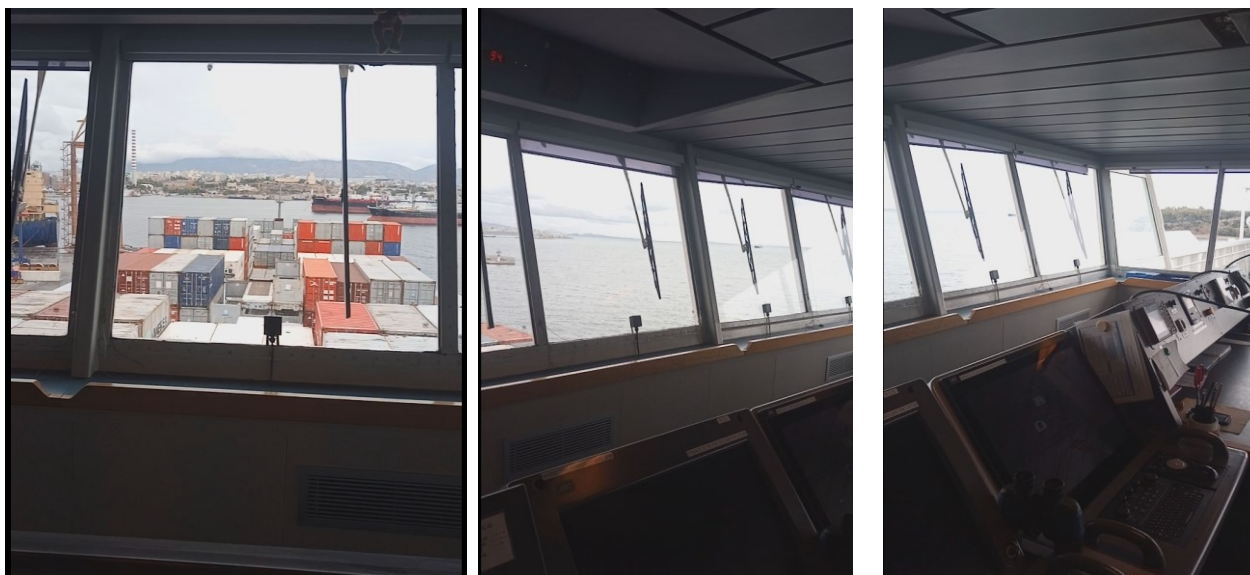
Figure 22. The visibility from the bridge's main console.

Apart from the fore visibility restriction no other blind sector caused by the cargo, cargo gear or other obstruction outside the wheelhouse, obstructed the conning position's sea view from right ahead to the beam on both sides (Figure 22).

Considering the above it can be deduced that the Master could maintain a very good visual contact of the vessels navigating on MAERSK LAUNCESTON's Starboard bow or abeam.

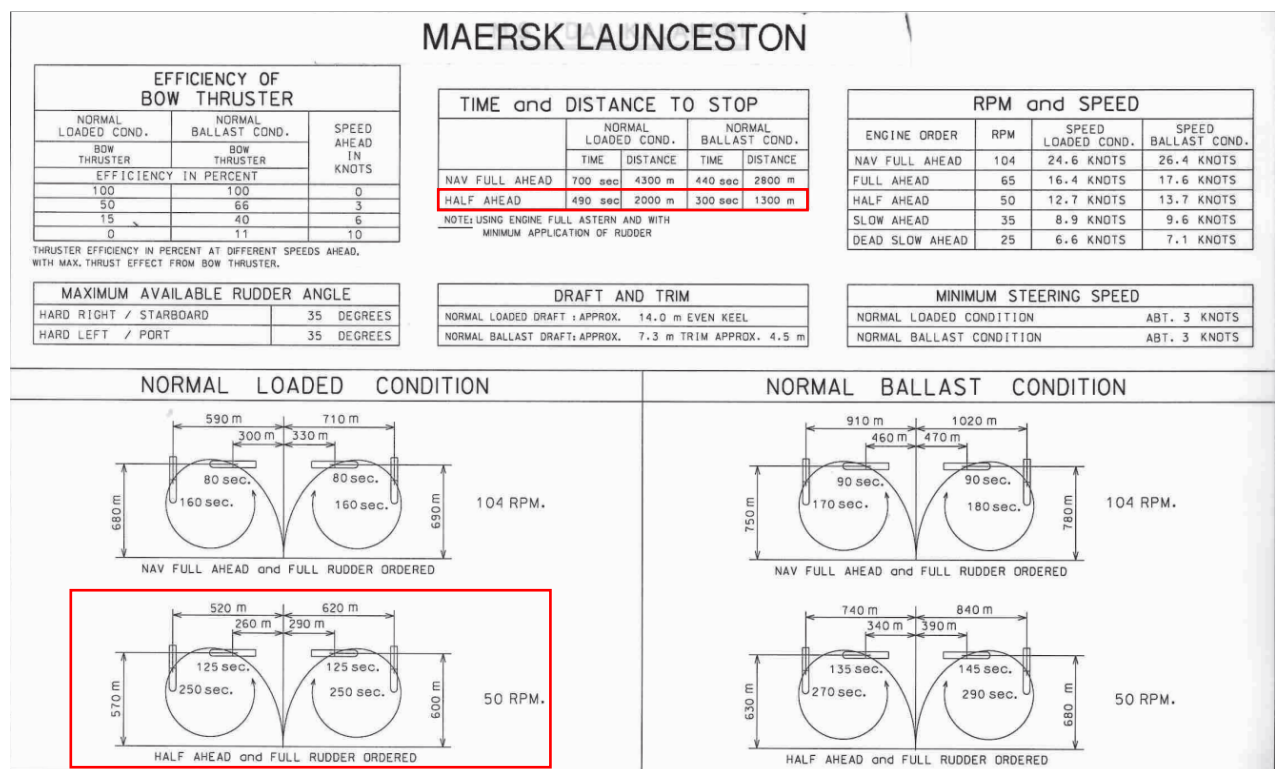
Figure 25. MAERSK LAUNCESTON maneuvering table.

From the vessel's maneuvering characteristics table (Figure 25), the closest condition to the actual speed at the time of the casualty is provided for engine telegraph at HALF and engine speed at 50 rpm. At this speed (HALF - 50 rpm) and normal loaded condition, the emergency maneuver to put the engine telegraph at Full Astern and with minimum rudder application, the vessel would need a time of 8min and 10 sec and a distance of 2000m for a full stop.

At the same condition (Half speed – loaded), the turning circle<sup>3</sup> of a hard to port rudder application provided an advance<sup>4</sup> of 570m and a 520m tactical diameter<sup>5</sup>. With a hard to starboard rudder application the vessel's turning circle provided a 600m advance and 620m tactical diameter.

Taking into account that the bridge complement, as provided by the passage plan, was not followed, the traffic of the area and that the Master was the sole person on the bridge at the time of the casualty, it derives that Rule 6 of COLREGs concerning the safe speed was not followed.

In light of the above the vessel's speed while navigating towards Piraeus TSS is considered a contributing factor to the examined marine casualty.

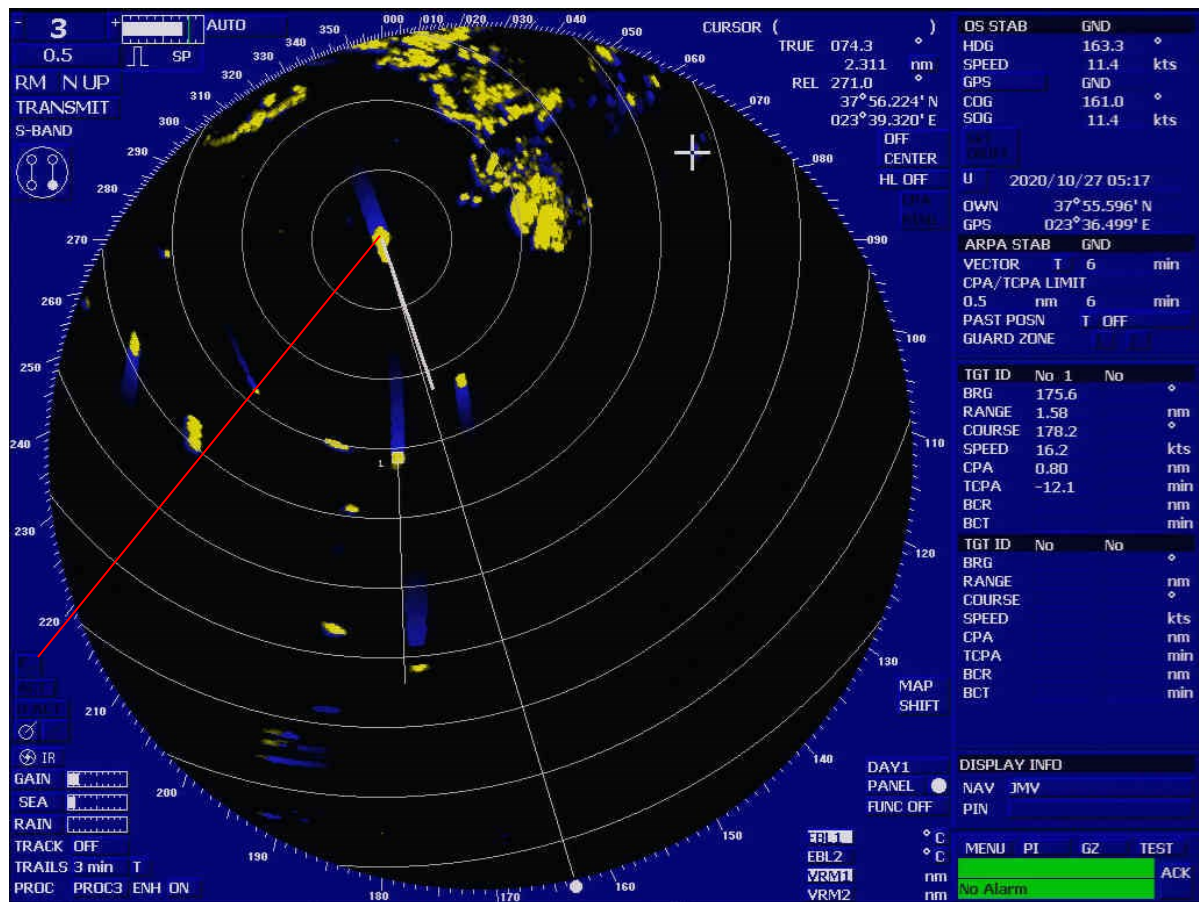
Figure 26. Depiction of MAERSK LAUNCESTON S Band radar at time 07:17:06.

Considering the above as well as the fact that no action was recorded to keep out of the “overtaken” HS KALLISTO’s course prior to the blast of the vessel’s whistle at 07:28:19, such as acquiring the target’s navigational data to the radar-ARPA to check the CPA and TCPA, it is suggested that until that time HS KALLISTO’s course was not properly

assessed and the “overtaking” situation, as per COLREGs, Rule 13, was not identified.
