HELLENIC REPUBLIC  
HELLENIC BUREAU FOR MARINE CASUALTIES INVESTIGATION

MARINE CASUALTY SAFETY INVESTIGATION REPORT  
03/2014

EXPLOSION ON BOARD M/V "NAKHODKA"

September 2016

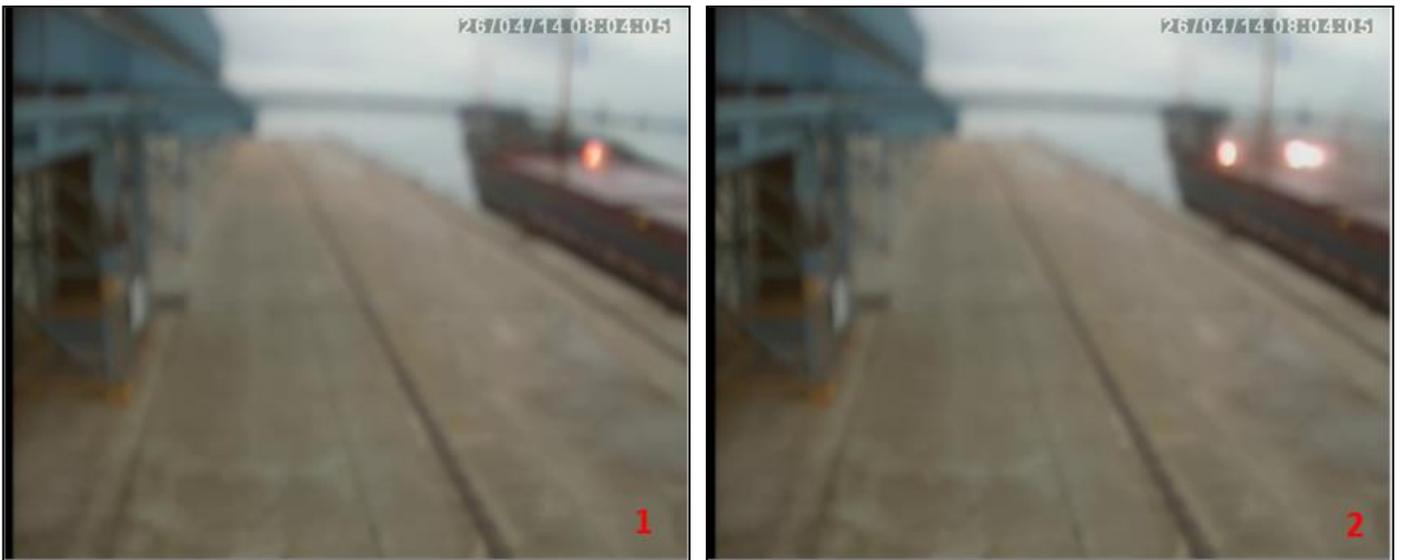
At 08:04:05, as recorded by the port facility's CCTV, an explosion occurred inside the forecastle's spaces. The location of the initial explosion was determined to be at the starboard side of the forecastle, while it was followed by a stronger second explosion at the port side of the Boatswain's Store. The fire outbreak inside the Boatswain's Store and the adjacent Paint Room compartment (Figures 4,5).

**Figure 4:** Screenshots of the recorded video by the port facility's CCTV at 08:04:05, indicating the flame from the initial explosion at the starboard side, followed by a secondary blast at the port side.

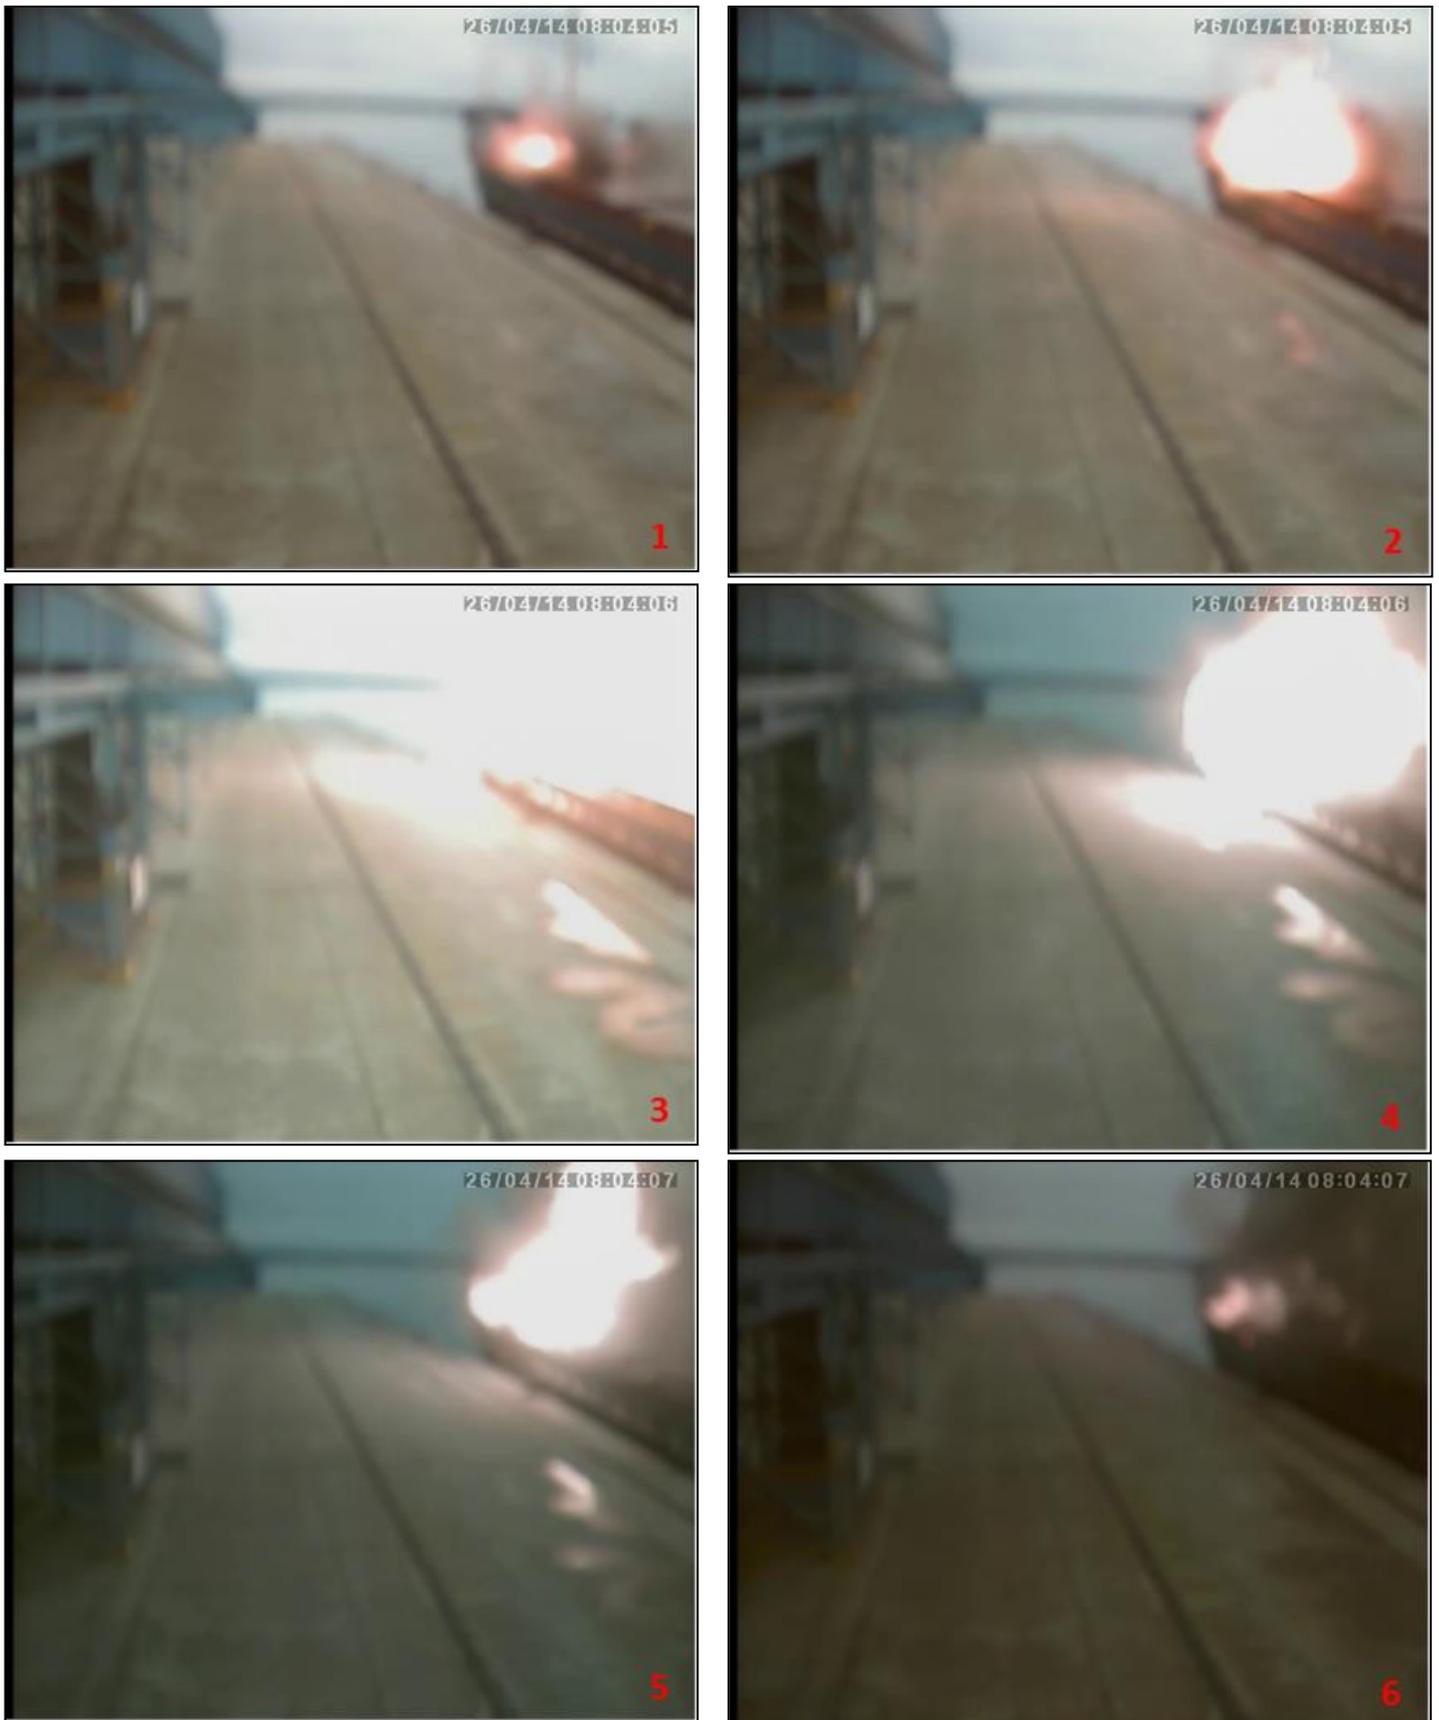
**Figure 5:** Screenshots of the recorded video by the port facility's CCTV during 08:04:05 – 08:04:07, indicating the higher energy of the secondary explosion at the port side.

Considering the flame outspread of the explosion as recorded by the port facility CCTV and presented at par. 3.2, it is inferred that an explosive atmosphere was created inside the forecastle mostly in the passageway area and inside the Boatswain's Store. The first blast indicates that the initial ignition occurred close to the passageway while the second blast as well as the extended damages of the bulkhead between the Paint Room and the Boatswain's Store, indicates that the second and more powerful explosion occurred at the Starboard side of the Boatswain's Store.

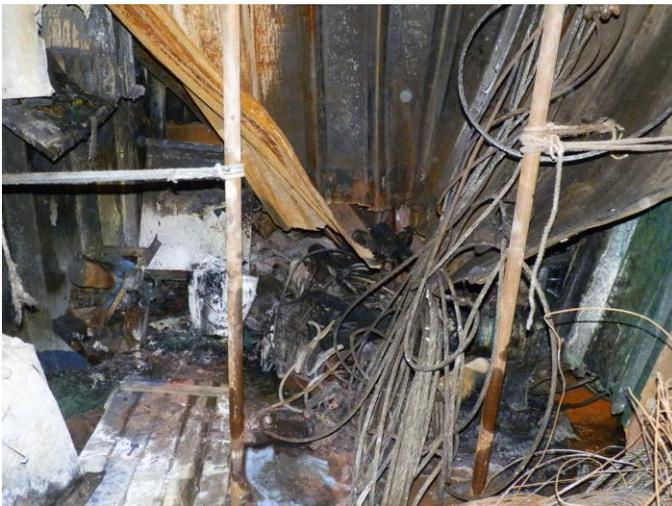
The second explosion cracked the bulkhead between the Paint Room and the Boatswain's Store, in the direction from the Boatswain's Store to the Paint Room. The explosion's heavy blast forced open and deformed the watertight door of the Paint Room which was closed and locked, and a fire broke out at the two aforementioned compartments. The explosion's blast wave casted parts of metal components and vessel's equipment in the forecastle area as well as overboard (Figures 6,7).

*“a crack in the watertight bulkhead, fr. 15, CL, at the height of 2m from the double bottom, length: 2m; paint room watertight door has been deformed; carpenter shop bulkhead has been deformed without destruction; corrugated bulkhead and ladder of paint room have been destroyed from the deck in the boatswain and rope stores and heavily deformed; boatswain's stores deck was damaged; windlass cable feed was damaged.”*

**Figure 6:** Capture of the cracked bulkhead of the Paint Room after the extinguishing of the fire. It is evident that the intermediate (between Paint Room and Boatswain's Store) bulkhead has been heavily buckled by the explosion, blocking the access to the lower space, while the door has been deformed by the explosion gases.

The vessel undertook temporary repairs for a direct passage to a repair port in Izmail, Ukraine where by the 12<sup>th</sup> of May 2014 all damages had been permanently repaired, and the vessel retained her class.

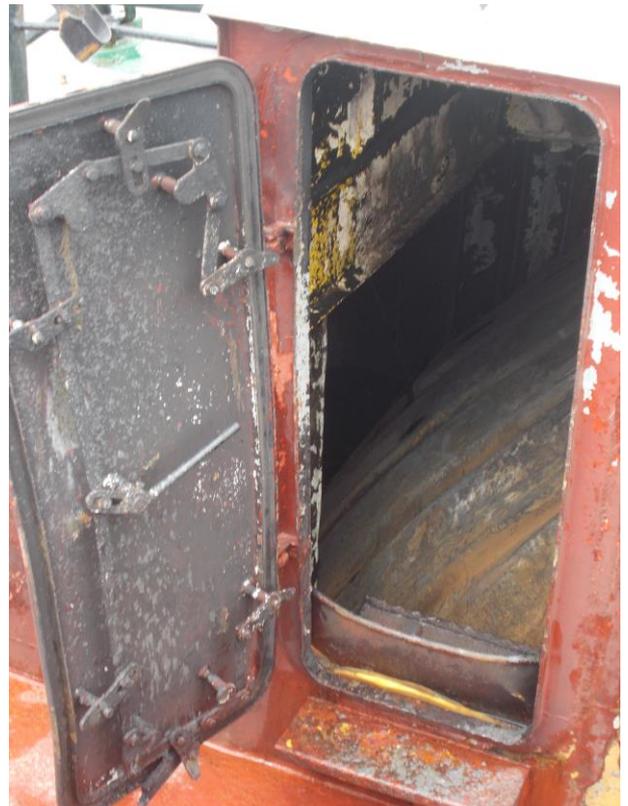
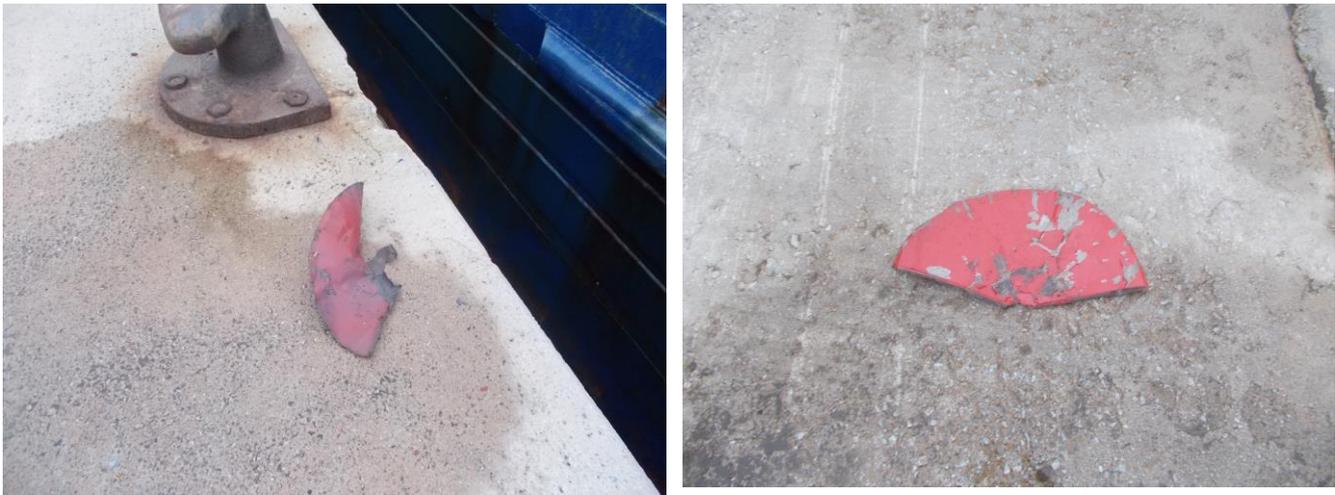
Figure 7: Metal pieces found overboard, casted by the explosion

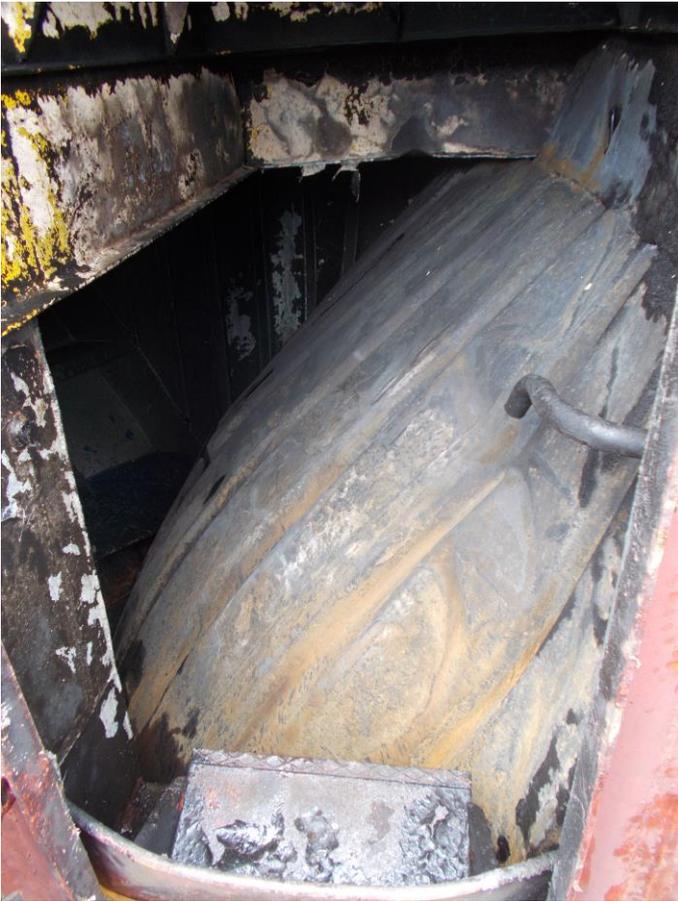
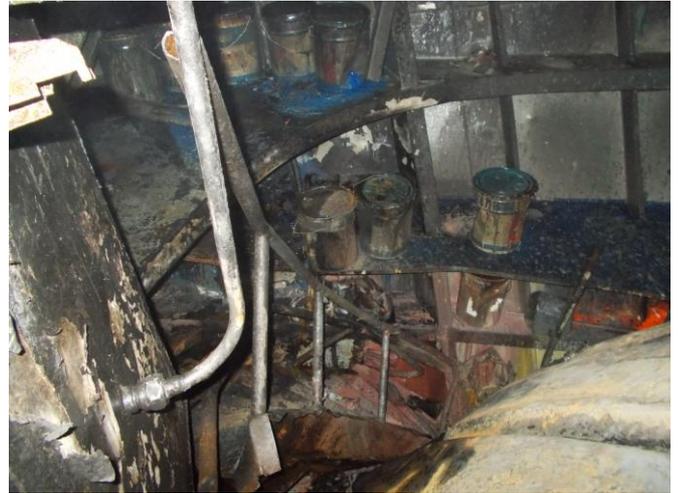
The Paint Room had sustained severe damages due to the explosion and the fire. The bulkhead between the Boatswain's Store and the Paint Room had been damaged mostly, as it had been cracked at its bottom and bended towards the Paint Room. Moreover, the watertight door of the Paint Room was deformed as it was forced open due to the explosion's blast.

Some paint buckets were found inside the Paint Room. The exact quantity of paint that was stored in the Paint Room prior to the explosion could not be identified; however based on the consequences of the explosion it could not be considered as a significant quantity for the creation of an explosive atmosphere (Figure 10).

**Figure 10:** The bended bulkhead and the paint buckets found inside the Paint Store.

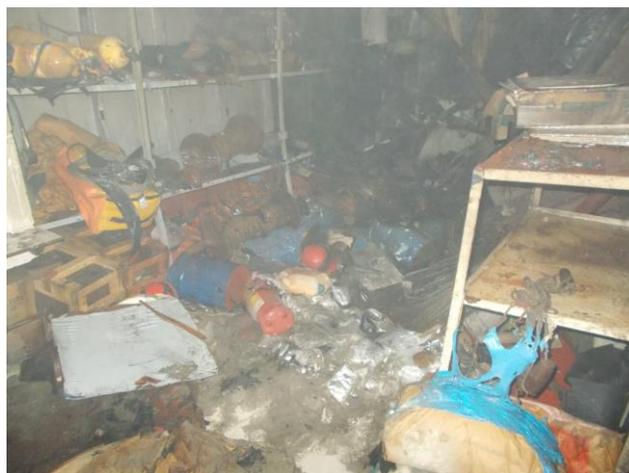
The Boatswain's Store was damaged by the explosion and the fire, while several materials and equipment were burnt and spread on the floor. The Boatswain's Store had a storage section used to store firefighting equipment including fire extinguishers and air breathing apparatus cylinders as well as other materials and equipment such as wires, ropes, etc. However none of them could be related to the cause of the explosion as they do not produce vapors that could form an explosive environment when mixed with air (Figure 11).

**Figure 11:** The Boatswain's Store after the explosion showing the storage section selves

Based on the extend of the damages at the area, it is concluded that the Boatswain's Store door was opened and the propane accumulated inside the lower levels of the port side of the Boatswain's Store.

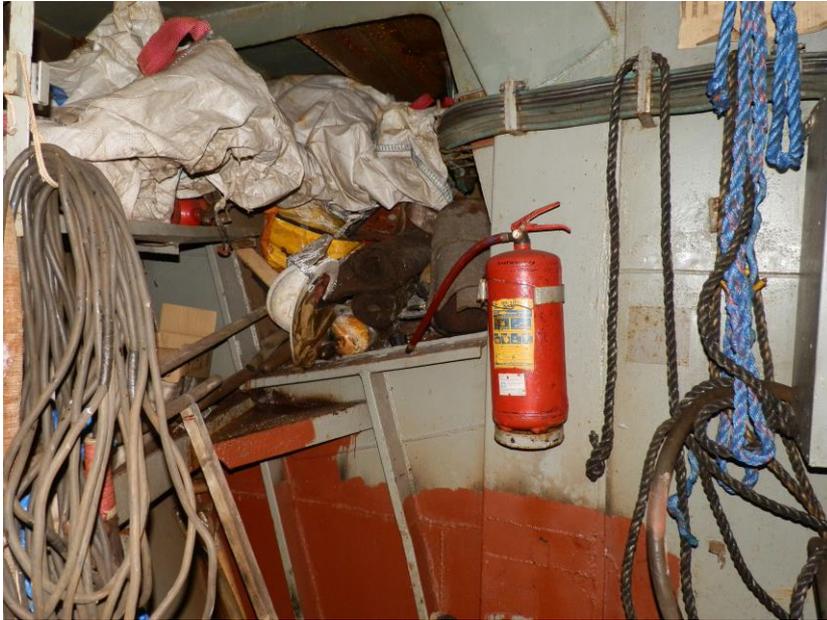
No signs of the explosion, fire or burnt material were found in the Carpenter's Shop. The equipment and material stored inside was found intact and in good condition, indicating that the explosion and the fire of the examined marine casualty did not affect it (Figure 12).

**Figure 12:** Equipment and materials stored inside the Carpenter's Shop.

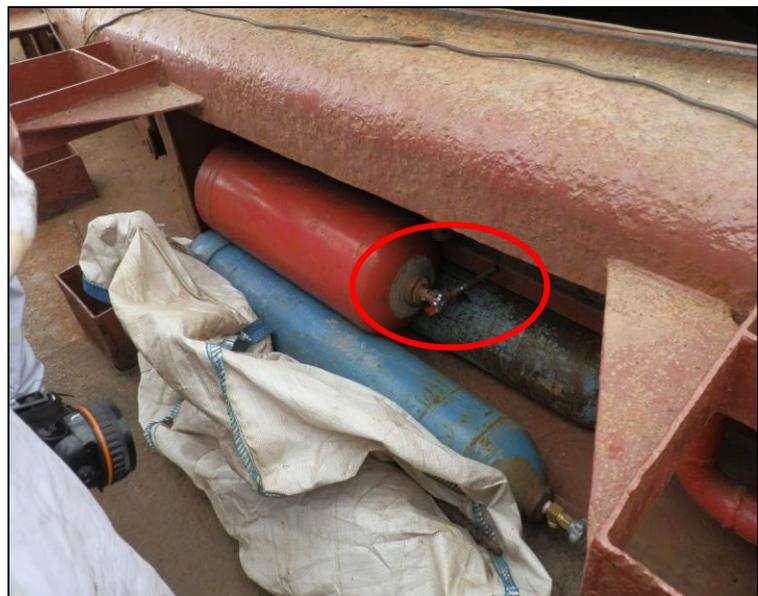
However, in said compartment one propane cylinder and two oxygen cylinders were found placed in it. The propane cylinder was connected to a flexible pipe almost 30m long, which at the other end was connected to a flame tool found on the work bench at the port side of the Rope Store. After the fire was extinguished the propane and oxygen cylinders were removed by the crew members of NAKHODKA, who assisted the Fire Brigade personnel and were placed on the deck. During said process it could not be established if the propane cylinder valve handwheel was open or closed. The propane cylinder was weighted by the HBMCI investigation team and was found almost empty (Figures 13, 14).

**Figure 13:** The two oxygen (blue) and one propane (red) cylinder that were carried from the Carpenter's Shop to the open deck, after the fire extinguishing operation. The flexible pipe that was connected to the cylinder before it was cut in order to remove it is marked.

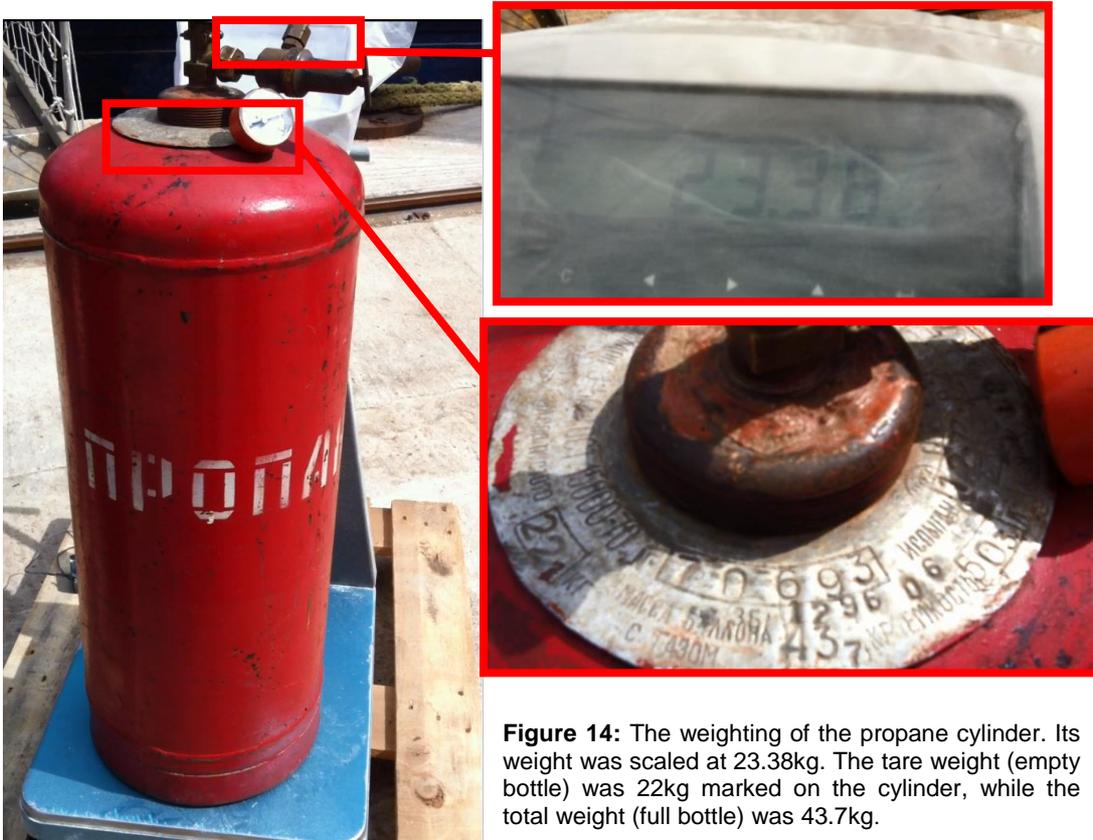
**Figure 14:** The weighting of the propane cylinder. Its weight was scaled at 23.38kg. The tare weight (empty bottle) was 22kg marked on the cylinder, while the total weight (full bottle) was 43.7kg.

In light of the above, as well as the data referred to par. 4.3.1.3 and 4.3.2.1, it is inferred that the explosive atmosphere was created by a leakage of propane. Based on the evidence collected during the investigation process the leakage point of the propane could not be identified; however considering the good condition of the propane cylinder it could be suggested that the propane leaked from the cylinder's connection or the flexible pipe connecting the cylinder and the flame tool found on the work bench in the Rope Store.

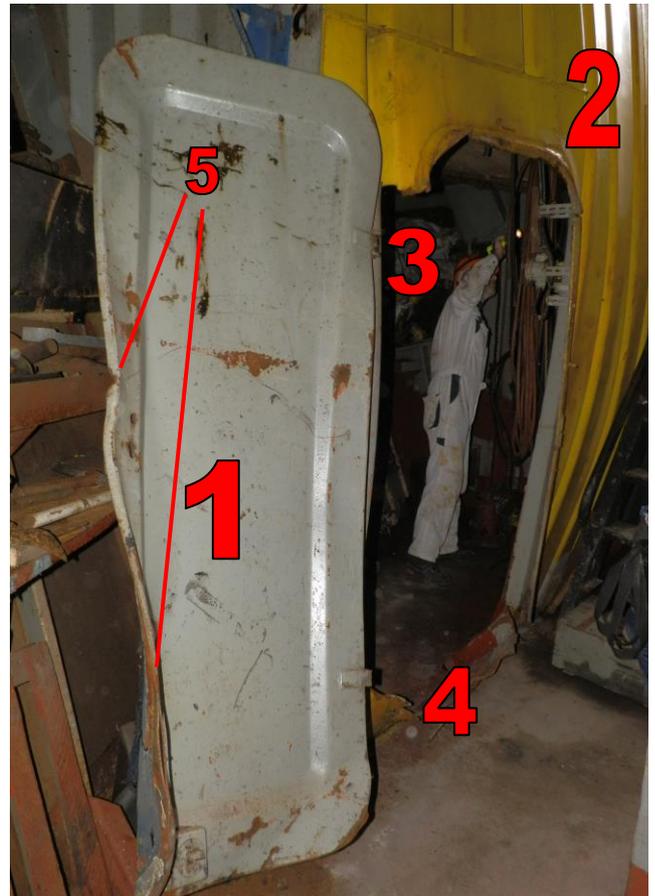
The Carpenter's Shop compartment had clear signs of explosion incident in the past. More specifically the port bulkhead of the space was bended towards the passageway, while the door casing was cracked and the door was deformed and could not be closed. Additionally, although the door was constructed to open towards the inner side, as indicated in the Fire Control Plan, the door remained open towards the outer side of the compartment. Furthermore, cracks were found on the door and the door casing with deep oxidation signs which could not be attributed to the water spraying efforts to extinguish the fire as these efforts were targeted inside the Paint Room (Figures 14,15).

**Figure 14:** The door of the Carpenter's Shop (1) and the internal bulkhead (2). They were evidently deformed, while there were cracks on the door's casing (3) and (4). The paint coating was clear and in good condition. The deep corroded points on the door (5) and at the lower casing (4) cannot be attributed to the oxidation from extinguishing water sprays suggesting that the occurrence had happened quite some time ago.

The Carpenter's Shop door could not be closed, as it had been deformed from the previous explosion in the past, thus any propane gas leaking from the cylinder connection or the flexible pipe inside the Carpenter's Shop could be easily transferred and concentrated in the adjacent spaces, such as the Rope Store and the Boatswain's Store.

.1 During the “on scene” investigation process it was observed that the bulkhead as well as the door between the Carpenter's Shop and the internal passageway were deformed, indicating an explosion inside the room. However, there was no sign of fire inside the Carpenter's Shop, while the equipment that was stored in it was found that remained intact, suggesting that the explosion and fire of the examined marine casualty had not occurred in this compartment. The door had no lock on it and it bore signs of corrosion that were deep enough and could not be attributed to recent surface oxidation by the fire extinguishing water. Furthermore, other points, such as the doorstep, were deformed or cracked and showed a good and clean condition of their painting coat around the corroded parts. Considering the above, it is concluded that the cracks and deformations of the Carpenter's Shop door and bulkhead are not related to the examined marine casualty and considered to had been caused due to a past explosion, which occurred inside the room.

During the interviewing process, it was confirmed that there had been another incident of explosion on board, inside the Carpenter's Shop, which caused the deformation of its internal bulkhead and door. However, the exact time of the previous incident could not be specified by the interviewees; it was reported that it should had occurred more than 4 months from the date of the examined accident. It is noted that the damaged bulkhead and door had impact on the structural integrity of the Carpenter's Shop. Consequently, the “Class A division” criteria as defined in SOLAS 60, Ch. II, Part D, Reg. 35 and presented in Nakhodka's Fire control Plan, as referred in par. 4.1, was abolished.

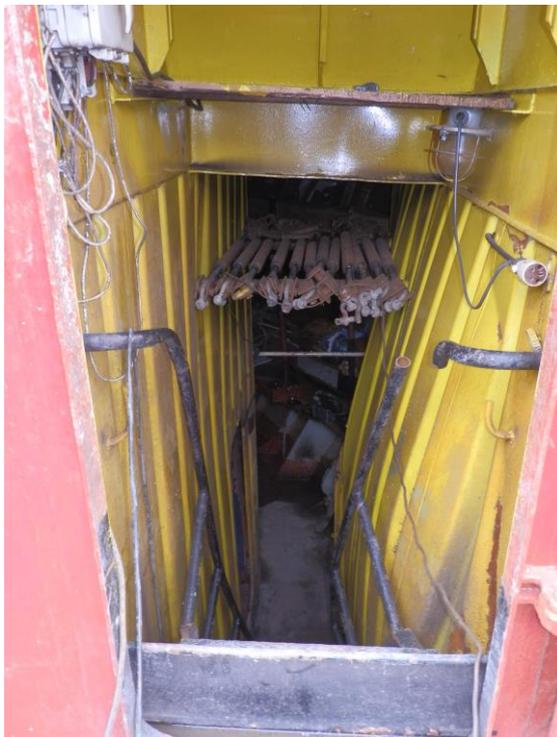
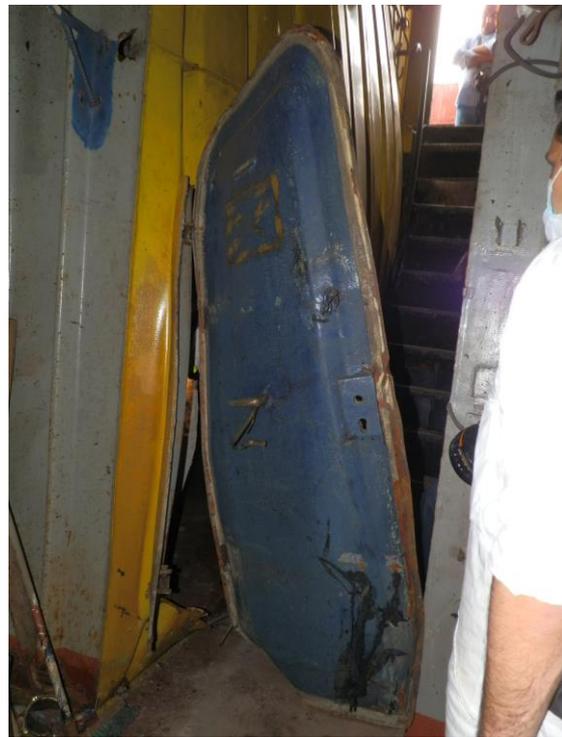
**Figure 15:** The door and the Starboard bulkhead of the Carpenter's Shop, clearly deformed, yet thoroughly painted.

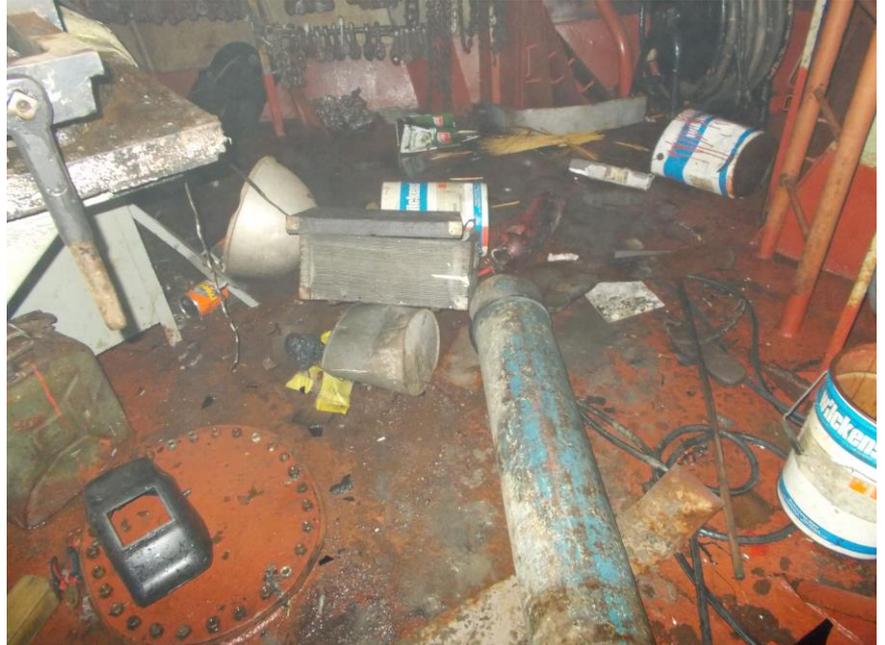
Inside the Rope Store a work bench was placed at the port side. One more oxygen cylinder was found near the bench connected to the flame tool which was found on the bench. Moreover, according to Fire Service's Officers, a welding machine was placed in the Rope Store; however its cables were stored indicating that it was not in use at the time of the accident (Figure 16).

**Figure 16:** The Rope Store as found after the explosion. On the left upper corner of the picture the working bench is shown, while an oxygen cylinder connected to the flexible pipe of the flame tool lies on the floor.

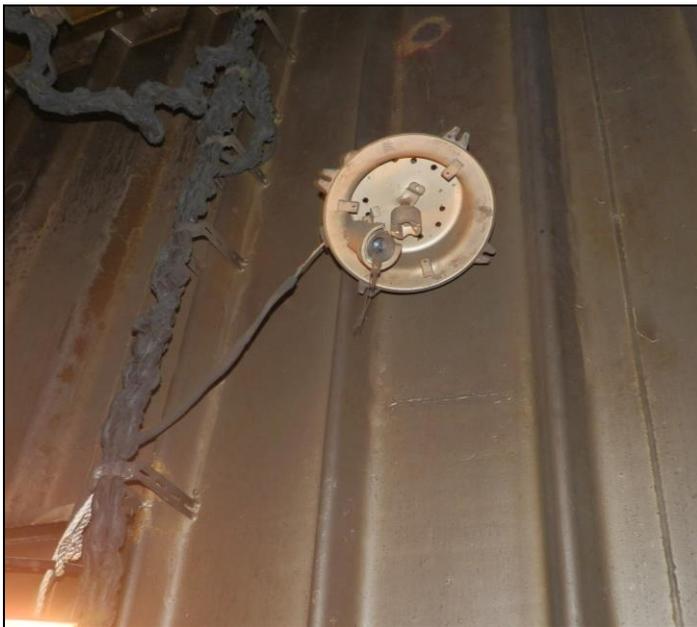
The electrical lighting equipment installed in all spaces of the forecastle was of enclosed type; nonetheless it was evident that additional electrical connections were used by the crew. More specifically an extension cable was found connected inside the Store leading to an open unprotected lampholder above the door of the compartment (Figure 17).

**Figure 17:** The connection at the entrance of the forecastle and the open lampholder found above of the Boatswain's Store door.

Despite the above, the ignition of the explosive atmosphere could be attributed to an electrical spark of the electrical equipment in the forecastle area. As stated in par. 4.3.1.5, evidence of unprotected lighting electrical equipment was found. More specifically, next to the Boatswain's Store door an extension cable was found leading to an open unprotected lampholder above the door. However, no further "in situ" evidence was available due to the damages caused by the explosion's strong blast and the fire.

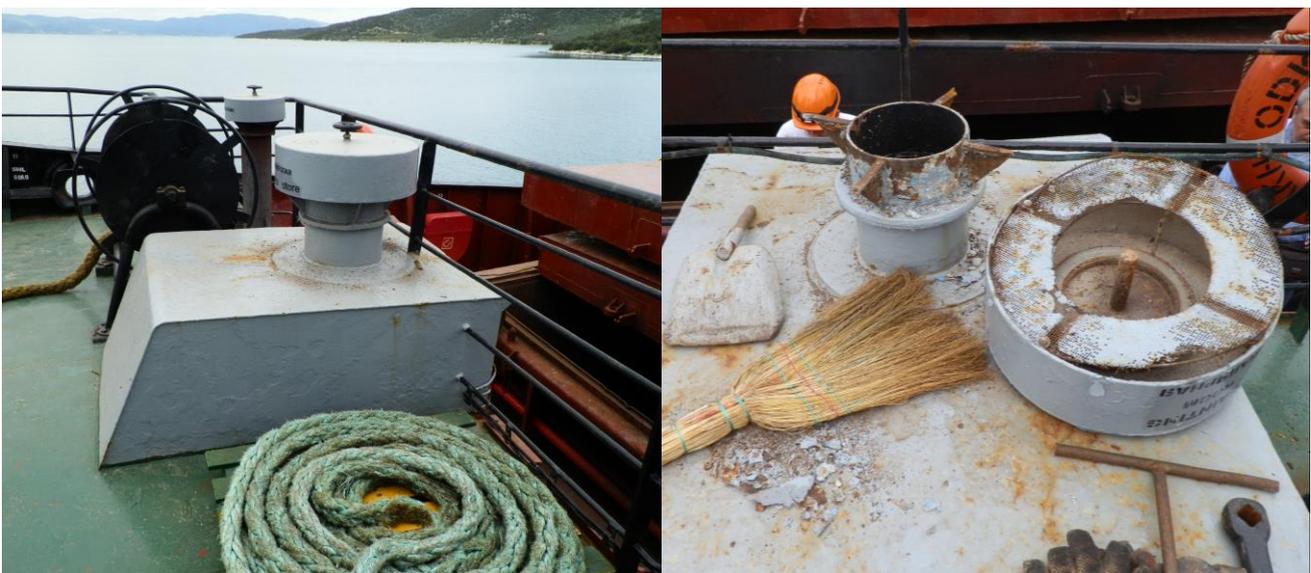
The fact that propane is transparent, heavier than air and concentrates in the lower parts of an enclosed space thus it cannot be easily seen or smelled makes it difficult to be detected by anyone who does not suspect a leakage. Therefore, in the examined case the two engineers could not easily detect if any leakage from the propane cylinder or its flexible pipe had occurred. Moreover, the fact that propane vapors concentrate at the lower levels of a space, renders the ventilation of the space by natural means, such as the air ducts which existed on top of the forecastle spaces, insufficient.

**Figure 18:** Photos of the ventilation mushrooms placed on top of forecastle's spaces (one port and one starboard side).

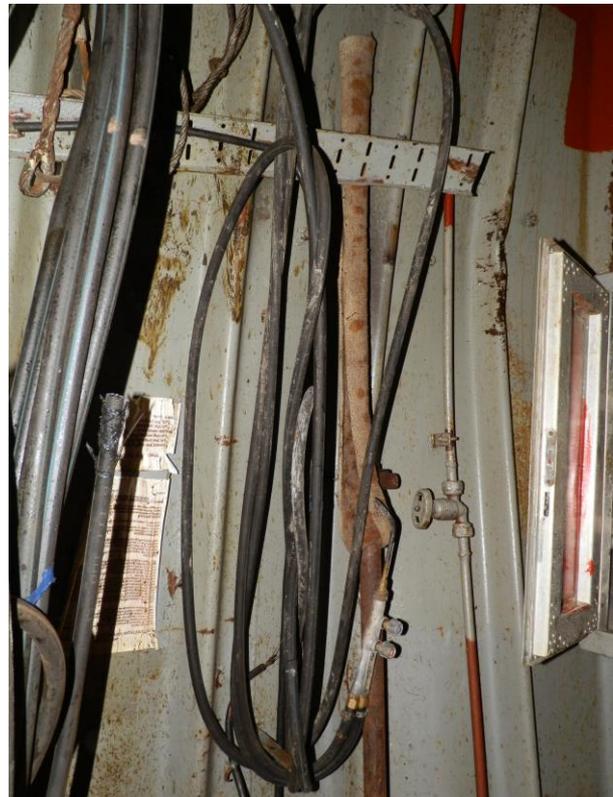
As already mentioned, propane and oxygen cylinders as well as their flexible pipes were stored in the Carpenter's Shop. Moreover a welding machine with its cables and a welding protective mask were found in the forecastle area. The crew was aware of the existence of the gas cylinders in the Carpenter's Shop and during the fire extinguishing operation the cylinders were promptly removed to the open deck for safety purposes.

During the interview process it was reported that Nakhodka's crew was not allowed to use the propane cylinder and they were stored only to be used by shore repair personnel, when required. However the flame tool found on the work bench after the explosion which was connected to the propane and the oxygen cylinder, suggests that it had been used by the vessel's crew or it was about to be used by the two Engineers.

**Figure 19:** The flexible pipe hanging on the bulkhead of the Carpenter's Shop.

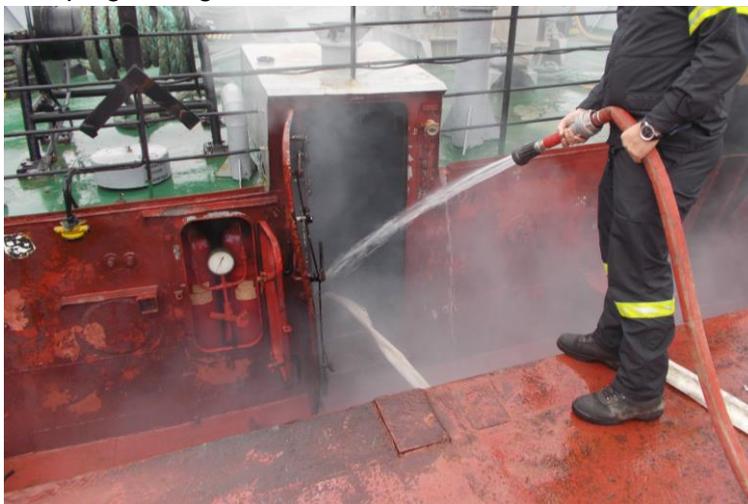
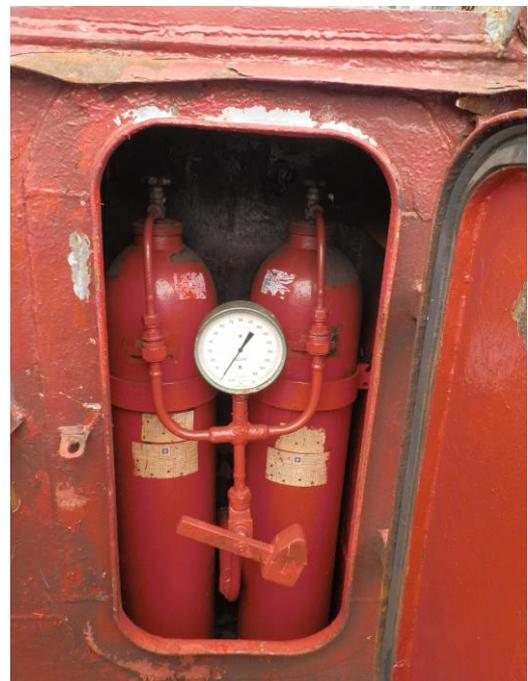
Apart from the above, the Paint Room was equipped with a fixed CO<sub>2</sub> fire extinguishing system. The CO<sub>2</sub> cylinders were located at the aft bulkhead of the forecastle on the main deck close to the Paint Room door. It was reported during the interview process that the Chief Officer attempted to close the door of the Paint Room in order to release the CO<sub>2</sub> but he couldn't get close due to high thermal emissions and smoke that were being generated by the fire and escaping through said door.

**Figure 22:** The fixed CO<sub>2</sub> fire extinguishing system located outside of the Paint Room door.
