HELLENIC REPUBLIC

**HELLENIC BUREAU FOR MARINE CASUALTIES INVESTIGATION
MARINE CASUALTY SAFETY INVESTIGATION REPORT
03/2020**

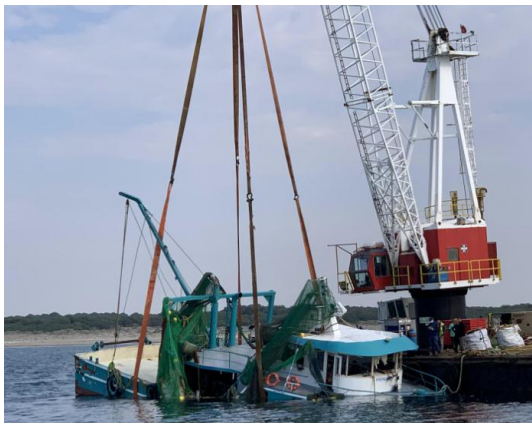
Figure 1. F/V POLAT BEY 1 under salvage operation

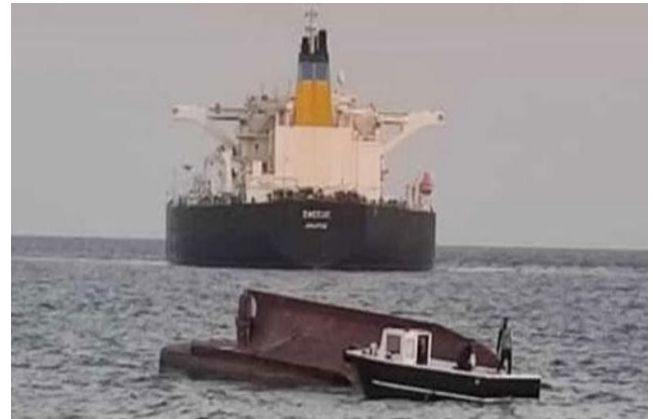
Figure 2. F/V POLAT BEY 1 capsized at the casualty area

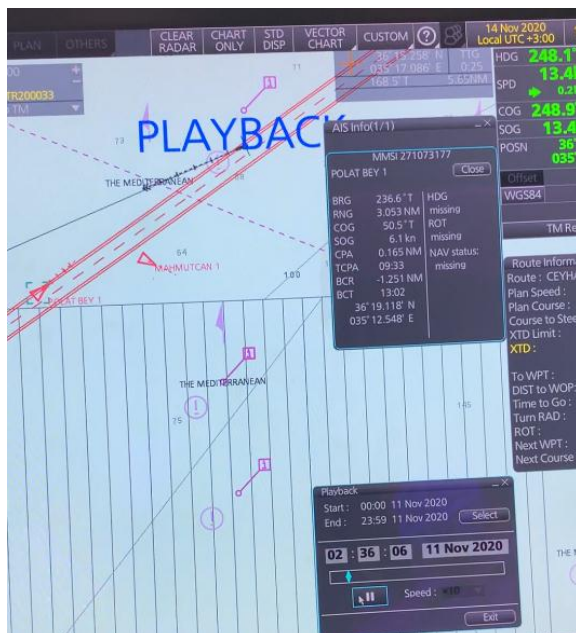
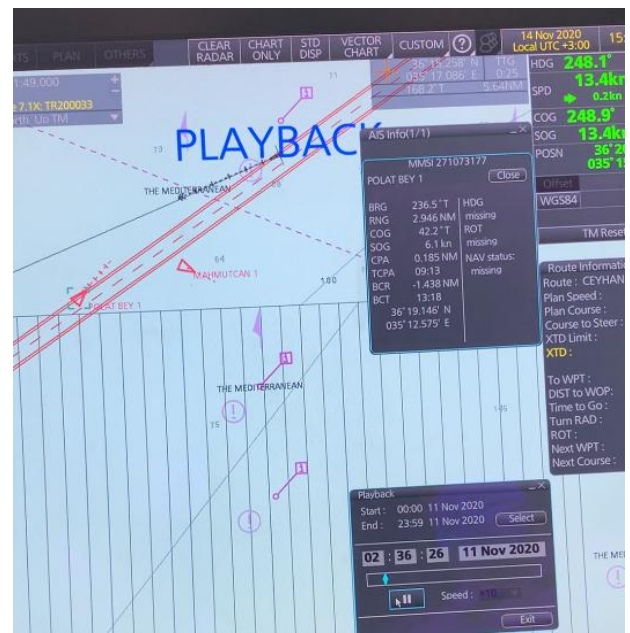
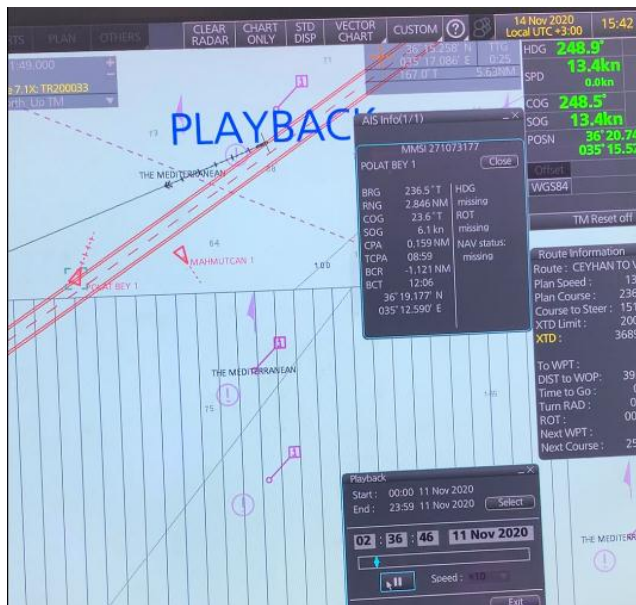
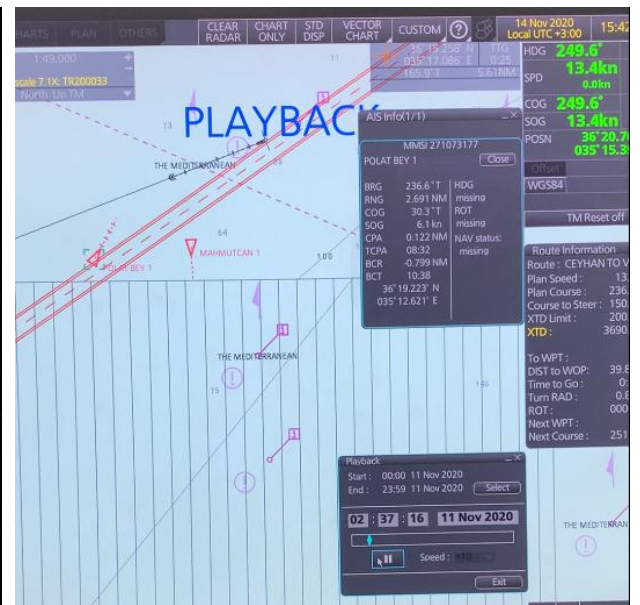
Figure 27: ECDIS at 05:36:06; POLAT BEY 1 course at 50.5°; CPA:0.165 nm - TCPA: 09:33 minutes; BCR: -1.251 nm

Figure 28: ECDIS at 05:36:26; POLAT BEY 1 course at 42.2° CPA:0.185 nm - TCPA: 09:13 minutes; BCR: -1.438 nm

Figure 29: ECDIS at 05:36:46; POLAT BEY 1 course 023.6°; CPA: 0.159 nm - TCPA: 08:59 min; BCR:-1.121.nm. MAHMUTCAN 1 under maneuvering to starboard with reduced speed. Distance between the Fishing vessels about 1 nm.

Figure 30: ECDIS at 05:37:16; POLAT BEY 1 course 030.3°; CPA:0.122 nm - TCPA: 08:32 minutes; BCR:-0.799 nm. MAHMUTCAN 1 under maneuvering to starboard with reduced speed.

Based on the navigational data (course and speed) of POLAT BEY 1 as plotted on ECDIS, the OOW presumed that vessel's course would not result to a dangerous "crossing situation" on the grounds that the Bow Crossing Range (BCR) indication was recorded at -1.251 nm; -1.438 nm; -1.121.nm; and -0.799 nm respectively. It is noted that the symbol (-) denotes that the acquired target's bow will cross the course track (pass clearly from the aft) of the vessel and will not cross her heading.

At 05:35, 11 minutes before the collision, 2nd officer called POLAT BEY 1 three times with no response. POLAT BEY 1 was acquired on ARPA and was observed to have a clear pass (see **Figures 27, 28, 29, 30**). At that time MAHMUTCAN 1 was maneuvering to starboard making a large course alternation moving away from EPHESOS passage. On the other hand, POLAT BEY 1 was continuing to navigate towards EPHESOS course.

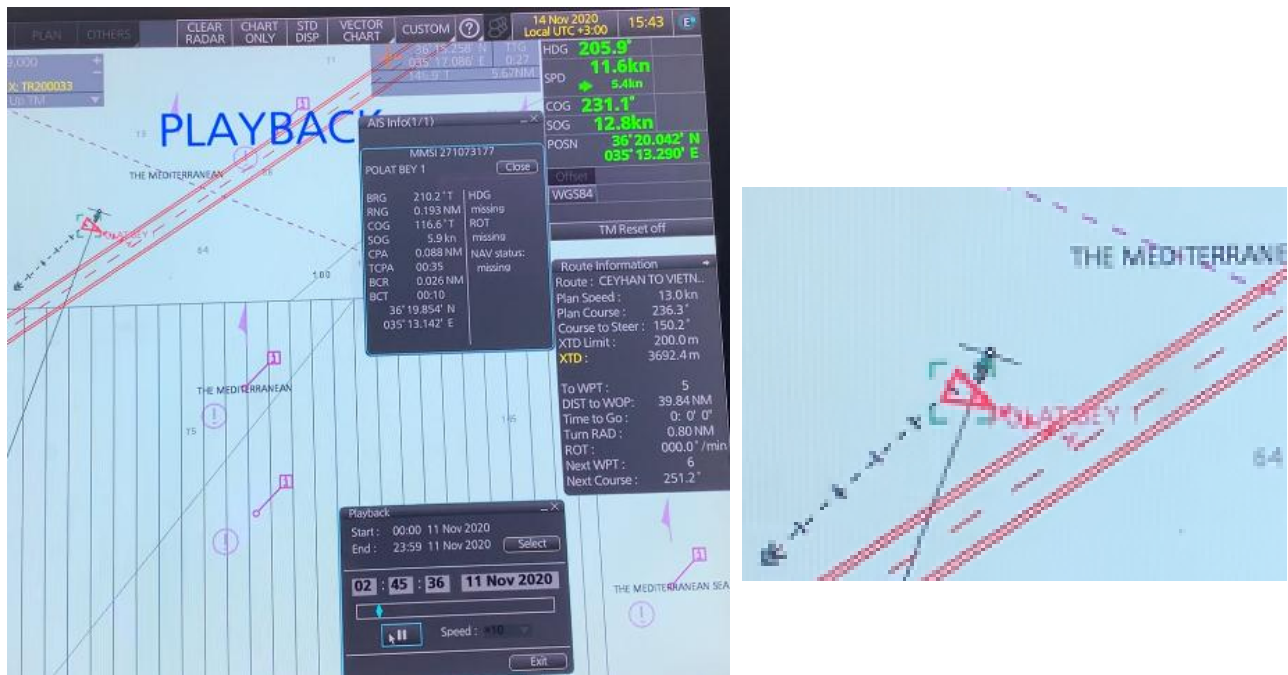
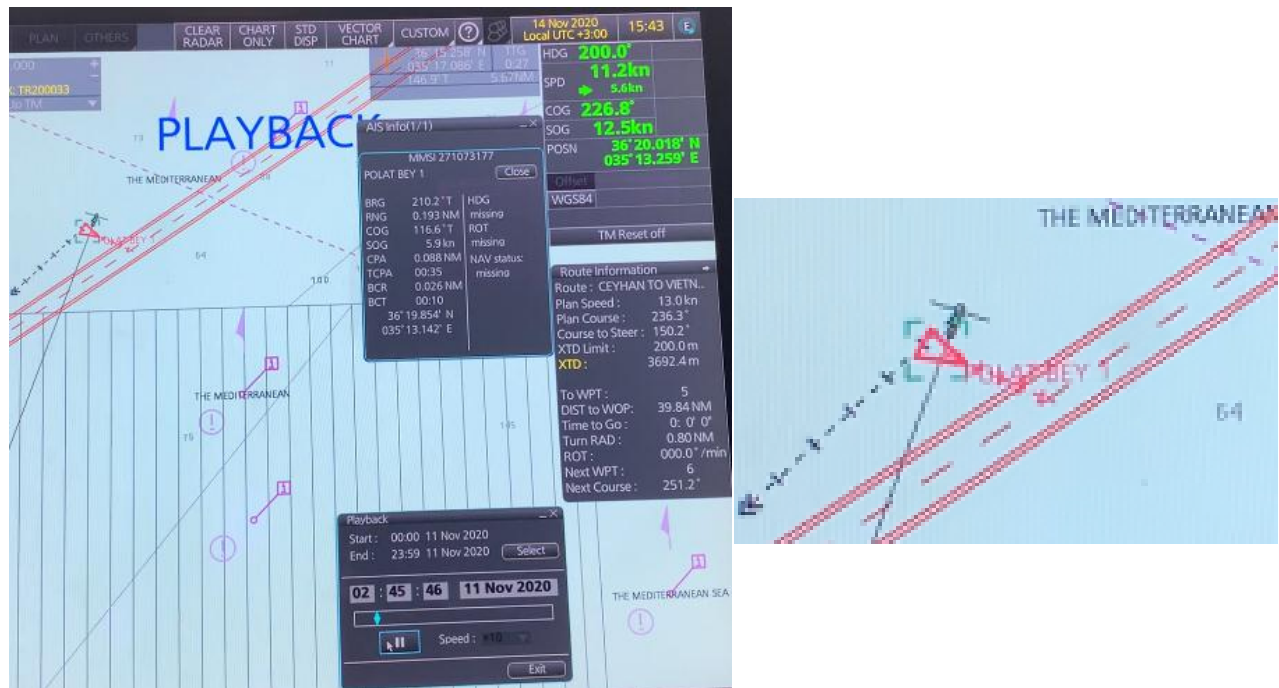
Figure 52: ECDIS depiction at 05:45:36

Figure 54: ECDIS data depiction at 05:45:46

EPHESOS course that was under maneuvering to port. This action to unreasonably alter the course caused a new “close quarter situation” and actually put EPHESOS on a threatening new collision course. Moreover apart from this impetuous act, the helmsman continued altering POLAT BEY 1 course further to starboard reaching 116.60, as recorded in EPHESOS ECDIS (see **Figures 52, 54**) while she was ranged less than 0.2 nm off EPHESOS bow.

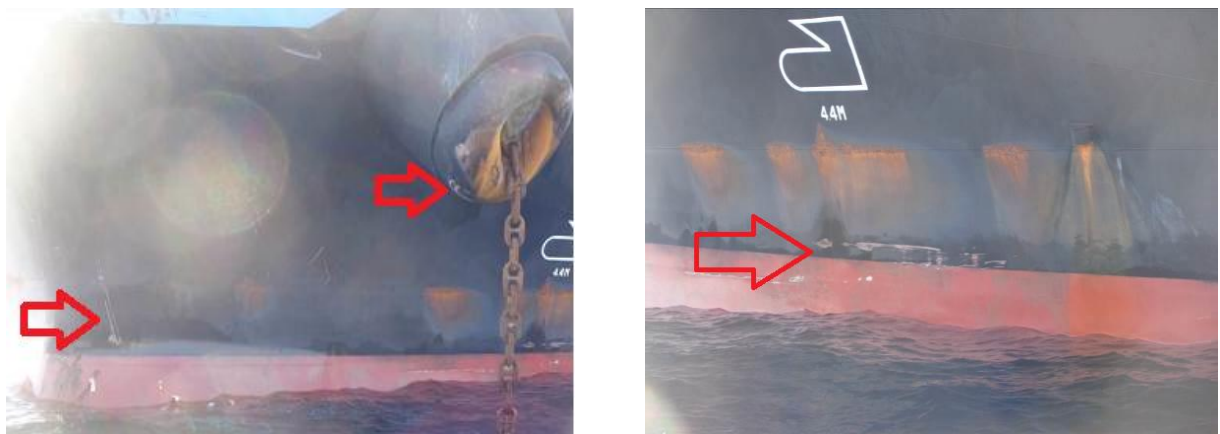
Figure 61: View of port bow. Paint and hull scratches are marked

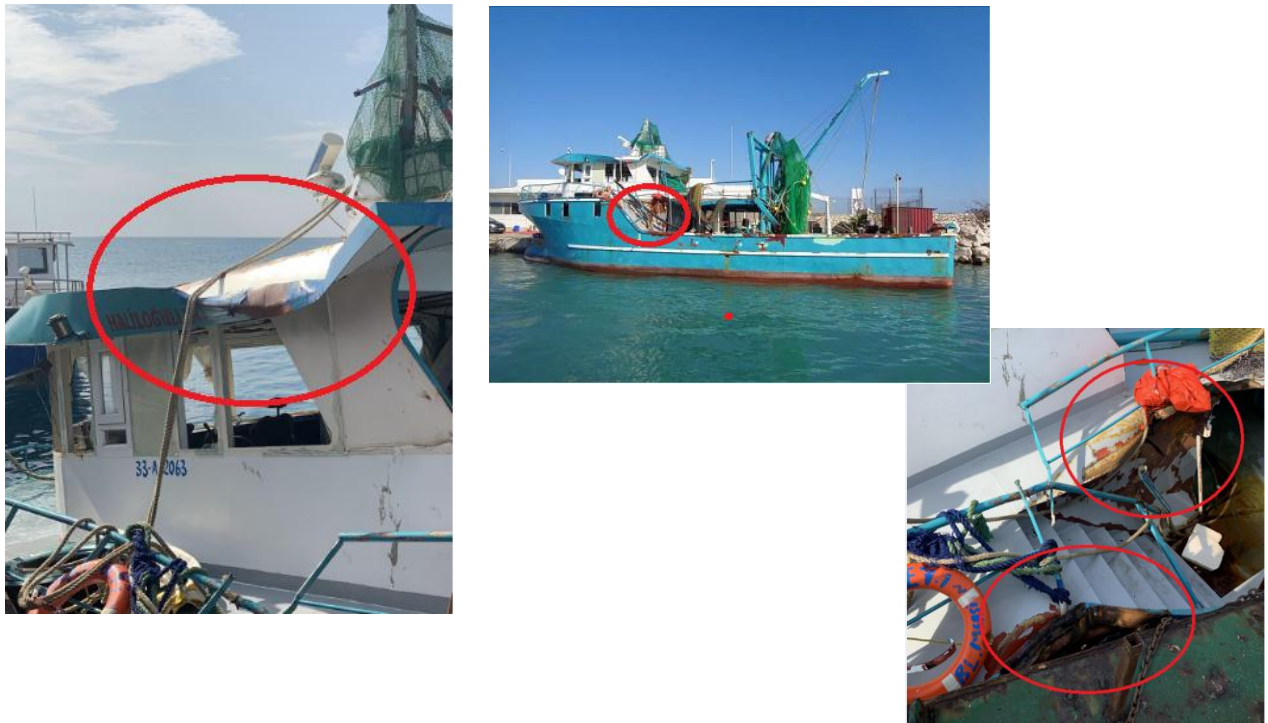
During the inspection of POLAT BEY 1, it was found that POLAT BEY had sustained structural damages on her port superstructure. More specifically the port staircase of the

main deck leading to wheelhouse was damaged as well as the bridge superstructure (see **Figure 62**).

No penetration or damage on POLAT BEY 1 hull and main deck bulwark was detected.

Figure 62: Picture at the right: The damage sustained in the wheelhouse superstructure of POLAT BEY 1. Pictures at the left: Damaged area of POLAT BEY 1

Based on aforementioned findings it was concluded that M/T EPHESES port anchor and anchor pocket struck on the port side of “POLAT BEY 1” at the point of bridge superstructure that forced her to list heavily to starboard, at a point that she lost her intact stability, allowing water ingress over the starboard bulwark or other deck openings that caused her total capsizing by 180°. POLATBEY 1 was severely damaged and became unusable as a result of the collision with the tanker.
