HELLENIC REPUBLIC
HELLENIC BUREAU FOR MARINE CASUALTIES INVESTIGATION

MARINE CASUALTY SAFETY INVESTIGATION REPORT
04/2014

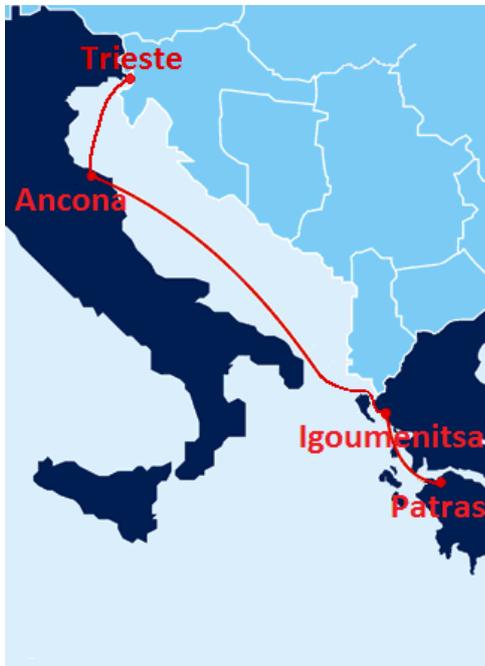
Figure 1/1: Depiction of Europalink itinerary

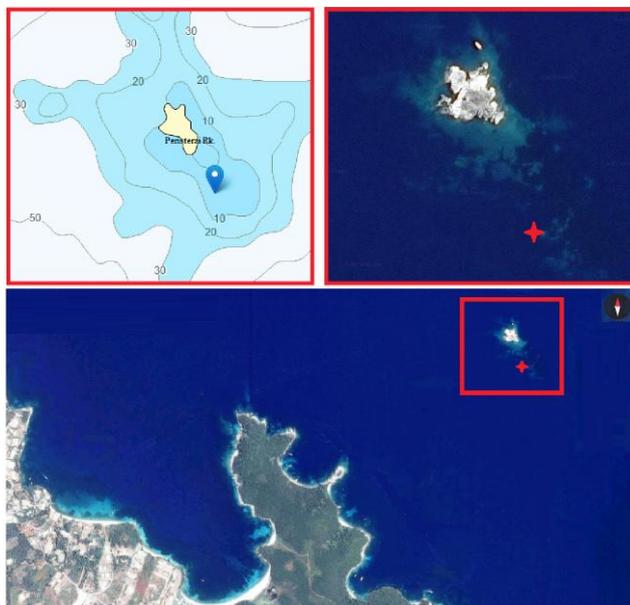
Figure 1/2: The grounding position (Lat 39° 47.47 N Long 19° 57.61 E).

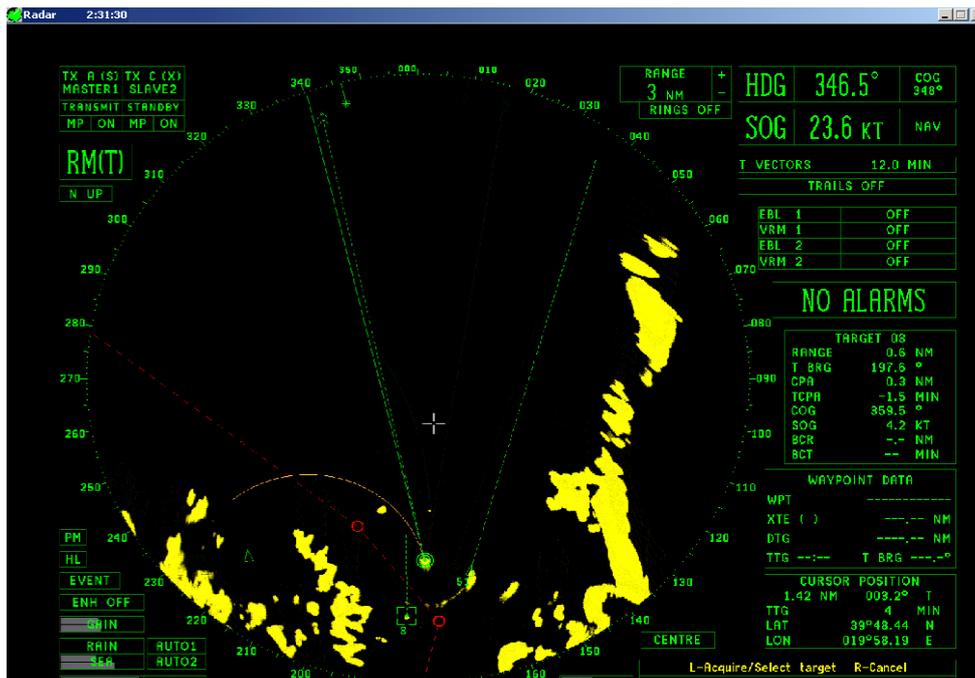
Fig. 3.5/6: *Snapshot from Europalink VDR at the time autopilot selector was increasing the rate of turn.*

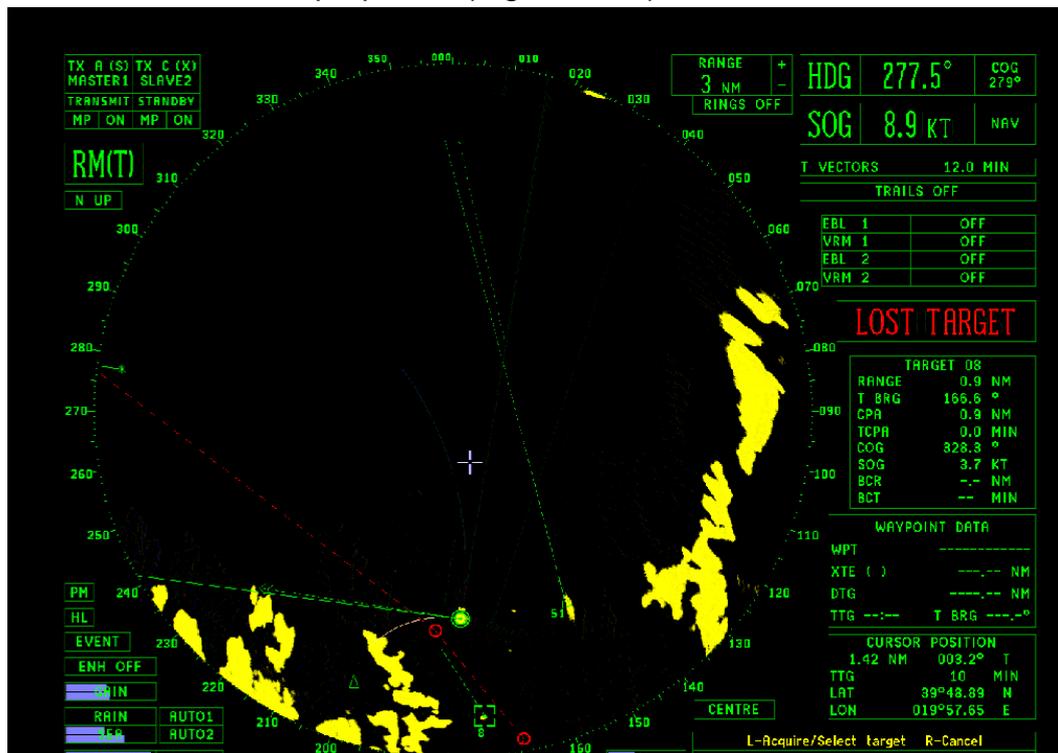
Fig. 3.5/8: Europolink VDR ARPA data showing her speed and course at the time she was raking on Peristerai shelves.

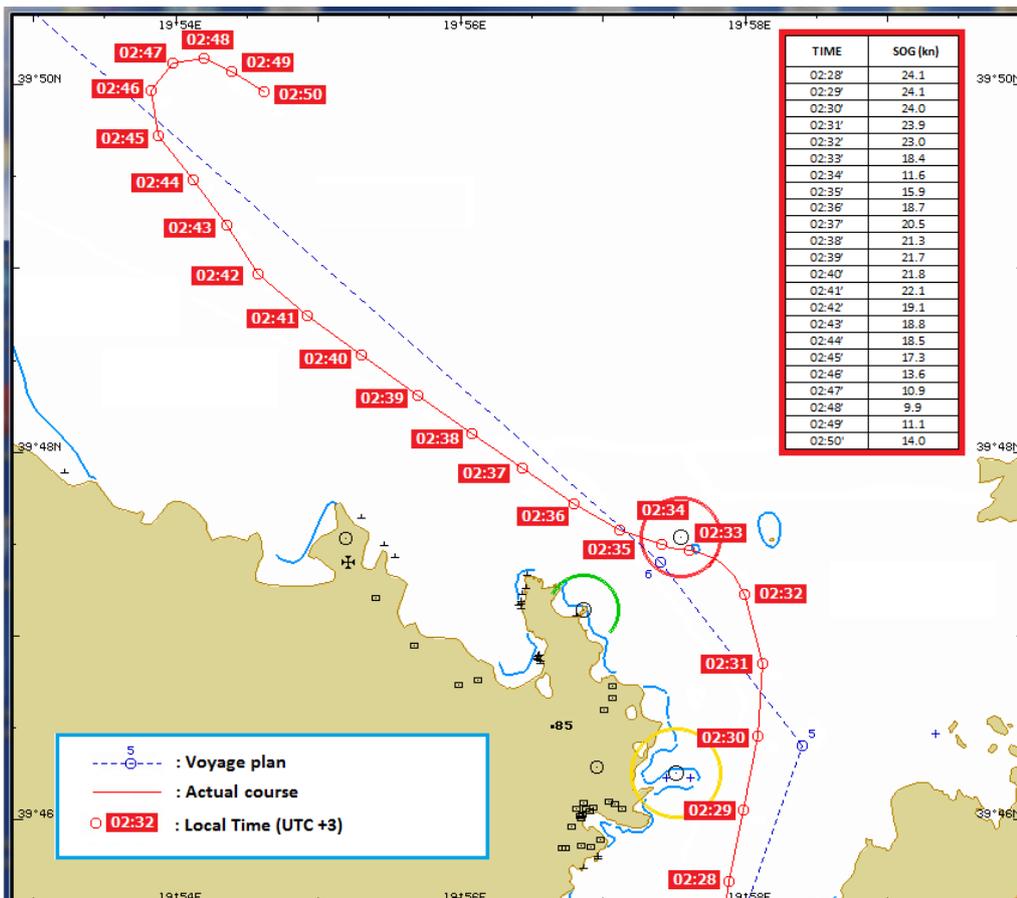
Fig. 3.6.1/1:
 Europolink time depiction and speed as plotted by HBMCI.

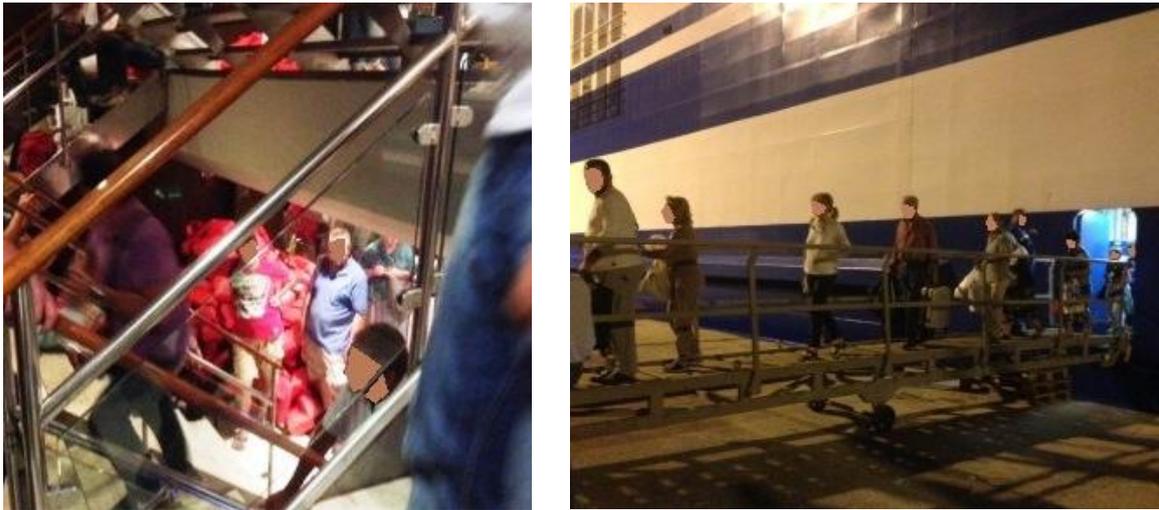
Figures 3.6.5/ 6 & 7: Photos from the mustering and the emergency evacuation of the passengers.

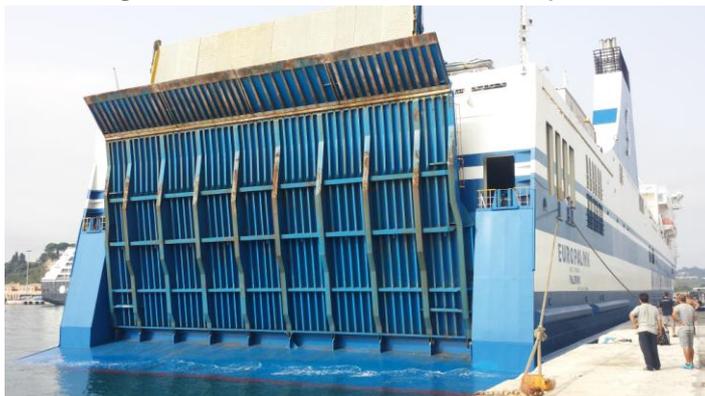
Figures 3.6.7/ 1:
*Europolink
condition prior to
shifting operation.*

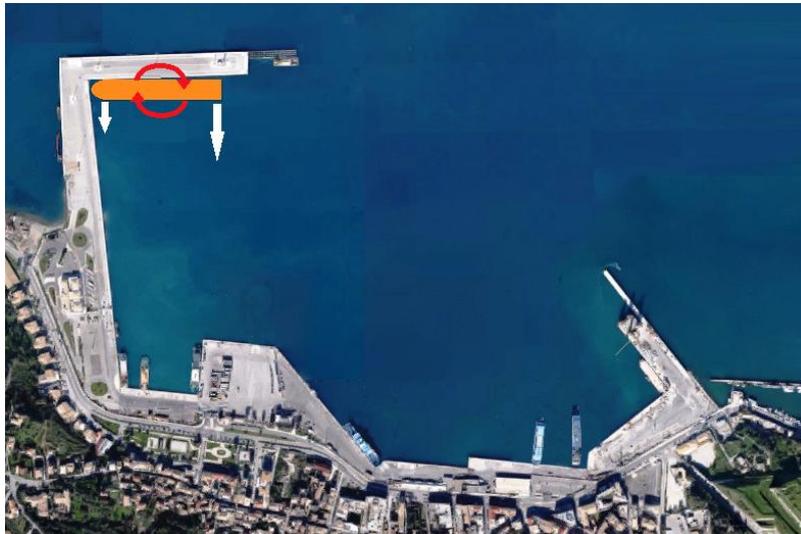
Fig. 3.6.7/2: The ship’s position prior to her rotation and the direction she was rotated to by T/B “DIAS” and T/B “DOXA” in order her stern ramp to be lowered against the dock (Map Source: Google Maps)

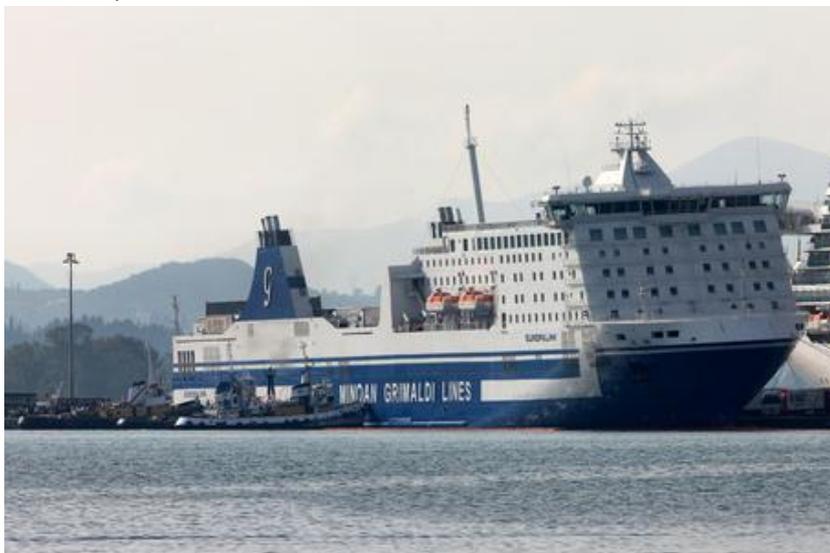
Figure 3.6.7/8:
Port tugs pushing Eurolink post to the completion of the shifting operation

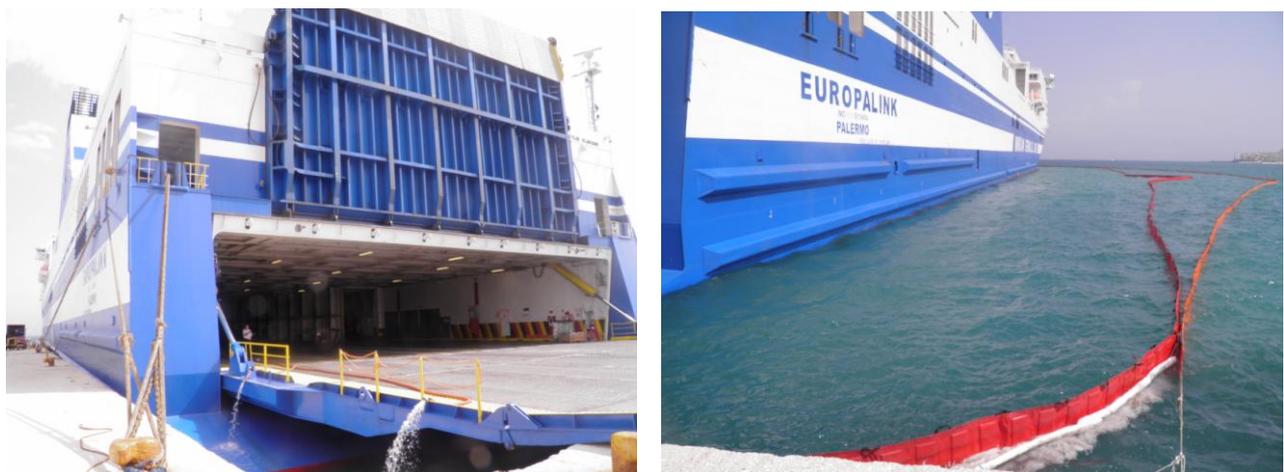
Fig. 3.6.7/ 9 & 10: *Europolink floating condition after vehicles were discharged.*

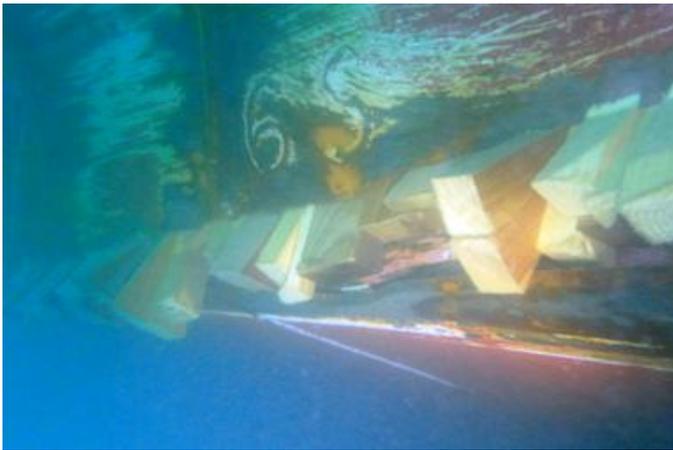
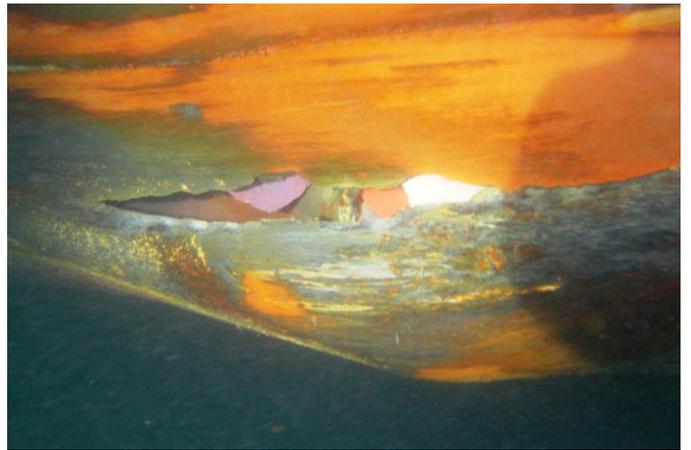
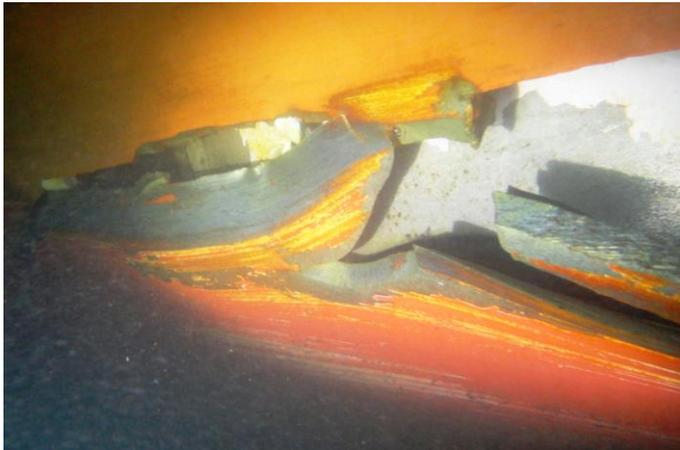
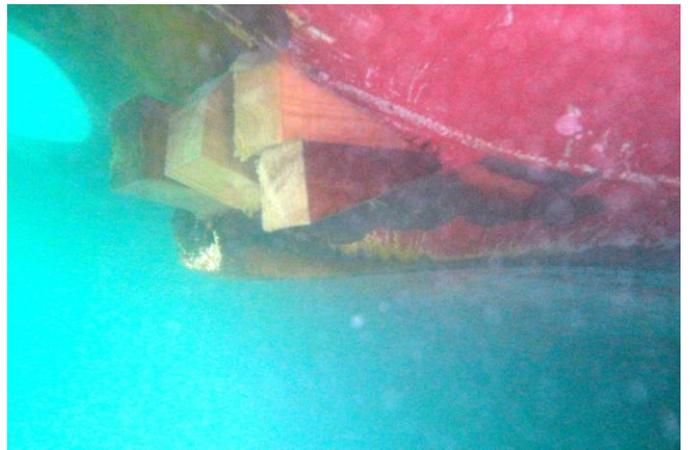
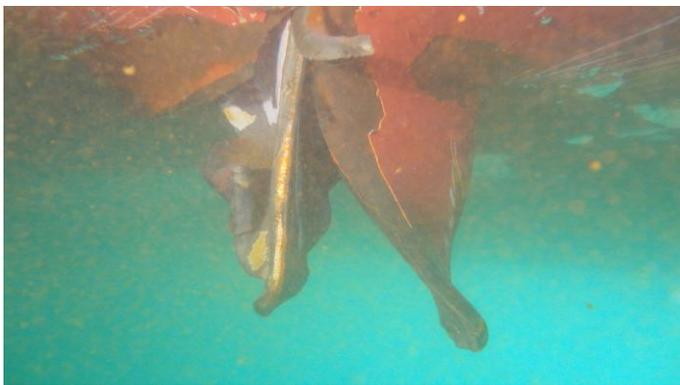
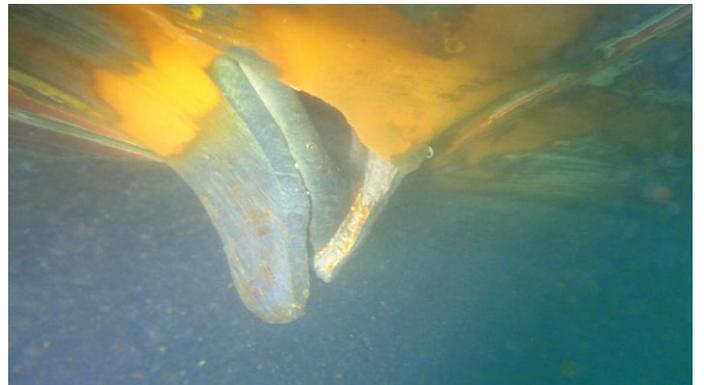
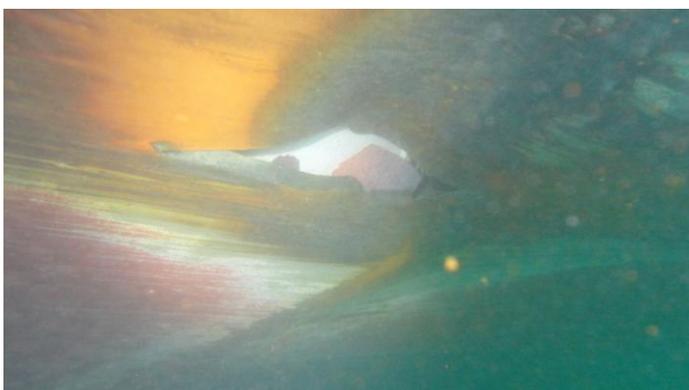
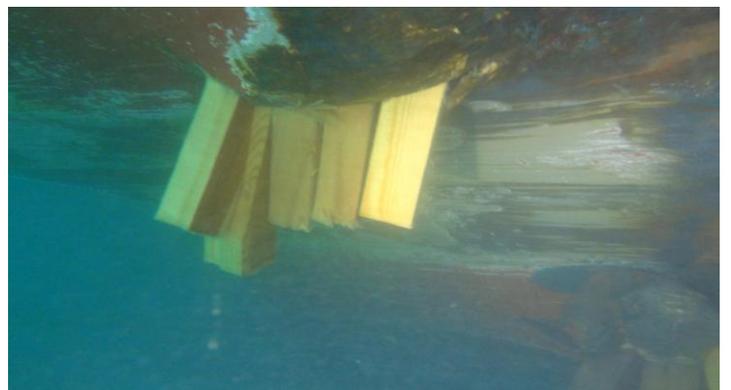
The bottom plating of the damaged area was deformed, cracked and holed and internal structural damages and fractures were caused to the adjacent transverse and longitudinal strengthening components. Indicative hull damages wedged by the diving team are depicted in figures 3.8.1/ 1 to 12.

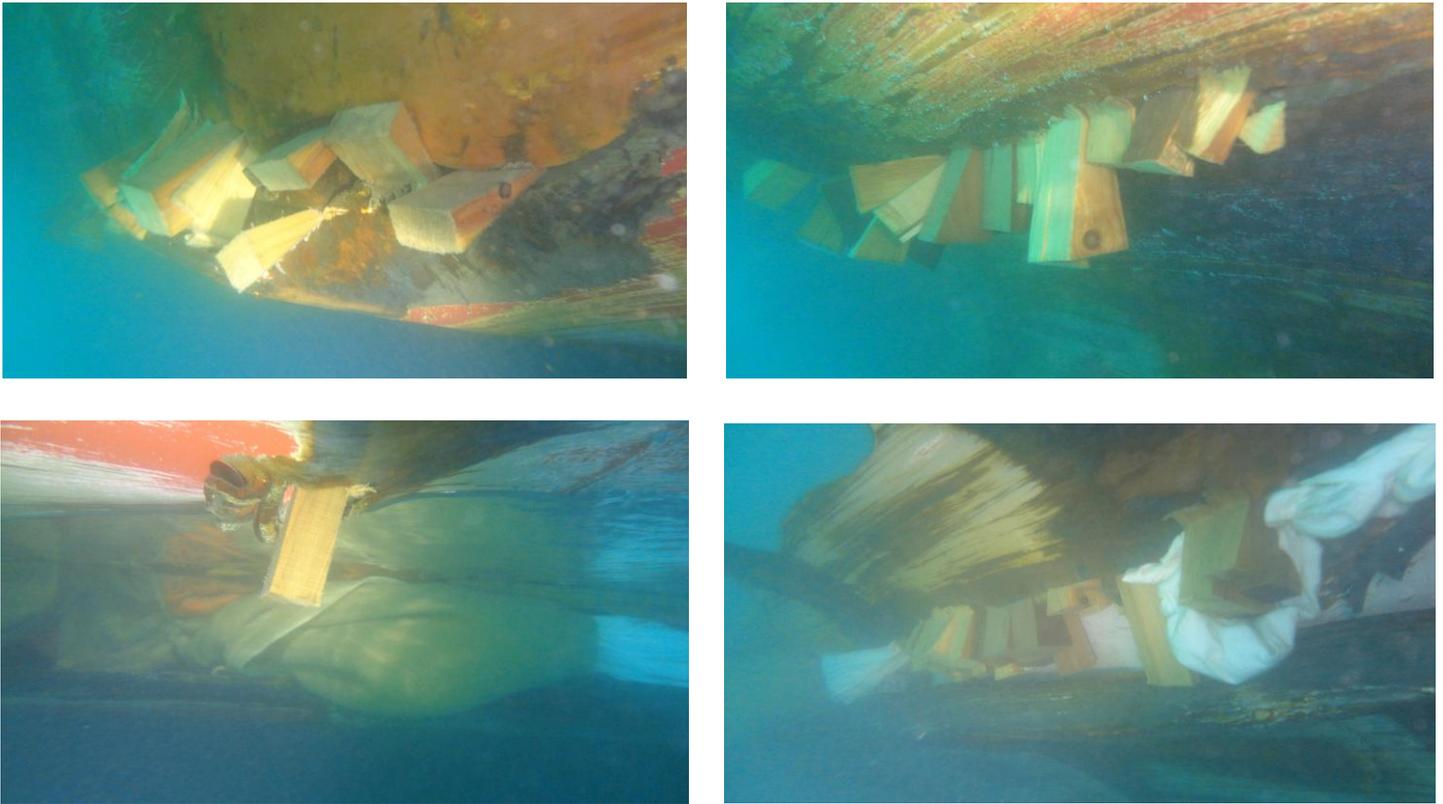
Fig. 3.8.1/ 1 to 12: Photos from the bottom damage and counter flooding underwater operations carried out by the local diver’s team (Source: Diving Team video file).

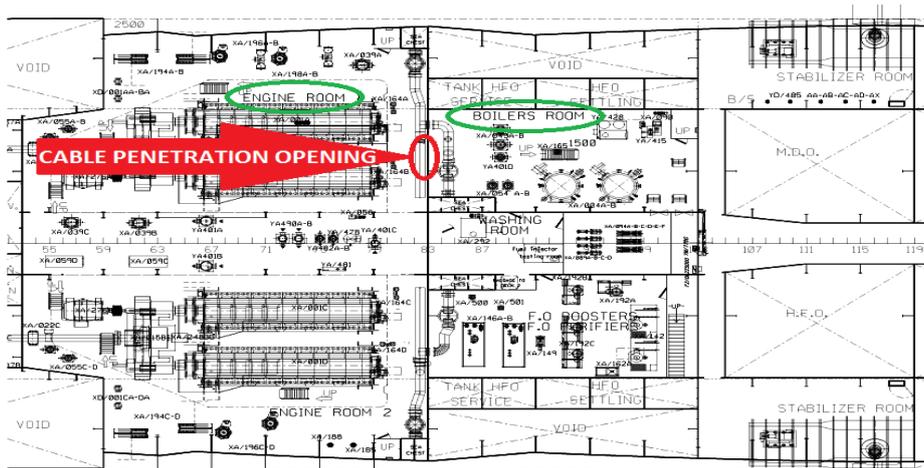
Figure 3.8.2 / 1: Red circle depicts the cable penetration box on the bulkhead between the engine room and the boiler room

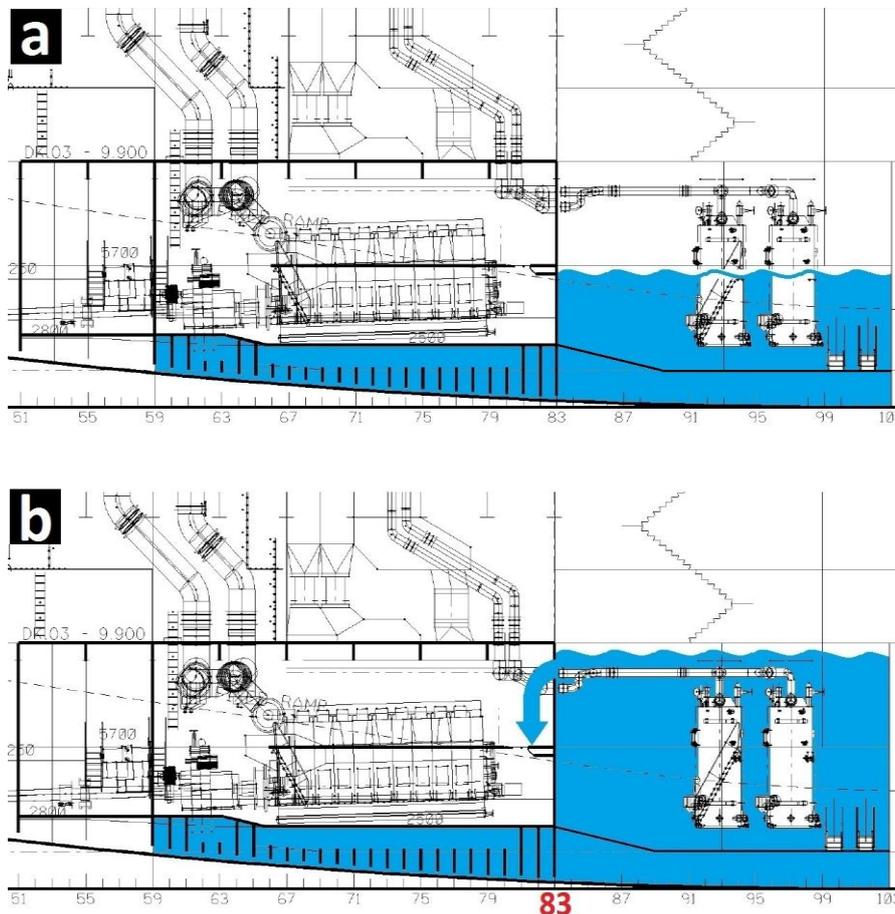
Fig. 3.8.2 / 2a & 2b: Illustration of the sea water ingress inside the Void Spaces and the Boiler Room and of the waterway (cable penetration opening) i.w.o. the bulkhead at frame 83 for the water ingress inside the Engine Room.

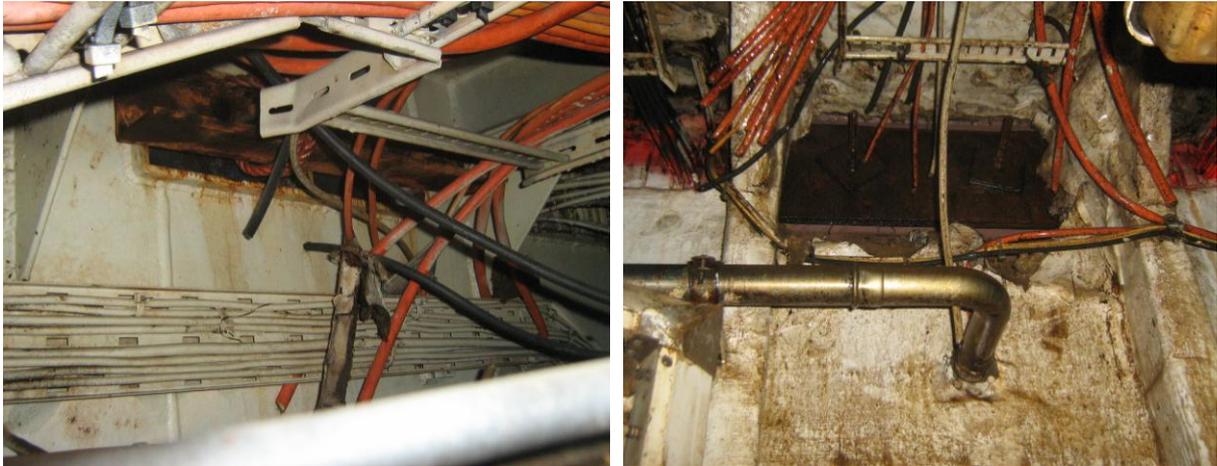
Fig. 3.8.2 / 3 & 4: The cable penetration opening i.w.o. the bulkhead at frame 83 sealed by the steel plating, as seen from both compartments, after pumping operation's completion.

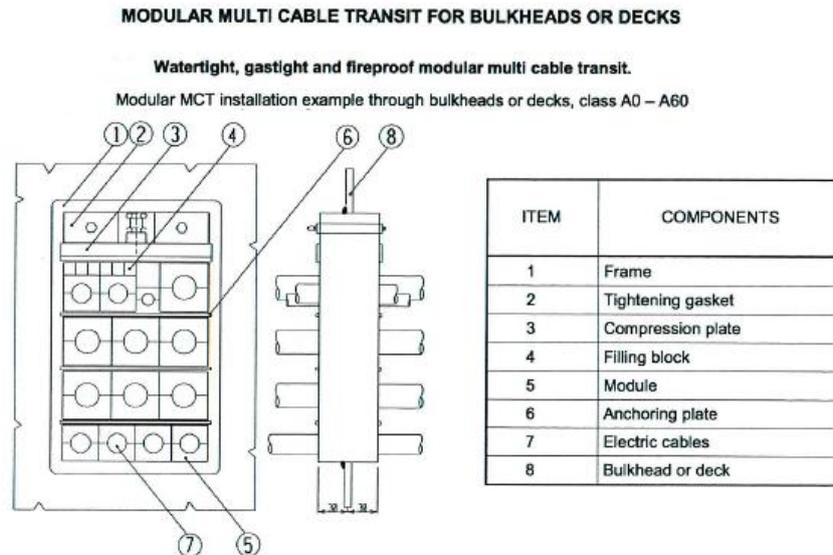
Fig. 3.8.2 / 7: Installation information for the sealing component for the cable penetration opening i.w.o. the bulkhead at frame 83.
(Source: Manufacturer's installation manual)

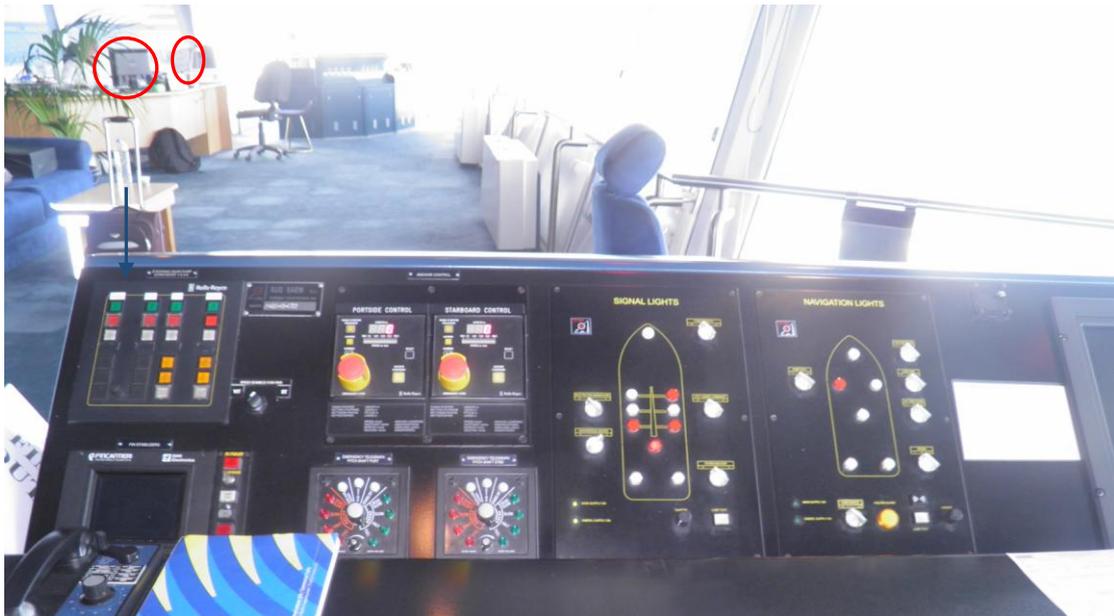
Figure 4.5.2.3 / 1: The documentation office equipped with a desk top computer and a table lamp marked in circles.

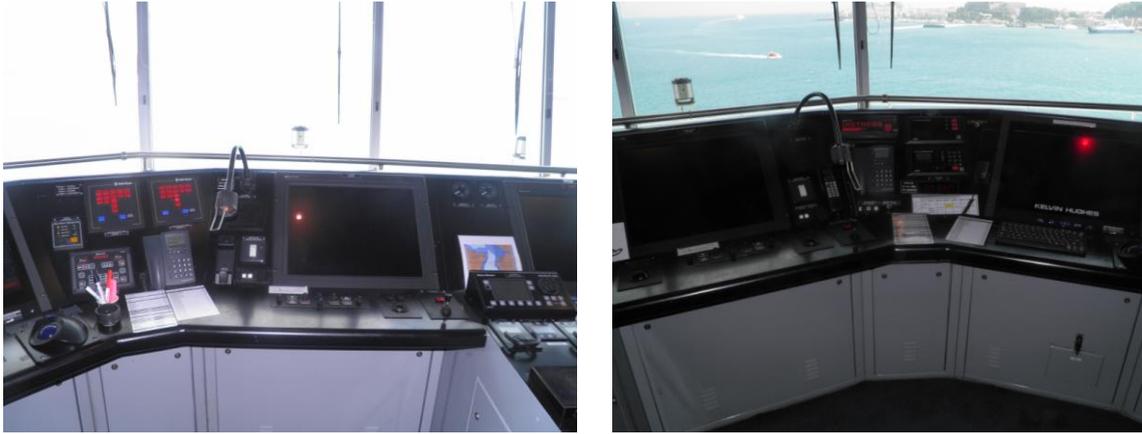
Fig. 4.6.2/ 1&2: S-band Radar and X-band Radar fitted in navigating console's port and starboard side respectively

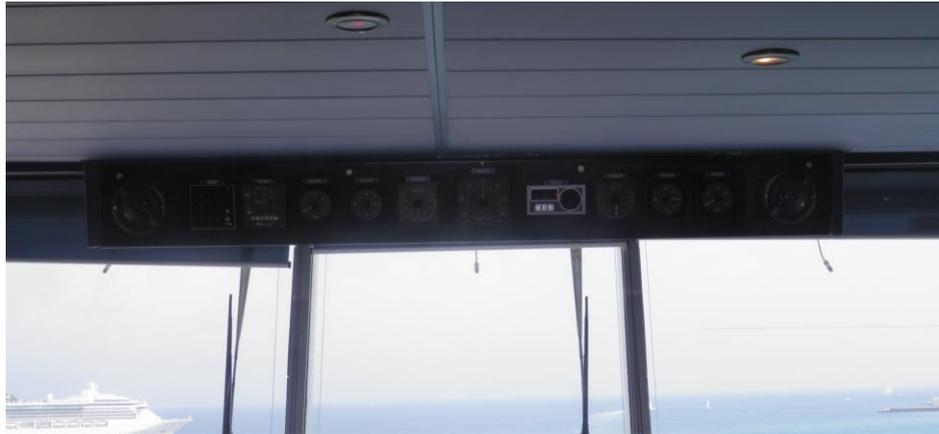
Fig. 4.6.5/1: Rate of turn indicator fitted over the bridge front windows.

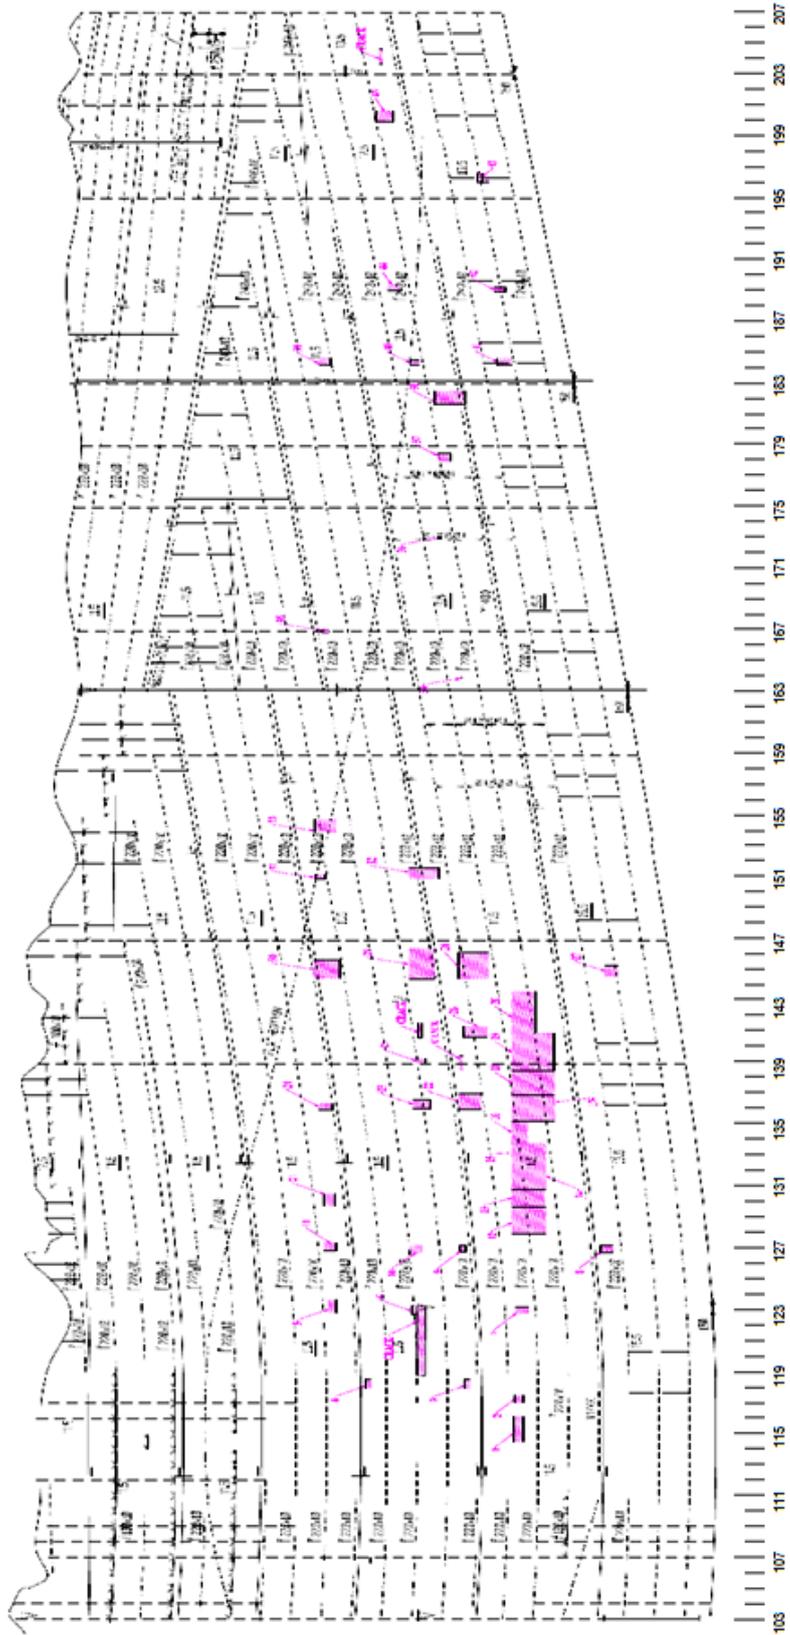
DAMAGE REPAIRS DESCRIPTION
SHELL EXPANSION
PORT SIDE
