**HELLENIC REPUBLIC  
HELLENIC BUREAU FOR MARINE CASUALTIES INVESTIGATION**

**MARINE CASUALTY SAFETY INVESTIGATION REPORT  
06/2015**

**Grounding and foundering of  
M/V Kerem S at Levitha Island, Greece.**

**May 2017**

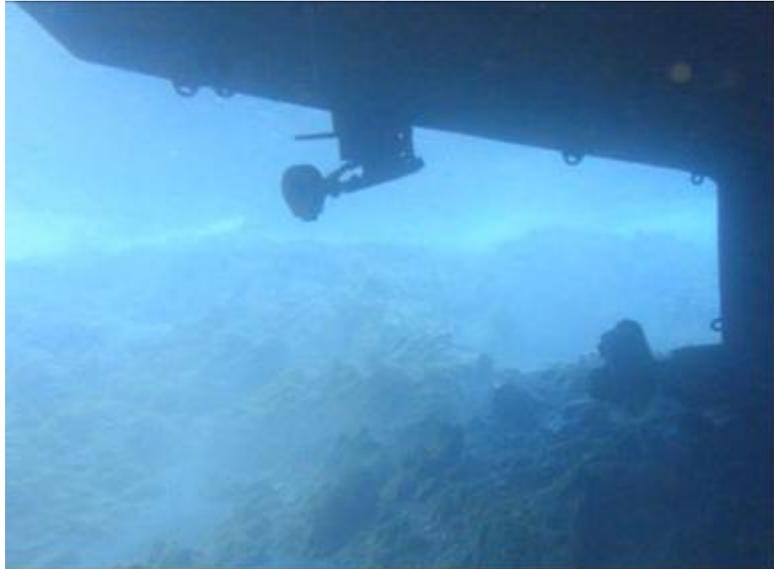
**Figure 3.2/1.**  
Missing rudder blade after the vessel's grounding.

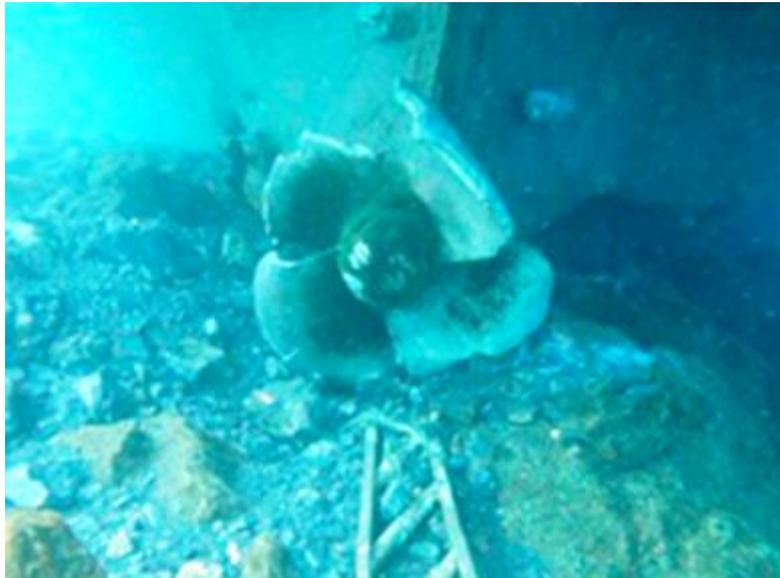
that there was no water ingress from the grounding in any compartment, decided to heave up the anchor and use the main engine and bow thruster in order to remove her from the rocky shoal. As soon as the main engine was started, strong noise and vibration was noticed to the aft part of the vessel from the propeller and the rudder. In short time the rudder detached from its mounting point rendering Kerem S unable to maneuver. The ship's propeller had also sustained severe damages and the main engine could not operate due to strong vibrations of the propeller shaft.

**Figure 3.2/2.**  
The damaged propeller after the vessel's grounding.

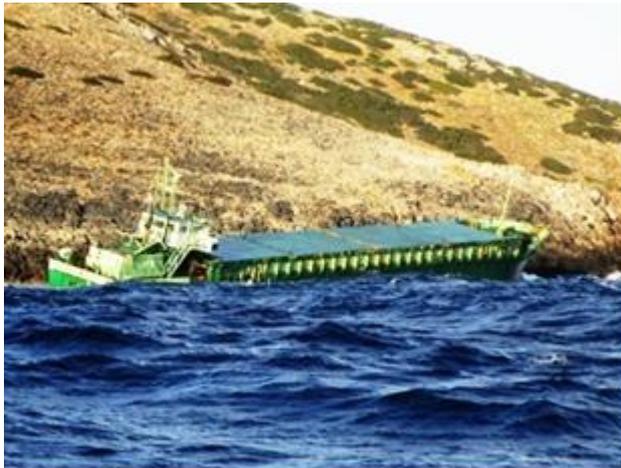
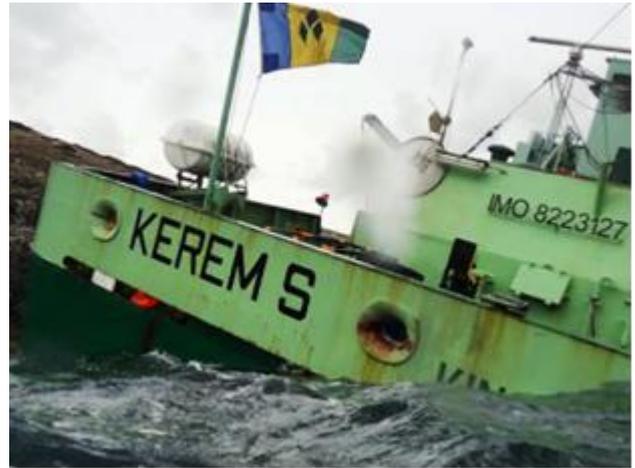
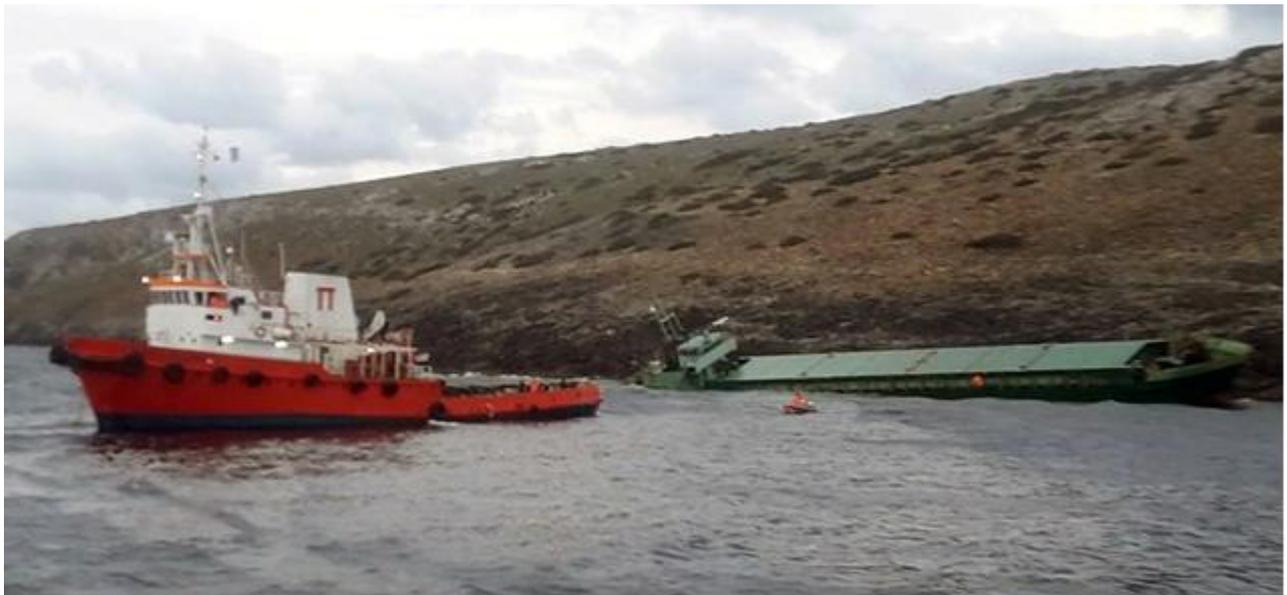
Due to the strong winds and the rough sea Kerem S started dragging her anchor and drifted until 17:40 when she grounded at the rocky coast NE of Levitha island by her port side. Her bottom hull was severely damaged and sea water started to ingress the Engine Room compartment causing the ship to list to her starboard side.

Figures 3.4/ 1, 2 & 3. Kerem S grounded at Levitha Island with a starboard list.

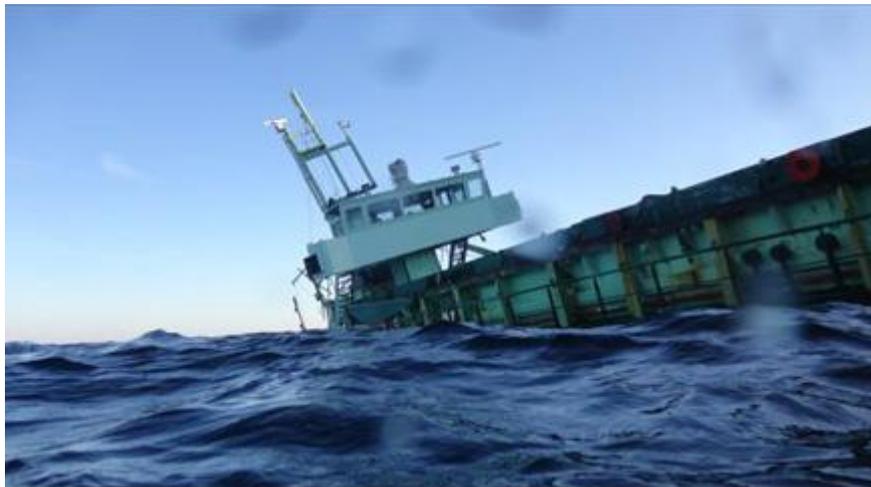
**Figure 3.6.1/1.** The vessel listed to starboard

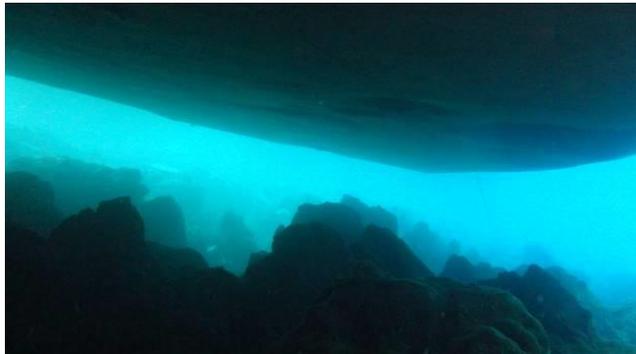
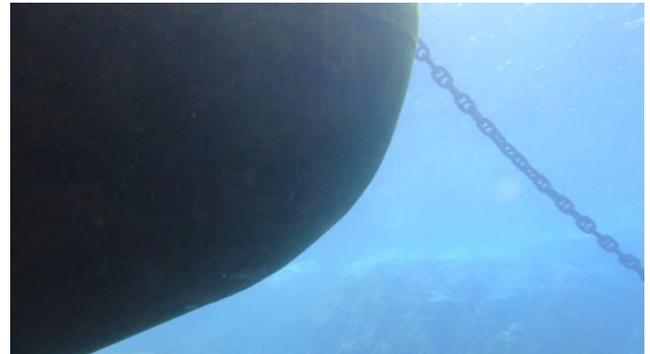
**Figures 3.6.1/ 2 & 3.** The bottom of the bow

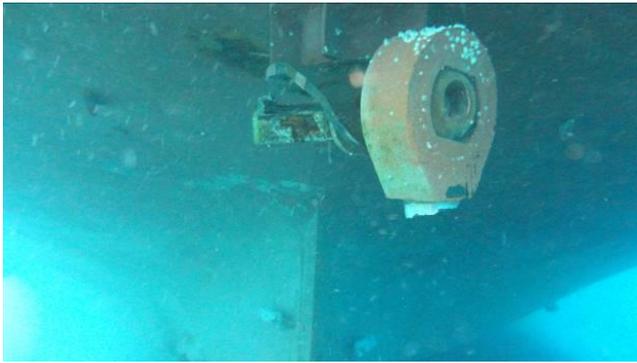
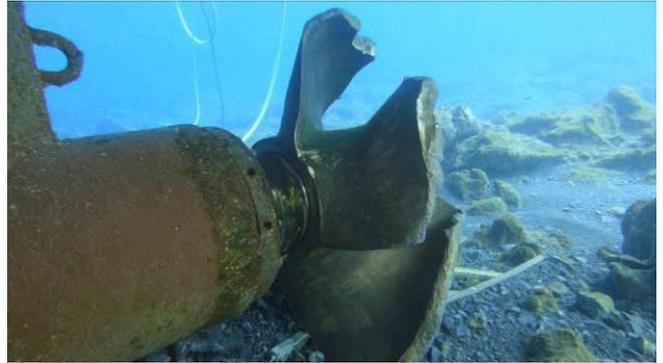
Figures 3.6.1/ 4 & 5. The missing rudder and the damaged propeller.

- 5.5 Kerem S grounded by her starboard aft part at a rocky shoal of Thymaina island and her propeller and rudder were severely damaged. The rudder was detached from its mounting while the engine could not operate due to strong vibrations of the propeller shaft (par. 3.1, 3.2 & 4.4.1).

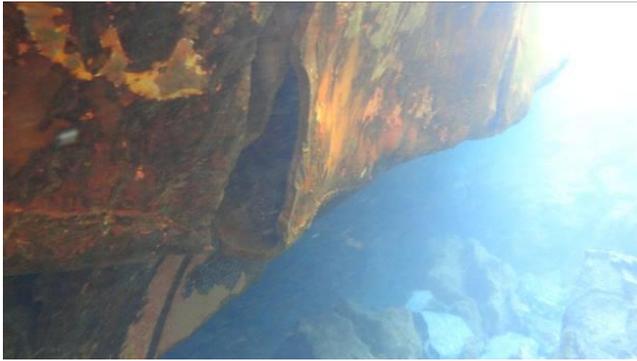
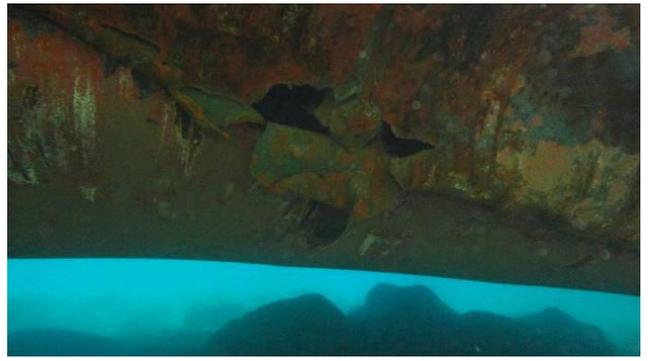
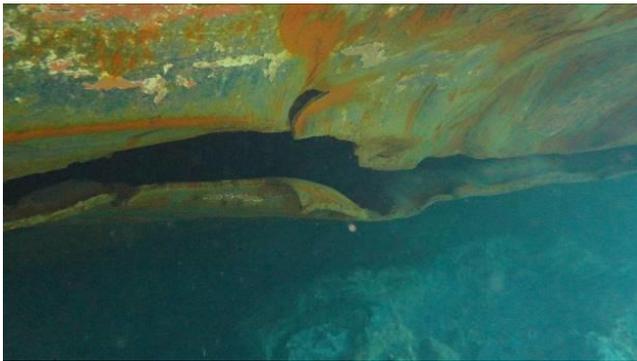
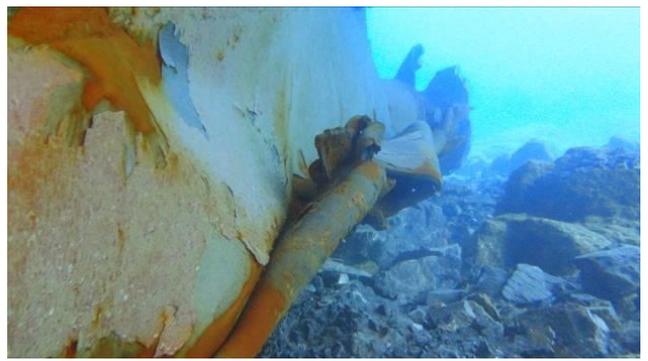
1. *Bulbous bow, fore peak area and bow thruster no damage observed*
2. *Port Side bilge area plating was found damaged and compressed more than one meter along the double bottom cargo area with several openings various sizes.*
3. *Stbd side bilge area plating was found damaged with few small openings along the double bottom cargo area.*
4. *Rudder blade was missing and was not found on the seabed.*
5. *Propeller blades found cropped uniformly.*
6. *Engine room bilge area hull plating port & stbd found damaged and compressed with large openings up to 50cm width.*
7. *The vessel is lying to the seabed with the port & stbd bilge and flat bottom engine room area. The remaining part of the vessel has a gap up to 1m between the rocky seabed and the hull plating.*
8. *The vessel has around 10 – 15 degrees list due to the inclination of the seabed.”*

Figures 3.6.1/ 6, 7, 8 & 9. Starboard and port cracked bottom platings.

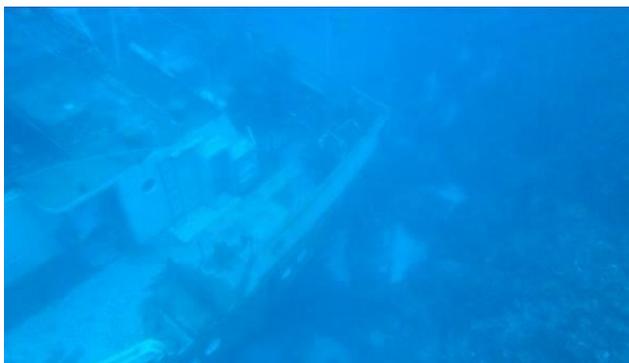
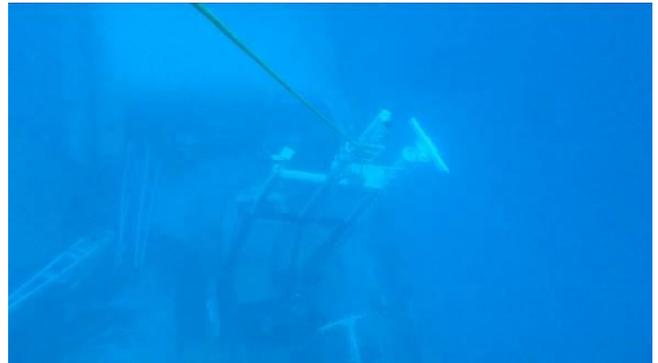
Kerem S remained at the grounding position for almost 03 days. The high waves were slamming the vessel against the rocky coast and the progressive flooding of her engine room and holds led to her foundering at approximately 09:05 on 23<sup>rd</sup> February 2015 at position lat: 37° 00.4800' N / Long: 26° 29.3898' E.

Figures 3.7/ 1 & 2. Photos showing Kerem s at her foundering position.
