**HELLENIC REPUBLIC  
HELLENIC BUREAU FOR MARINE CASUALTIES INVESTIGATION**

**MARINE CASUALTY SAFETY INVESTIGATION REPORT  
11/2015**

**ENTANGLEMENT OF THE TOWLINE USED FOR TOWING  
C/V “HAMMERSMITH BRIDGE”, FLAG PANAMA, IMO 9395147  
RESULTING TO THE DEATH OF THE MOTORMAN OF  
T/B “CHRISTOS XXII”, FLAG GREECE, IMO 7230135**

July 2018

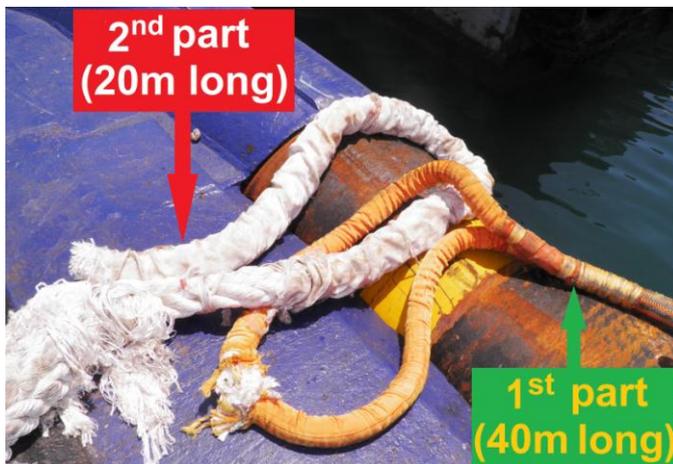
**Figure 3.2/1:**

eye-to-eye connection of the two lines used for the 60m CHRISTOS XXII towline (photo taken after the casualty, with the parted towline placed indicatively at the state it was used before it, for depiction purposes).

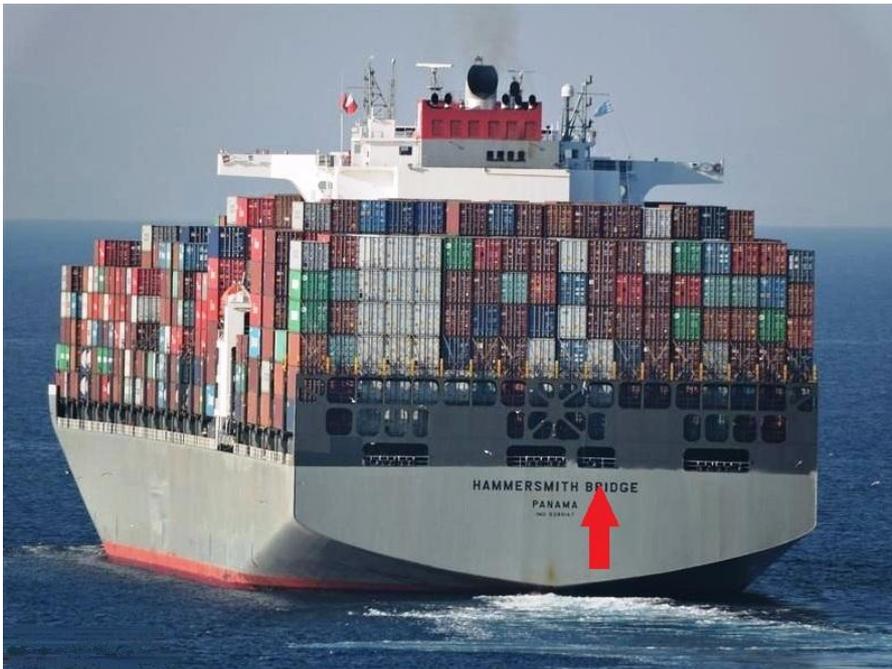
**Figure 3.3/2:** Indicative position (red arrow) of the towline’s eye while being released by the HAMMERSMITH BRIDGE aft unmooring team and prior the exit of the T/B crew on its deck.

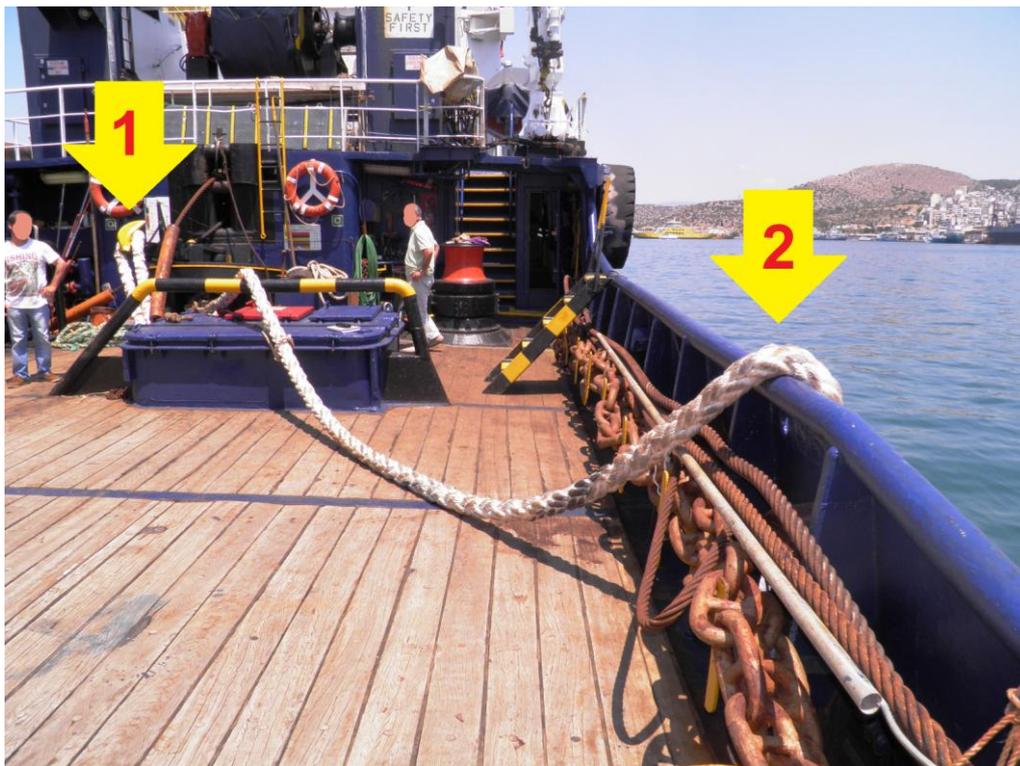
**Figure 3.3/3:** Depiction of the towline state prior to the casualty:  
 Position 1: Towline end secured to the towing hook.  
 Position 2: Position of the towline over the stbd bulwark.  
 The A/B and the Motorman were pressed by the towline against that bulwark.

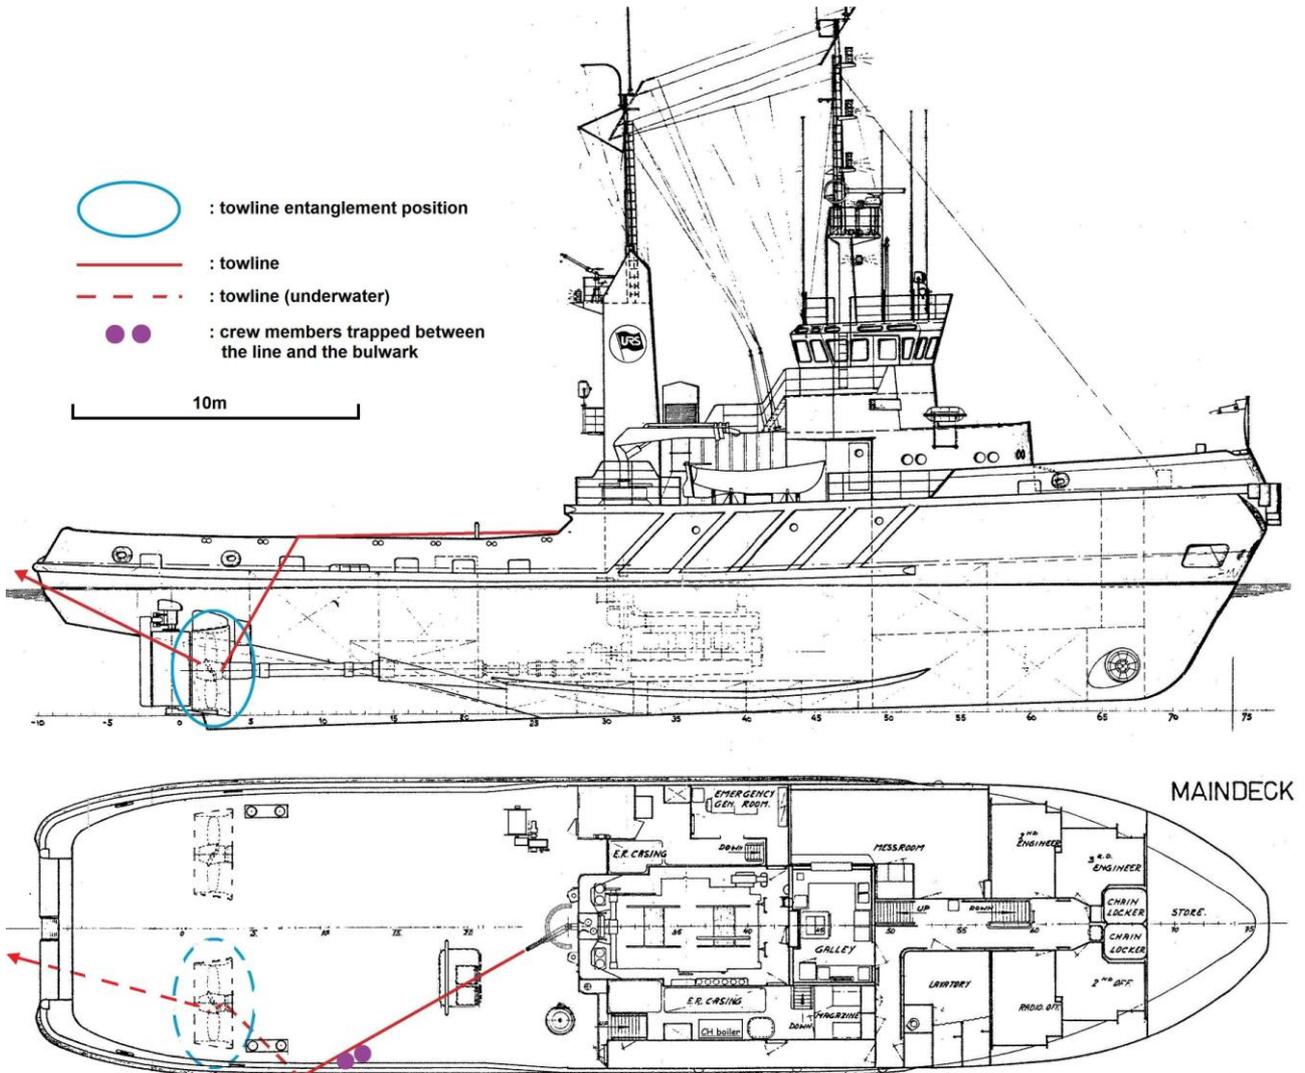
**Figure 3.3/4:** Depiction of the position of the towline and the trapped A/B and Motorman during the casualty.

The Motorman, aged 43, suffered severe chest injuries, when the towline unexpectedly became taut and pinned him against the tugboat starboard bulwark. His heart and thoracic aorta were ruptured and both his lungs collapsed by the hit, resulting to his death.

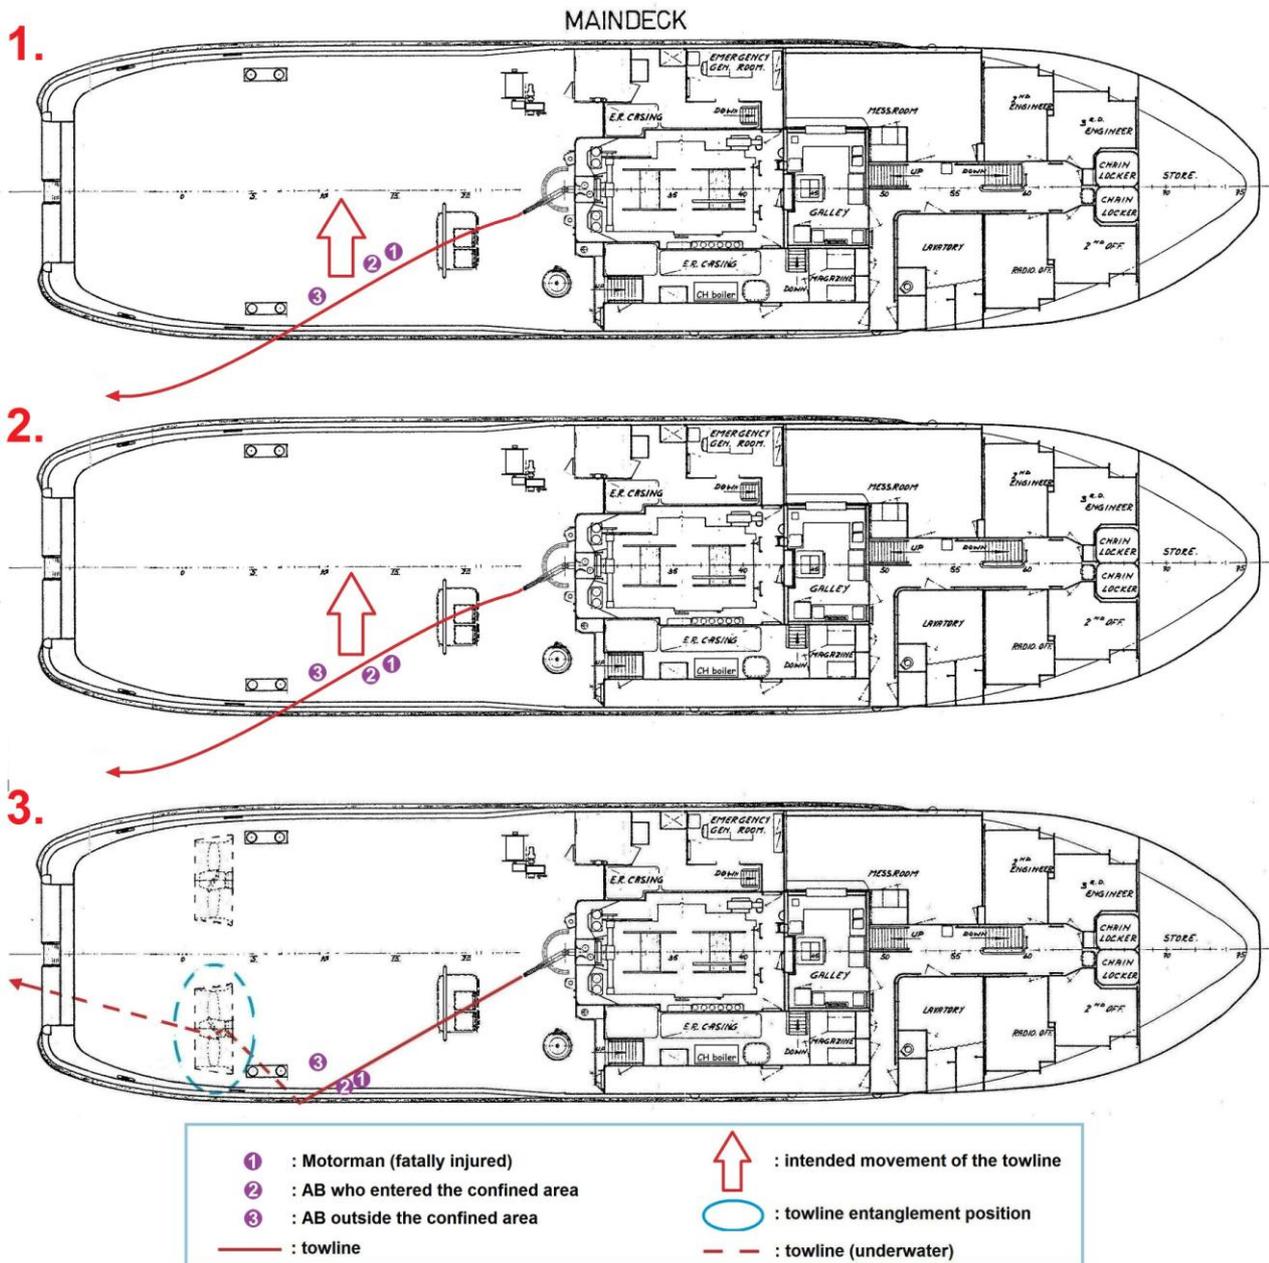
**Figure 4.2/1:** Phase 1: Pulling of the towline from all 3 crew members standing on its left side (looking forward).  
 Phase 2: Entrance of one AB and the Motorman in the confined area between the towline and the stbd bulwark.  
 Phase 3: Entanglement of the towline and entrapment of the AB and the Motorman.

The combination of the AB's misjudgment of the hazardous deck areas during the operation and the reliance of the inexperienced Motorman on the AB's skills is considered to have been a contributing factor in the examined marine accident.

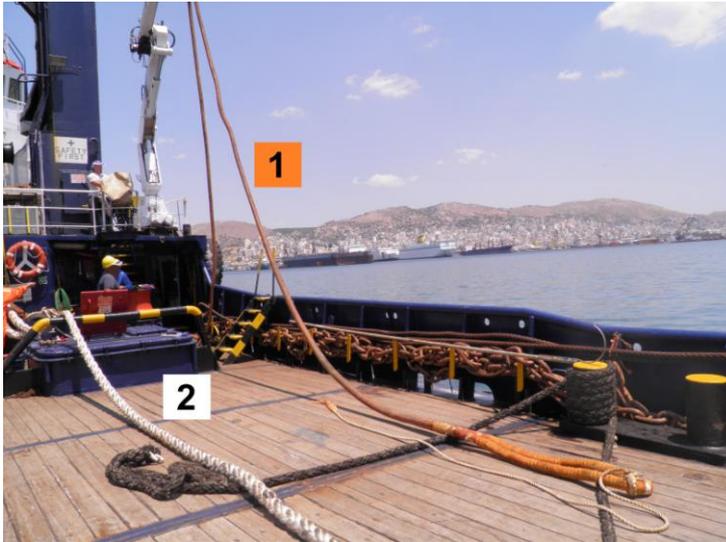
**Figure 4.3.2.1/1:**

The first part of the topline was a 40m Polyethylene fibre rope of a 52mm diameter (orange color rope) and the second part ("pennant") was a 20m 8-strand Polyamide ("nylon") fibre rope of an 88mm diameter (white color rope).

The two fibre rope parts which consisted the 60m towline, after the casualty.

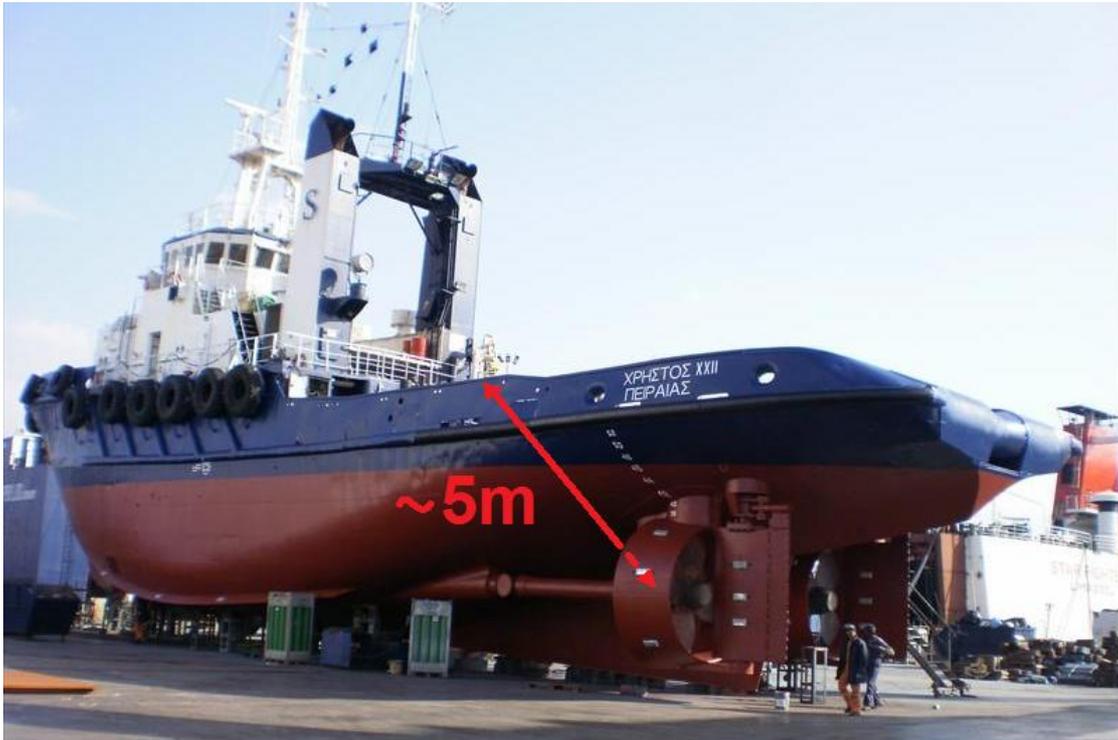
However, no measure had been provided to prevent the pennant from falling into the sea from the tugboat side, as was the case in the investigated casualty. As can be seen from **Figure 3.3/4**, the total distance from the towing hook up to the propeller, taking into consideration the stern hull structure (**Figure 4.3.2.1/4**), was approximately 14m, that was less than the pennant length.

**Figure 4.3.2.1/4:** View of CHRISTOS XXII at a shipyard, showing the distance from the estimated point of the bulwark where the towline was taut until the propeller shaft (although the photo shows the port side of the tug, the same estimation stands for the stbd side as well).

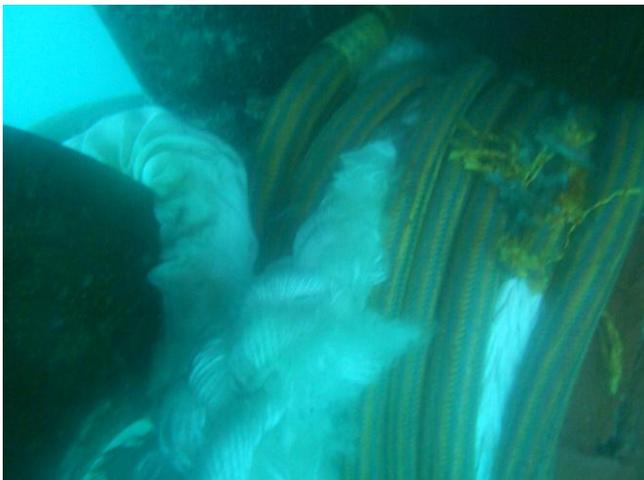
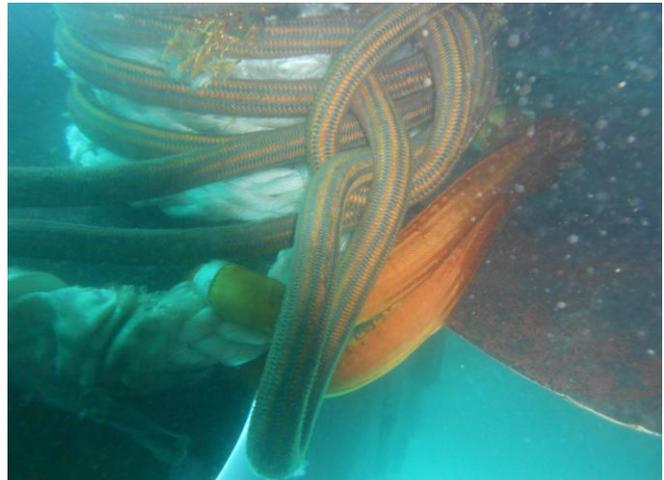
**Figures 4.3.2.1/5 & 6:** Underwater photos showing the entanglement of the towline at CHRISTOS XXII stbd propeller shaft

After the towline's entanglement at the stbd propeller shaft, the 20m pennant parted probably due to the induced friction by the shaft's rotation and the propeller blades' effect. The parts of the parted fibre rope are shown in the following **Figures 4.3.2.1/7 to 9**.

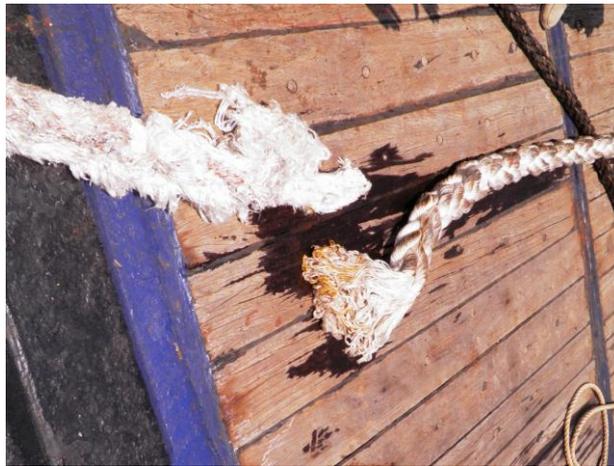
**Figure 4.3.2.1/7:**  
Both ends of the fibre rope parts of the 20m towline pennant, after the casualty.

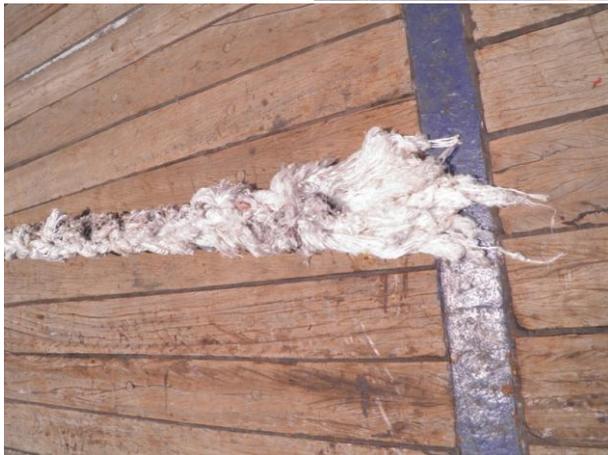
**Figure 4.3.2.1/8:**  
The end of the pennant's part that was affected by the shaft's and the blades' rotation.

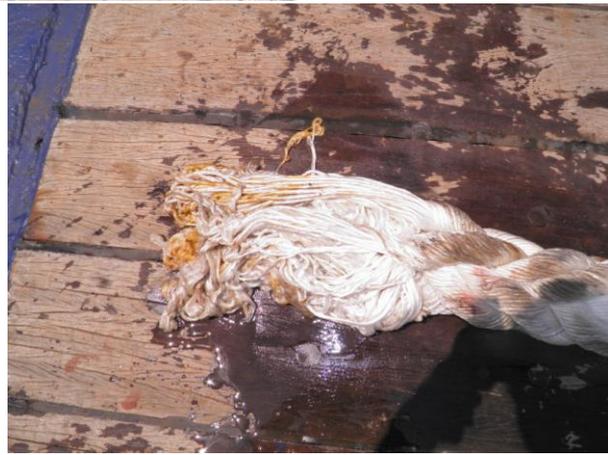
**Figure 4.3.2.1/9:**  
The end of the pennant's part on the tugboat side.

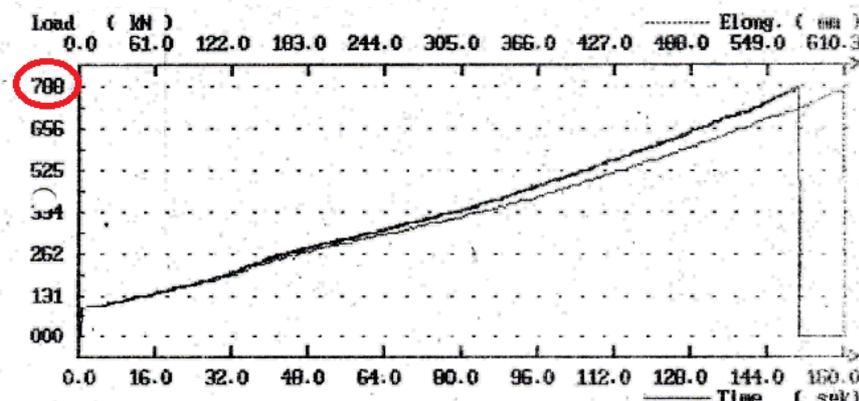
The 20m pennant had a diameter of 88mm and a nominal MBL of 190 tons, according to its manufacturer's certificate. In fact, its remaining part was tested a few days after the casualty, on 17<sup>th</sup> July 2015, in order its Braking Load to be determined, and could not be broken by a force of 80.4 tons which was applied by the test machine, as shown in **Figure 4.3.2.1/10** test result. Although its MBL could not be reached by the test machine that was used, due to the machine's dimensional restrictions, no signs of decreased performance of the line could be observed.

**Figure 4.3.2.1/10:**  
Abstract of the test result of the remaining part of the parted towline pennant. The line bore a Load of 788 kN (80.4 tons) before the test machine reached its maximum elongation distance.

Taking into consideration the above mentioned test result as well as the fact that the towline pennant's deterioration was attributed to its wearing due to the induced friction by the shaft's rotation and the propeller blades' effect it derives that the towline prior to the casualty was considered to be fit for the intended use by CHRISTOS XXII.

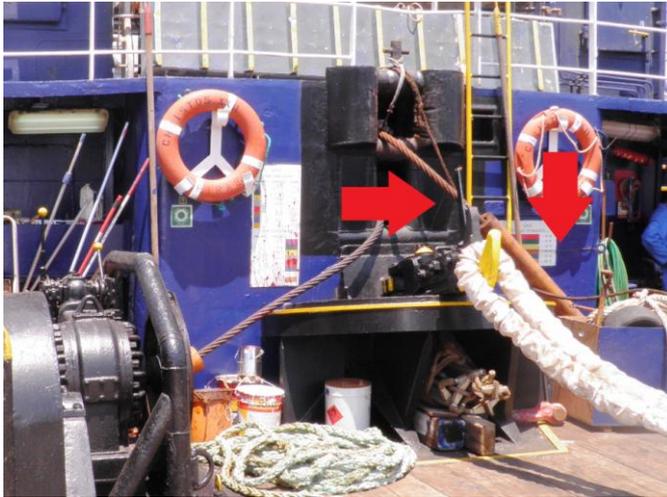
The operation of the quick release mechanism was inspected (with no tension applied) after the casualty and was found to be functioning adequately.

**Figure 4.3.3.1/1:**  
The towing hook quick release mechanism's wire route is indicated by the red arrows.

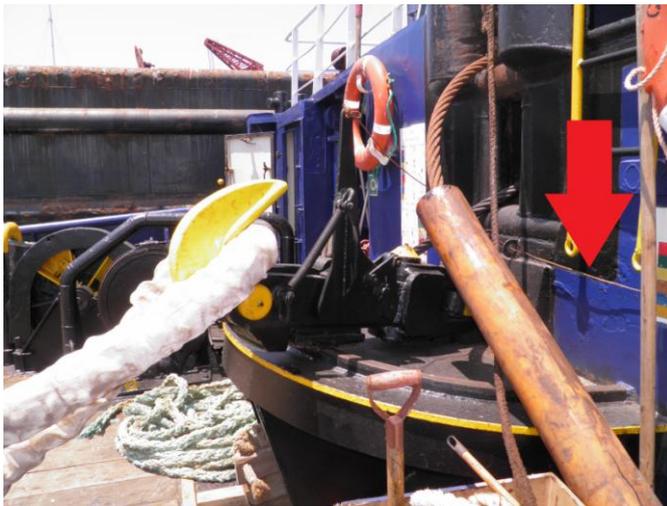
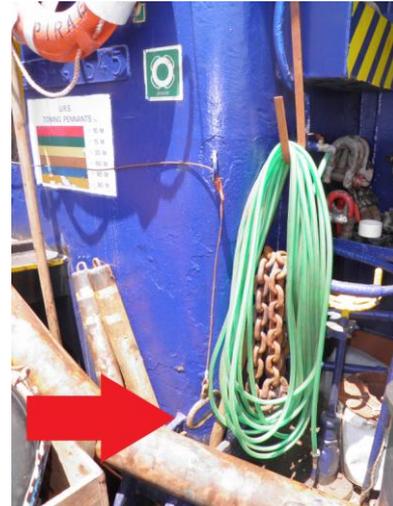
**Figures 4.3.3.1/2 & 3:** The towing hook quick release mechanism's wire route and handle are indicated by the red arrows.

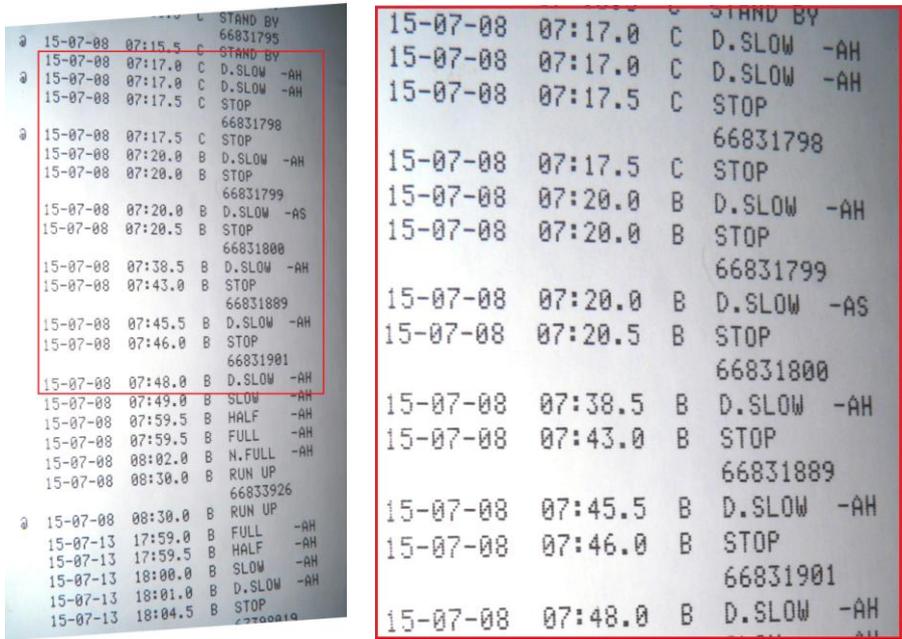
According to information collected by the interviewing process and the analysis of the Engine telegraph logger of HAMMERSMITH BRIDGE (**Figure 4.6.2/1**) it derived that she started maneuvering for her unberthing procedure at 07:17:00 (“Dead Slow Ahead”).

**Figure 4.6.2/1:** Abstract from the Engine telegraph logger of HAMMERSMITH BRIDGE, showing her M/E movements from the beginning of the unberthing operation until the exit from the port.

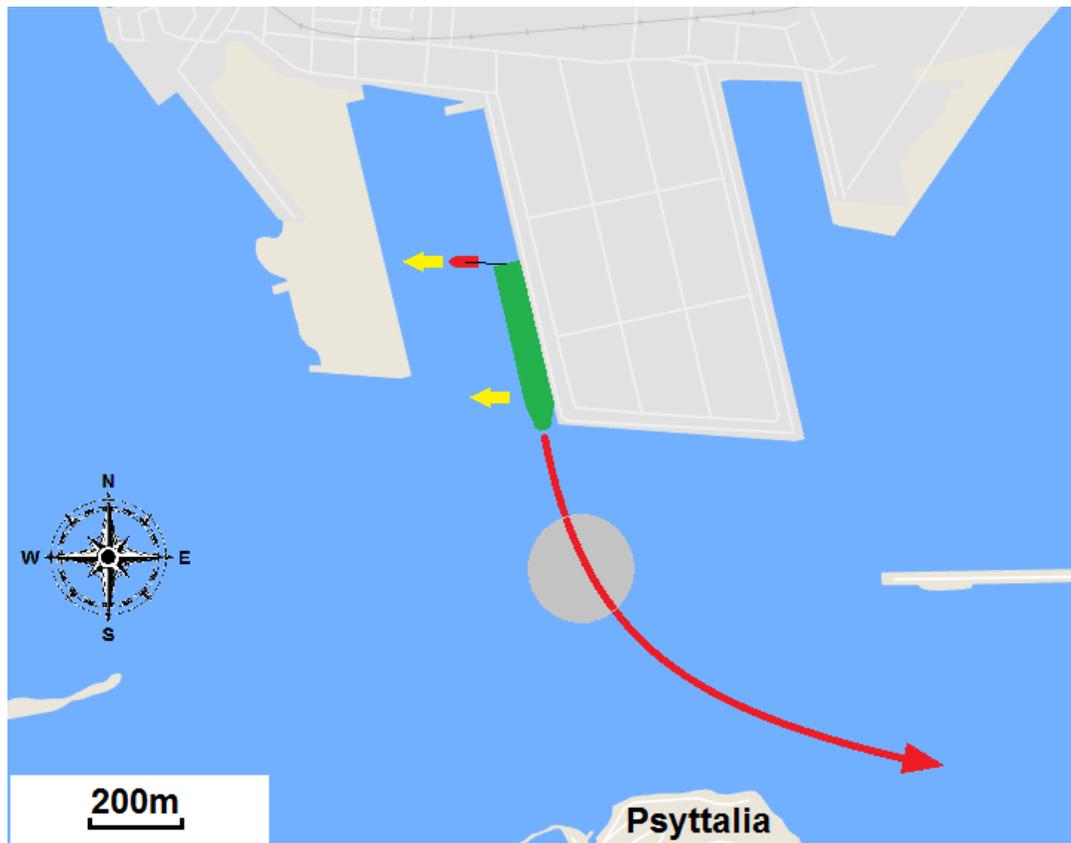
For approximately 2.5 minutes after the stopping of her M/E, that is from 07:43:00” until 07:45:30”, the tugboat was at a distance of almost 20-25m from the stern of HAMMERSMITH BRIDGE, waiting for the release of the towline from the vessel, presumably within the casualty area, as indicated by the grey disk area in **Figure 4.6.2/2**.

**Figure 4.6.2/2:** The appraised course of M/V HAMMERSMITH BRIDGE during her departure. The grey disk area indicates the estimated casualty area.

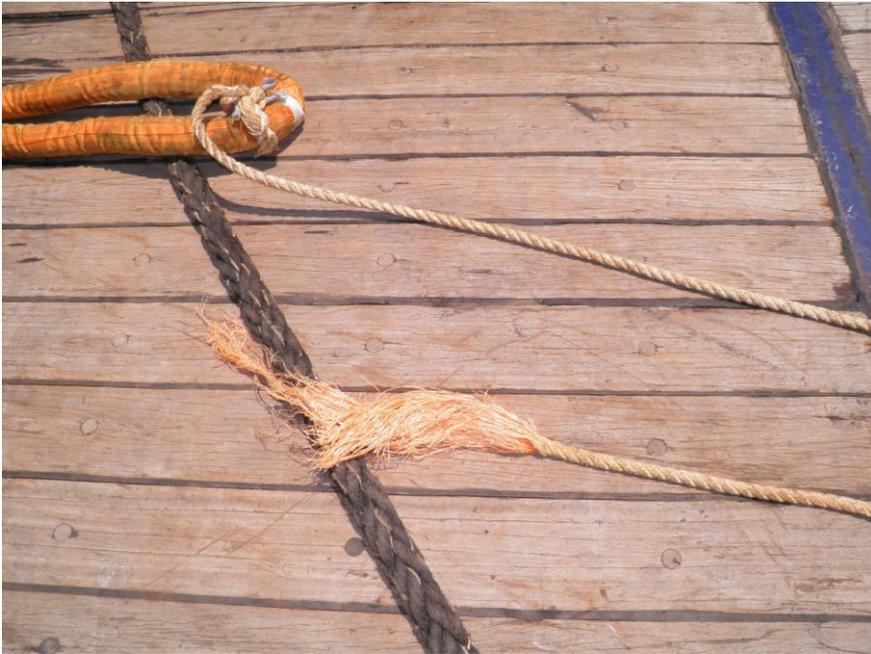
**Figure 4.6.2/5:**

The stern team of HAMMERSMITH BRIDGE was still waiting for the approach of the tugboat, when the part of the towline which had been slackened and was floating on the sea surface, got caught in the tug's starboard propeller and was entangled around it due to the swirling water generated by the operating propellers of both the ship and the tug and their relative movement. The towline was instantly taut and consequently the messenger line as well. At that point the 2<sup>nd</sup> Officer released the messenger line, which parted under the induced peak dynamic loading (**Figure 4.6.2/5**).

The part of the messenger line attached to the towline, after the recovery of the towline by the tugboat, after the casualty. The elongation of the parted messenger line segment was caused by its dynamic tension.

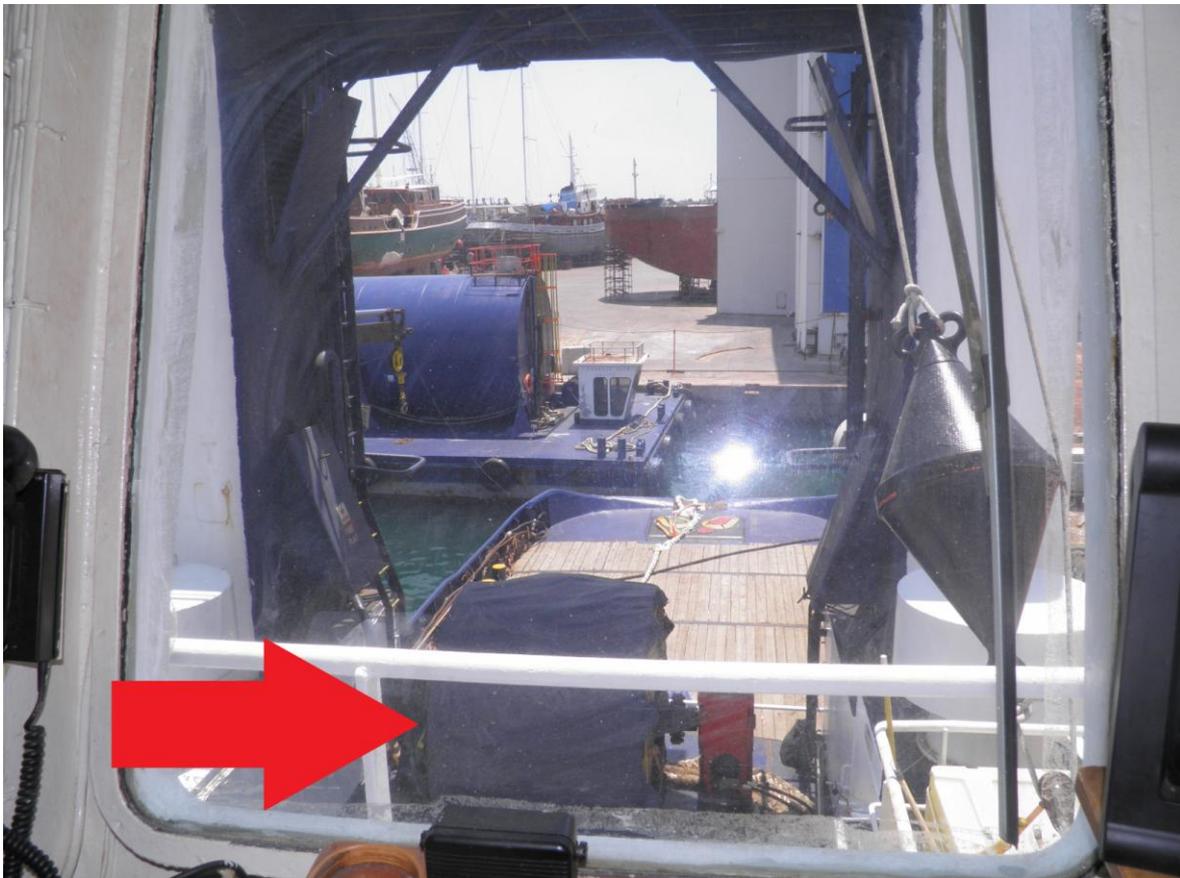
During their efforts, their exact position was not clear to the tugboat Master, as his stern view was partially blocked by towing equipment stowed abaft the wheelhouse (as shown in **Figure 4.6.3/1**).

**Figure 4.6.3/1:** Astern view from the wheelhouse of CHRISTOS XXII. The red arrow indicates the position of the stowed equipment that blocked the view of the main deck stbd area.
