Marine casualty

Very serious marine casualty

AUGUST 2022

G/C Vessel SEA BIRD

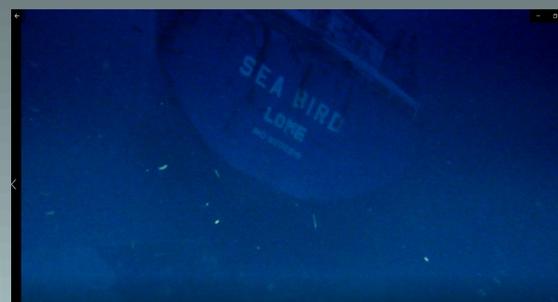
Fig. 2: Stern view of the vessel at the foundering position

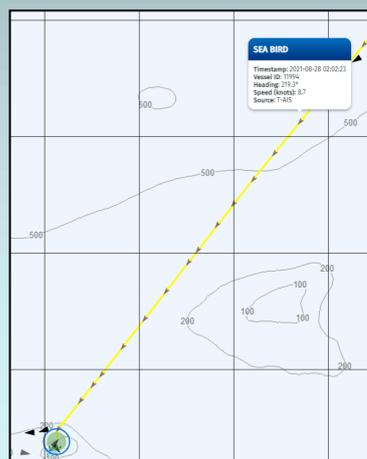
According to information from the interviews, the last plotted position on the chart was reported to have been recorded by the Chief Officer at approximately 02:00 and was on her charted course of 219° that was leading to Cape Maleas. The last recorded position by the IMDatE was at 03:09 showing that SEABIRD was in position Lat: 36°46' 26'' N - Long: 023° 36' 25'', navigating with COG 219° and speed 8.7 knots; Karavia Islet were 0.469 nm and approximately 17° off her port bow.

Fig. 3: SEABIRD's position at 02:02:23 as recorded by IMDatE, almost same time the Chief Officer plotted the last position on the chart.

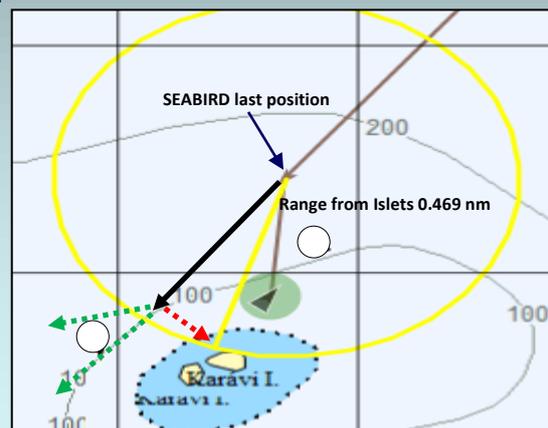
Shortly before the impact at approximately 03:10, the Cadet reported to the Chief Officer that he had visually spotted a dark object at a distance of approximately 250 meters from SEA BIRD's port bow. The Chief Officer rushed to the port bridge wing and assumed that SEA BIRD was heading towards the rocky Islets and he immediately returned in the wheelhouse, set the steering to manual and turned hard to port to avoid the Islets. Nevertheless, at approximately 03:11, SEA BIRD's starboard side hull heavily impacted on a rocky slope at the north side of Karavia Islets and was actually dragged for almost 40 m with the speed of 8.8 knots. Based on electronic evidence, it is deduced that had SEA BIRD maintained her current course of 219° or maneuvered to starboard, she could either have had a clear passage of approximately 0.15 nm west of Karavia Islets or avoid impacting on the rocky slope.

Figure 4: SEABIRD's last position recorded by IMDatE. Black line indicates the estimated followed course before maneuvering by Chief Officer. Red line indicates the maneuver that lead on to the rocky slope. Green lines depict the course that if followed Sea Bird would had had a clear passage.
