## Very serious marine casualty

July 2024

**M/V "OCEANIS"**

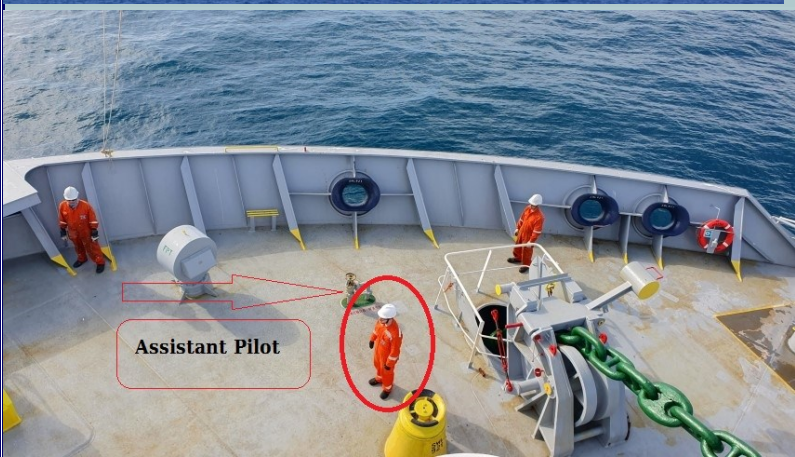
According to the facility's guidelines the unmooring procedure provided four steps, that is: a) *take the weight of the chain and hawser on the pickup rope using the windlass*, b) *disconnect chafing chain from the bow chain stopper*, c) *slowly slack the pickup rope until the support buoy is in the water and taking all of the weight of the chain* and d) *pay out the pickup line either to the mooring boat or as the ship clears the berth*. Following that, it was understood that the Starboard chain would be released first and when finished they would proceed with the port chain. Nonetheless, during the operation both chains were released and the Pilot started communicating with the Assistant Pilot in their native language which was not comprehended by the Master and the other crew members. Then the Pilot left the bridge and went to the fore mooring station to assess the situation "on the spot". The vessel was being held solely to the port chain which was not secured on the chain stopper and the Harbor Pilot instructed the shore personnel to reconnect the vessel's starboard messenger line (which is used for heaving up the pick up rope) with the starboard chain's pick up rope. He then instructed the crew to start heaving in order to balance the lengths of the starboard and port chains and then release the port chain. While heaving up the messenger line, the crew noticed the increased tension and alerted the Pilot; however he instructed the crew to continue heaving until the messenger line broke due to the extreme tension. The broken line hit the Assistant Pilot who was standing close to the line.

<div> Figure2: The standing position of the Assistant Pilot when the messenger line broke </div> </div>
