**INTERIM REPORT**

**MARINE CASUALTY SAFETY INVESTIGATION**

**Fatal injury of an AB during deck operations on board  
Container vessel EVER URBAN**

**February 2014**

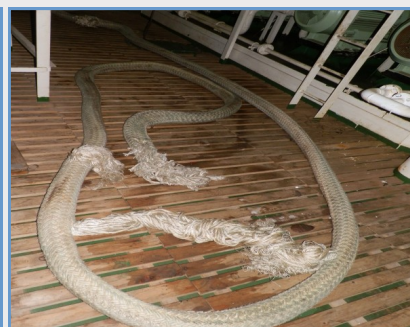
“Ever Urban” is a fully cellular containership under Panama Flag built in 2000, with TEU capacity of 5.652 containers trading world widely. On the 24<sup>th</sup> of December 2013 “Ever Urban” departed the port Rijeka - Croatia and was en route to Piraeus Port. The vessel was loaded with containers and had 21 crew on board. On the 26<sup>th</sup> of December morning hours she was underway in the South Ionian Sea, approximately 06 nm W of Kefalonia Island. At approximately 08:30 the Bosun and three members of the deck department were at forecassle assigned with the maintenance and repairing of the mooring lines. According to maintenance instructions two double braided fibre mooring ropes of “Nylon Core & Polyester Cover” had to be repaired at the “spliced eye” due to abrasion and wear on strands and yarns during mooring operations so as to be reinstated and in service. Instructions were given to the Bosun by the Chief Officer and the Master for cutting off a short length of the line and re-terminating the rope segment with a new “spliced eye”. Having prepared the new “eye” the Bosun and the deck crew engaged with the operation proceeded to the testing of its endurance and tension by placing it on a bollard through a roller fairleader and on the starboard winch drum in order to gradually heave the rope and tighten its spliced eye. At approximately 10:00 during the described handling the rope parted at the splicing point, snapped back and struck an AB on his left leg who was standing close to the bollard, inside the snapback zone.

Parted  
mooring  
rope
