HELLENIC BUREAU FOR MARINE CASUALTIES INVESTIGATION

MARINE CASUALTY SAFETY INVESTIGATION REPORT
08/2014

GROUNDING OF YUSUF CEPNIOGLU
ON MYKONOS ISLAND ON 08-03-2014

May 2017

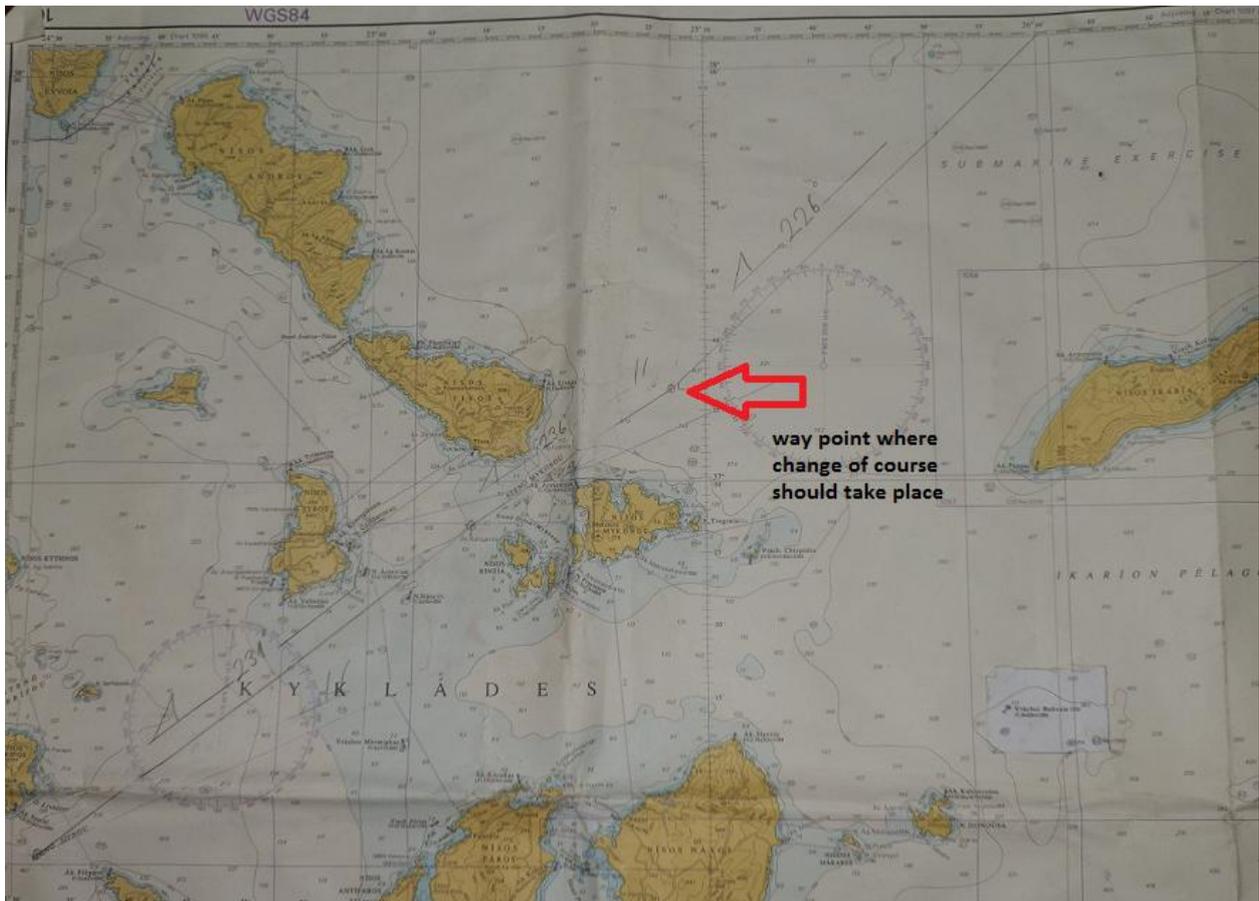
The voyage plan, according to Yusuf Cepnioglu's shipboard operational procedure was prepared by the 2nd Officer, signed by the Chief Officer and approved by the Master. The initial segment of the voyage plan was comprised of a passage East of Oinoussai Island, then a South West course for crossing the eastern strait of Nissos Chios, followed by a 226° course for crossing the Central Aegean Sea area and a 236° course for crossing the sea area between the islands of Mykonos and Tinos, as shown in Figure 2. The distance between the exit waypoint from Chios strait and the waypoint north from Mykonos Island was 46.2 nm.

Figure2: Abstract of Yusuf Cepnioglu voyage plan segment approaching the strait between Nissos Tinos and Nissos Mykonos.

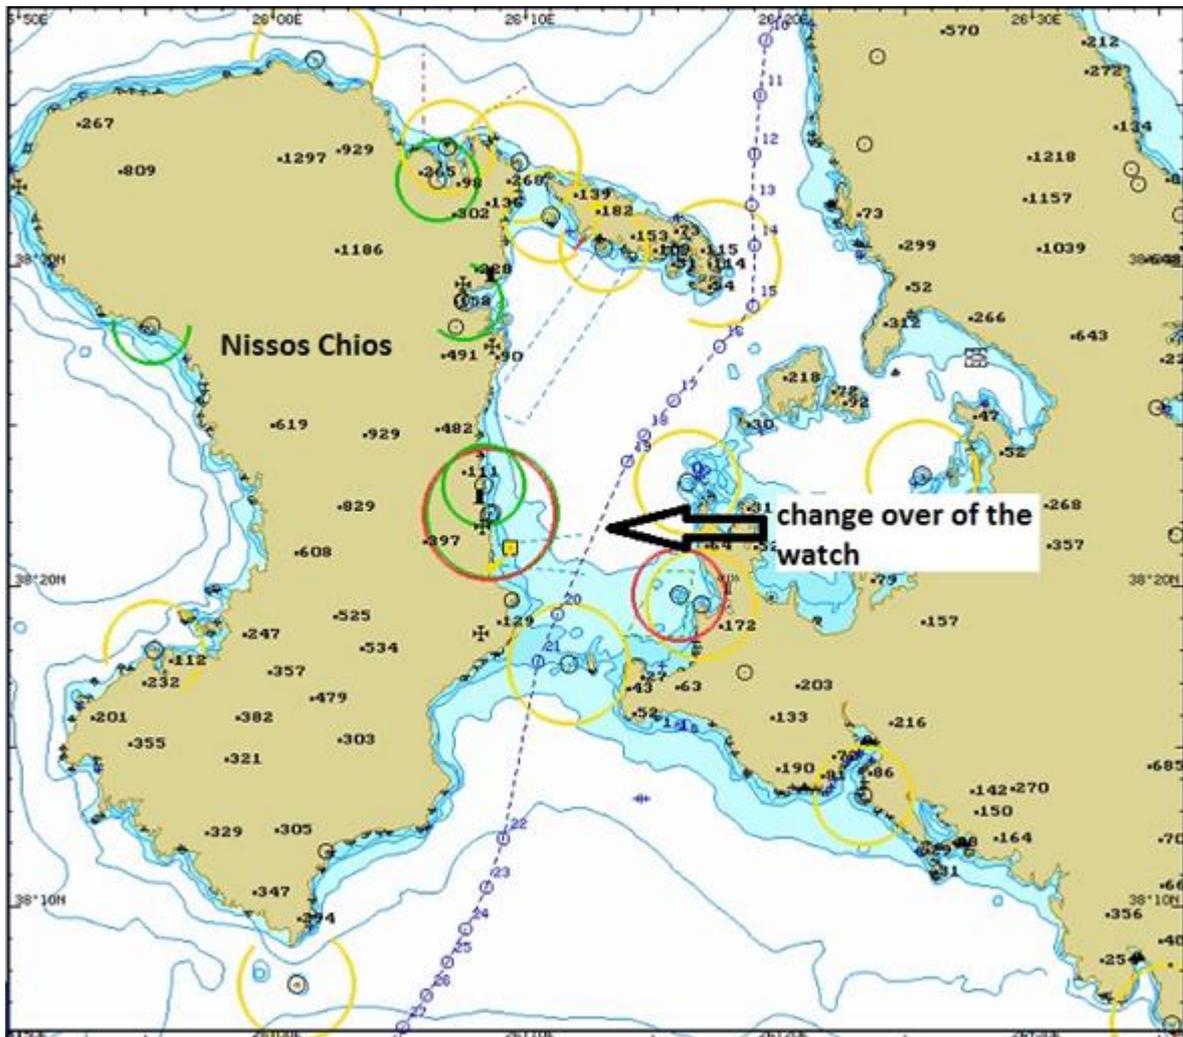
Figure 3: Crossing of Nissos Chios strait during change over of the watch.

At approximately 01:00 Yusuf Cepnioglu had cleared from Chios Strait (Figure 3, position 24) and shortly afterwards the Master left from the bridge and went to the engine room. At 02:00 he returned on the bridge and stayed with the 2nd Officer until 02:30, when he left and went to his cabin to rest. Before he left from the bridge he told to the 2nd Officer to call him in case of emergency. Until that time no lookout was posted on the bridge as the AB performing the 0000-0400 watch was allowed to stay at the mess room.

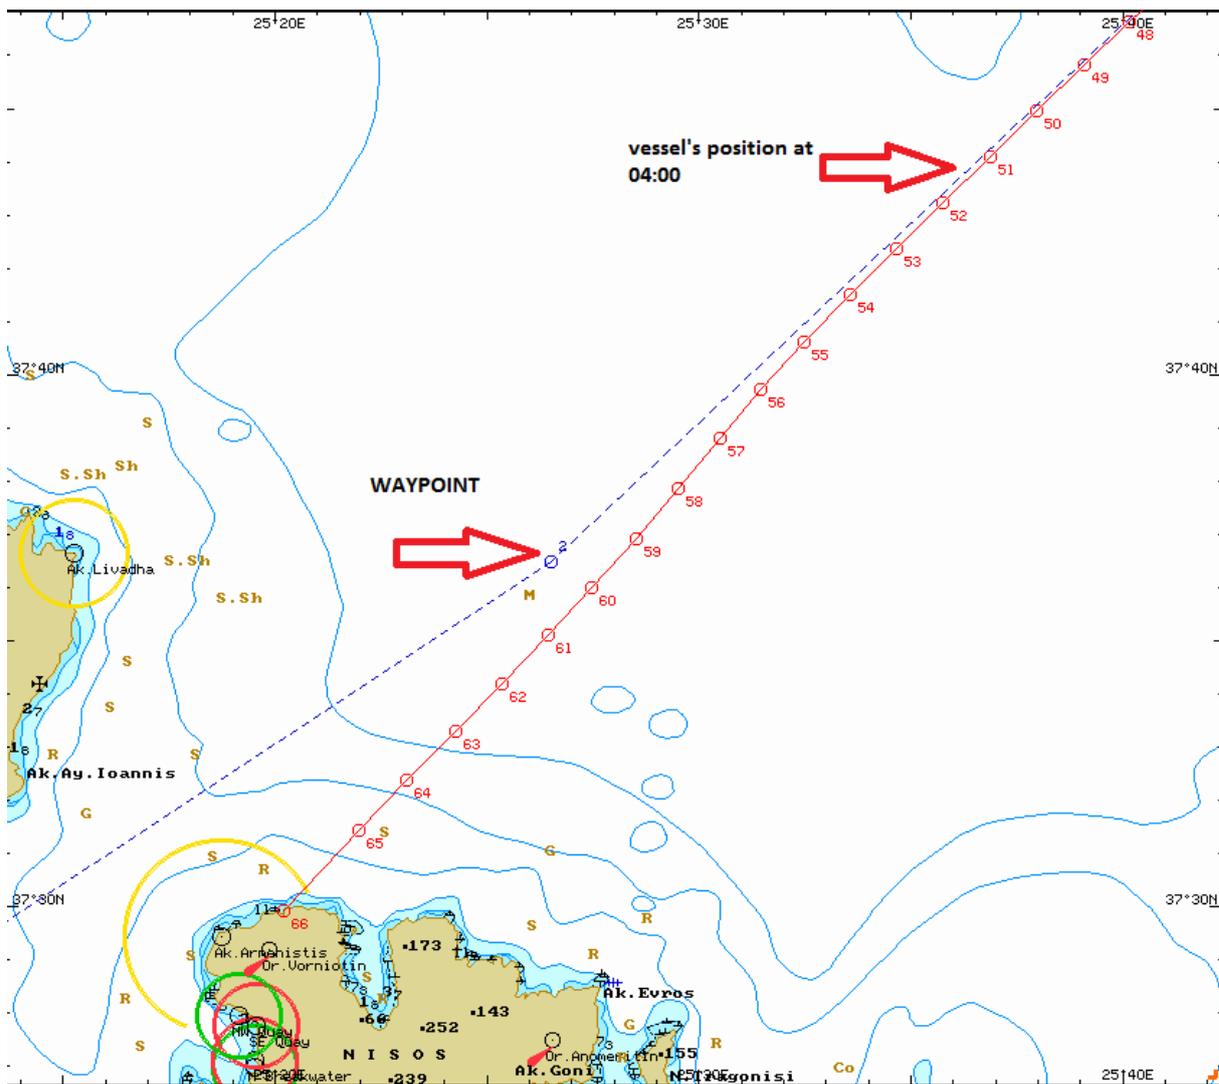
Figure 5: Yusuf Cepnioglu position shortly before 0400 sailing through the Central Aegean Sea (source HCG AIS).

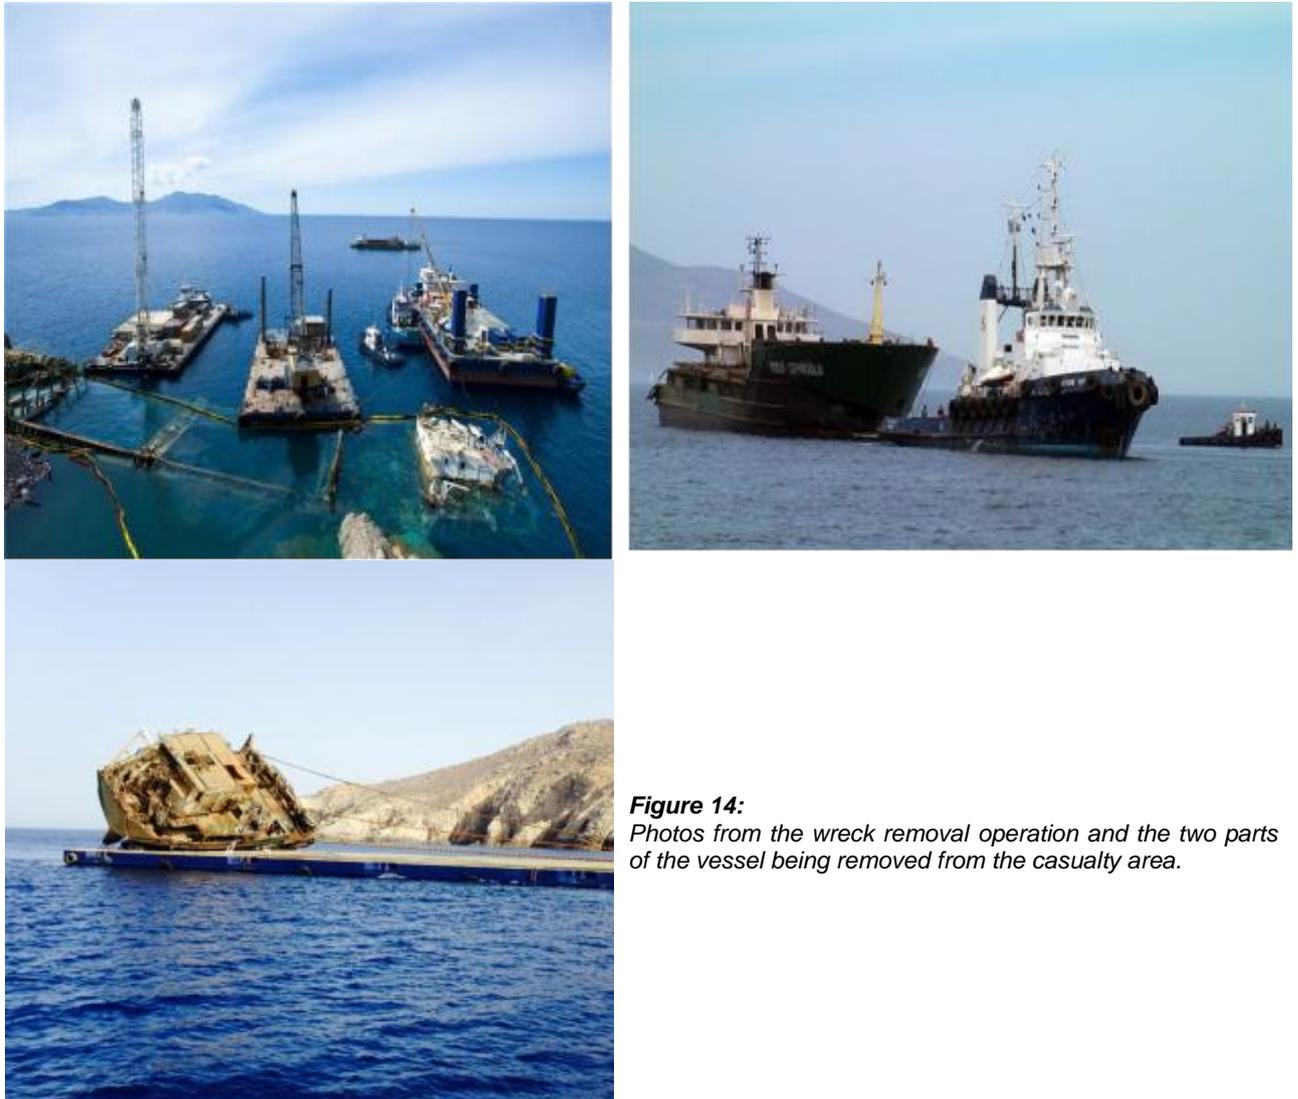
The wreck removal operation started on the 5th of May 2014. The first stage of the operation was completed on the 29th of May 2014 when the forward part of the vessel including the two cargo holds was removed. The second stage was completed on the 22nd September 2014 when the aft part of the vessel was removed as well.

Figure 14: Photos from the wreck removal operation and the two parts of the vessel being removed from the casualty area.

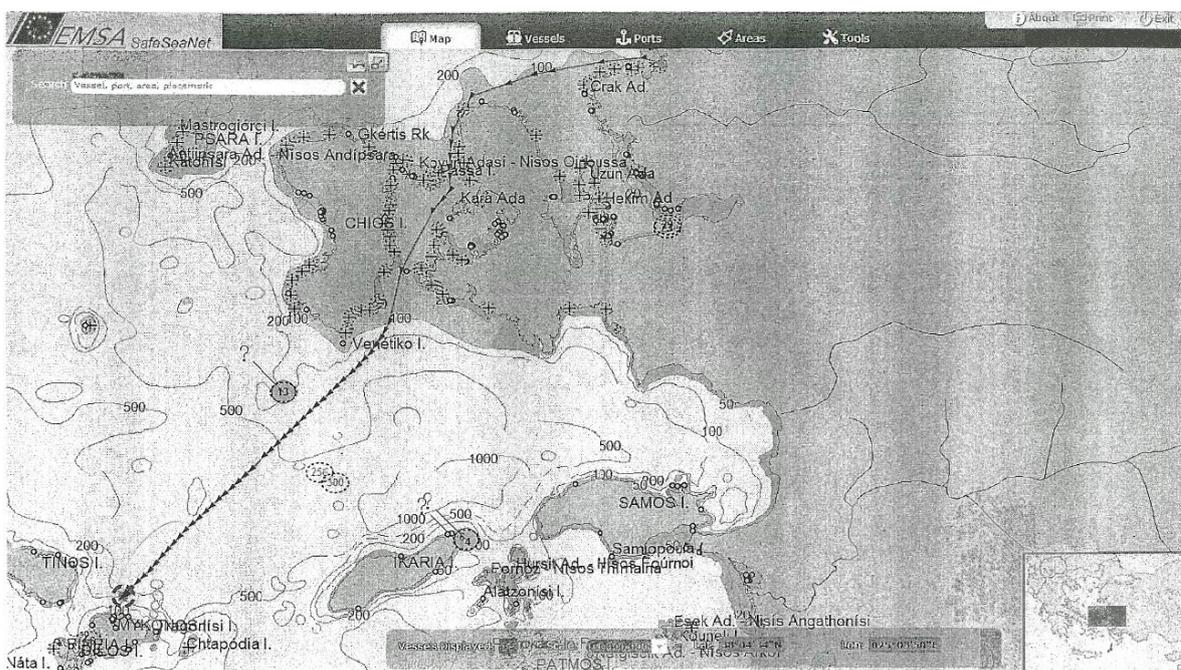
Figure 15: Overview of Yusuf Cepnioglu passage as extracted by IMDatE.

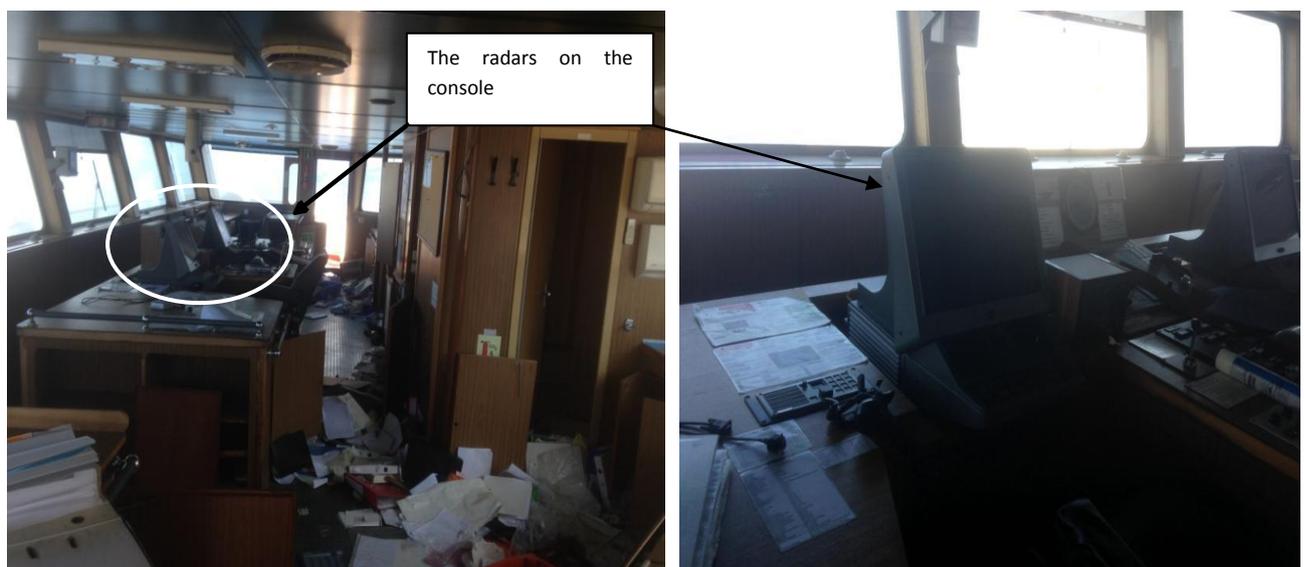
Yusuf Cepnioglu bridge was equipped with one main console mounted on the middle together with the steering and autopilot unit. The console was fitted with the ship's engine control lever and the intercommunication handsets. Two radars were fitted at the console, the X-Band (9 GHz) radar was installed next to the rudder unit and the S-Band (3 GHz) radar was on the other side. Both of them were featuring ARPA utilities (Figure 16).

Figure 16: General view of the bridge arrangement and the two radars at the main console

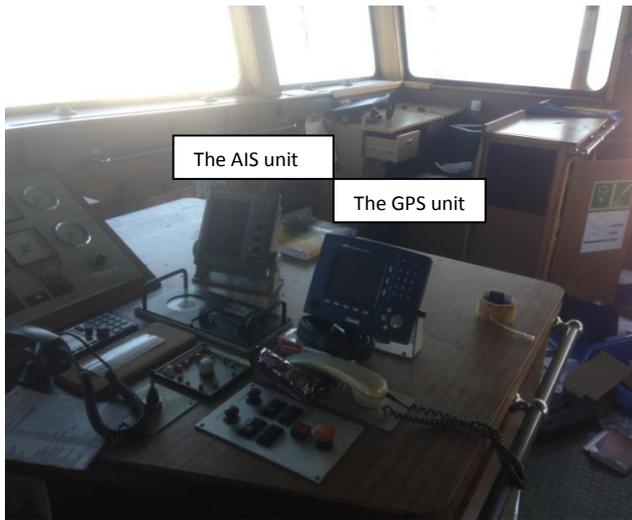
Figure 17: The AIS and the GPS units at the main console

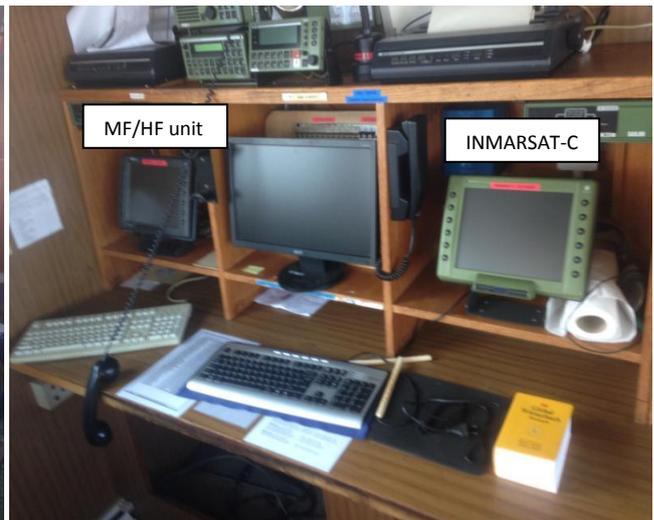
Figure 18: The INMARSAT-, and MF/HF equipment.

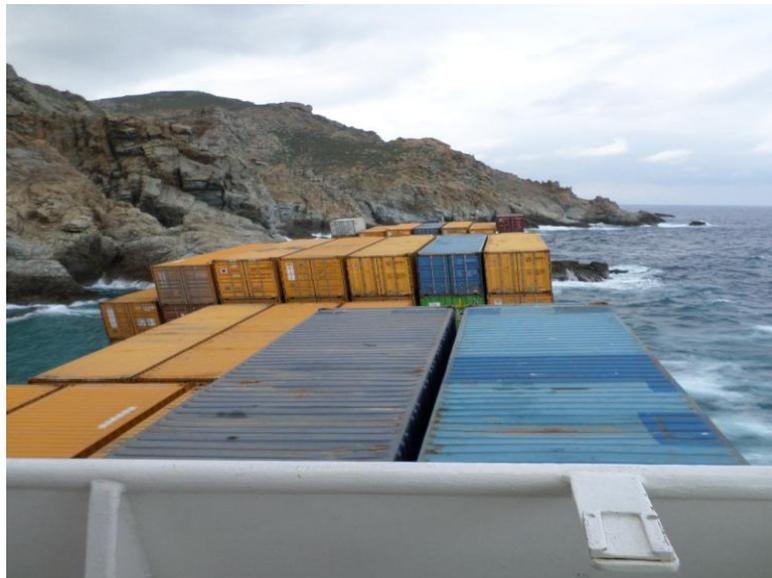
Yusuf Cepnioglu wheelhouse structural arrangement offered a good visibility from the conning position to the navigated sea area. The OOW could maintain a very good visual contact and monitoring of surrounding vessels and land. However, her loaded containers located at the main deck forward part created a blind sector at the imminent proximity of the bow, very common on same ship's type, which could be administered by the movement of the OOW at the bridge wings.

Figure 19: View from the starboard side wing.
