**HELLENIC REPUBLIC
HELLENIC BUREAU FOR MARINE CASUALTIES INVESTIGATION**

**MARINE CASUALTY SAFETY INVESTIGATION REPORT
10/2013**

Within the aforementioned framework HBMCI has been examining the fatal injury of a track trailer driver, occurred on board ROPAX Sorrento following her departure from the port of Igoumenitsa-Greece, on the 10th of July 2013.

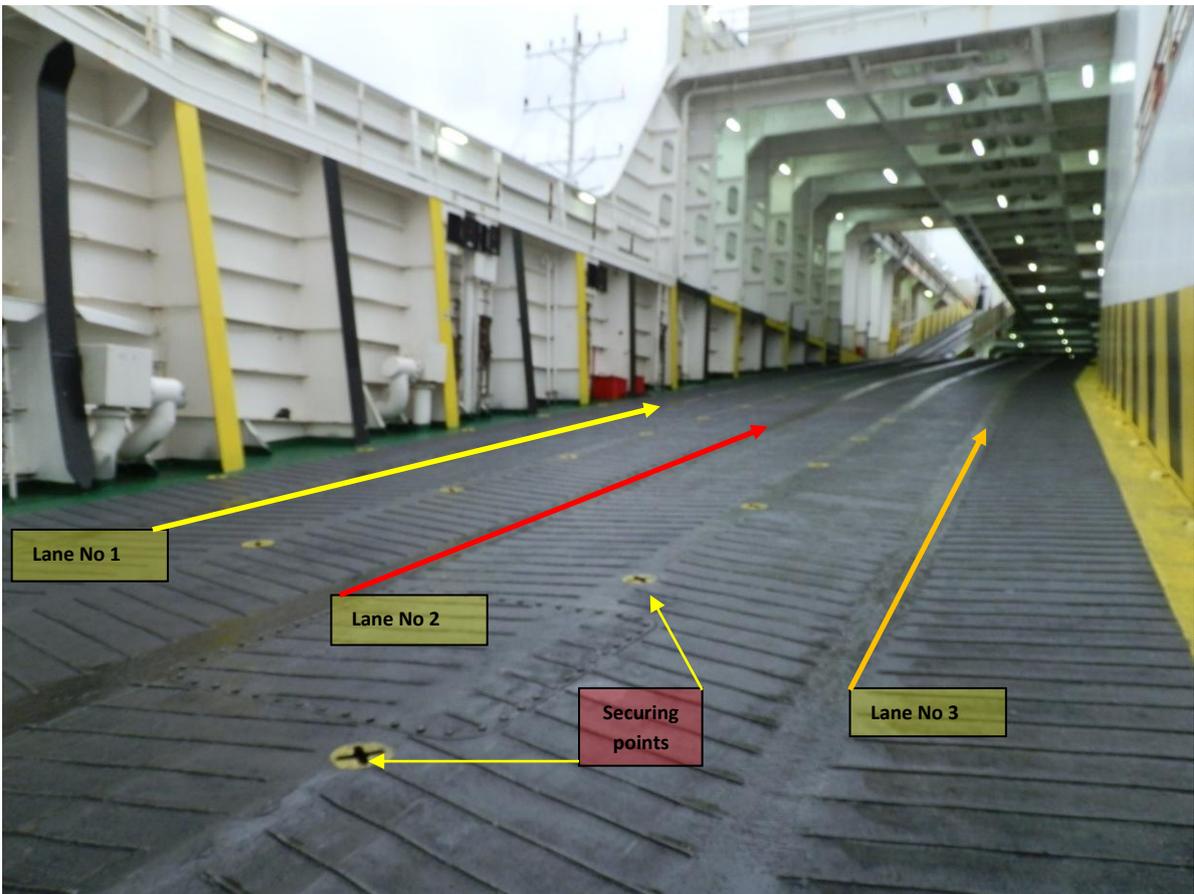
The inclined permanent ramp was fitted with 33 securing points (anchor holes) throughout its layout for the lashing of vehicles and trailers and with anti skid surface (figure 6 & 7).

The grading of the permanent external ramp leading to car deck no 4 was 7° and the inclination rate was 12.5 %.

Figure 6. The permanent stern port ramp leading to car deck no 4, looking upwards and forward .

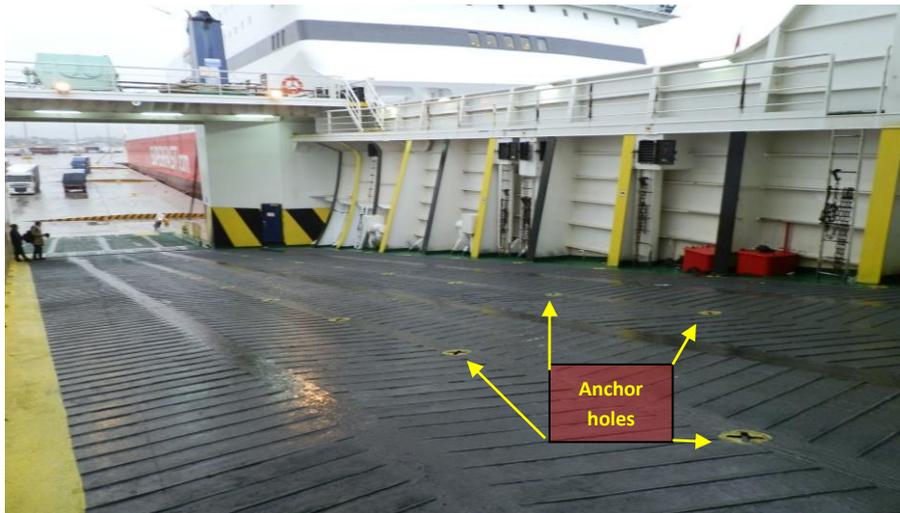
Figure 7. The permanent stern port ramp leading to car deck no 4, looking downwards and astern.
