Fatal fall from height on board DSM Capella Kalamata, Greece 20 January 2024

BMSR ID Safety
Investigation Report 1/2024

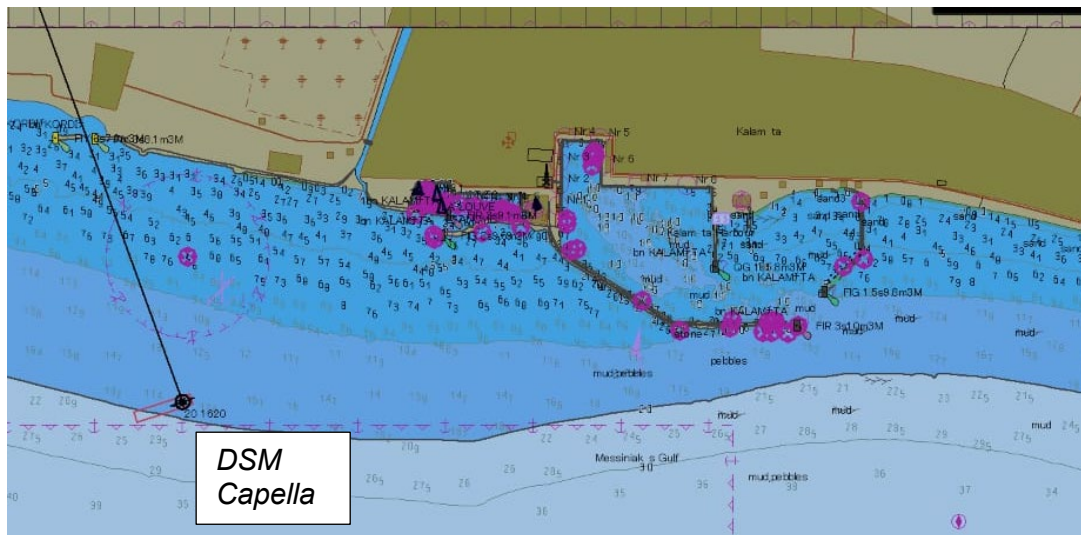
Figure 1 – DSM Capella anchorage position

At 0600 on 20 January 2024, the Barbados registered cargo ship *DSM Capella* anchored 0.5nm off Kalamata, Greece (**Figure 1**) to embark spare engine parts. The weather was fine, with clear skies and light winds.

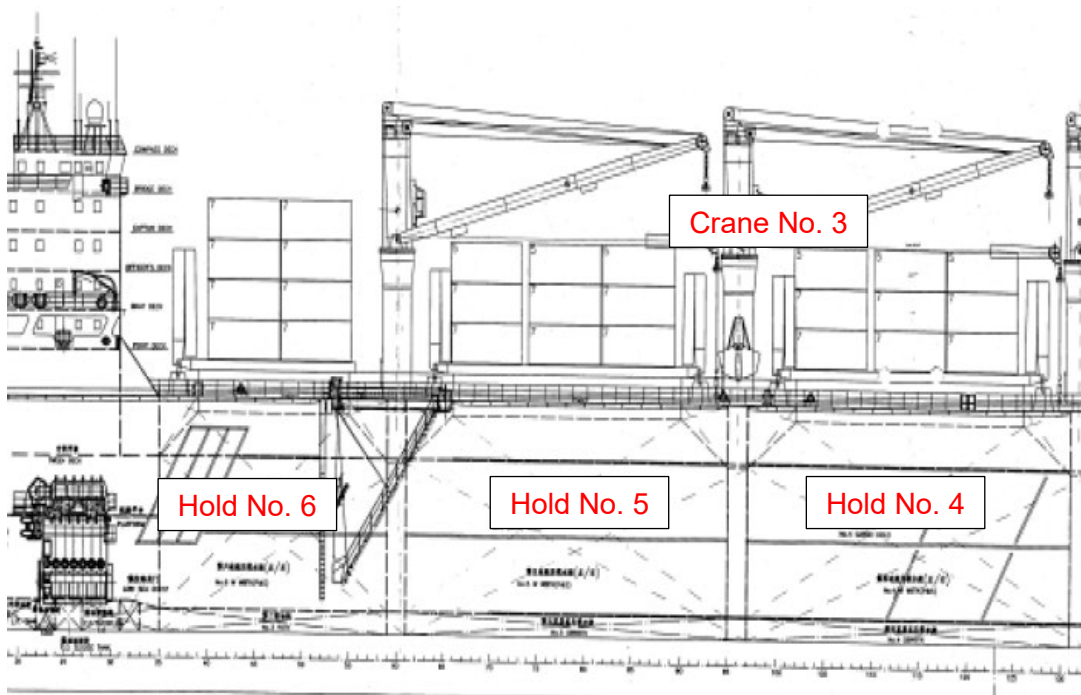
Figure 2 – Extract of DSM Capella's general arrangement showing holds 4,5 and 6

At 0800, the chief officer (C/O) met with the bosun and the other deck ratings to discuss the day's work. At about the same time, a port state control (PSC) officer boarded to conduct an expanded PSC inspection. During the morning, the deck crew conducted maintenance in hold No. 5 (**Figure 2**). This focused on the chipping and painting of corroded areas that could be reached from the bottom of the hold.

No.3 crane (**Figure 2**) was used to hoist and position the portable gangway in hold No.5. It was manufactured by Macgregor and had a radius of 26m and a safe working load of 40t. The crane was not specifically authorized for man-lifting operations.
