HELLENIC BUREAU FOR MARINE CASUALTIES INVESTIGATION

February 2018

Under the above framework HBMCI has been examining the grounding of Bulk Carrier St. Gregory, which occurred on the 7th of June 2017, in the South Coast of Peloponnese (Kokkala), in Greece. This report is mainly based on information and evidence that have been derived from vessel's Voyage Data Recorder (VDR), the Hellenic Coast Guard AIS Monitoring system and the interview process.

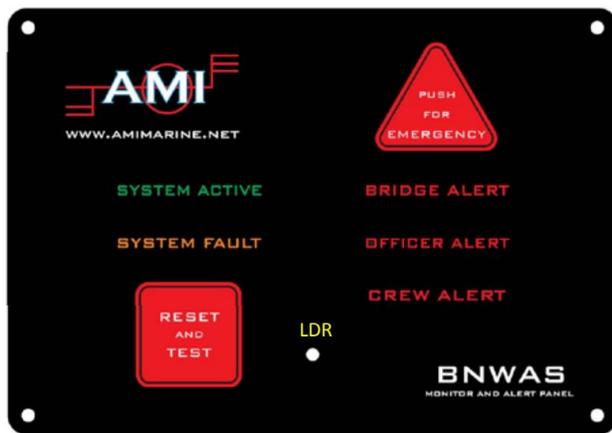
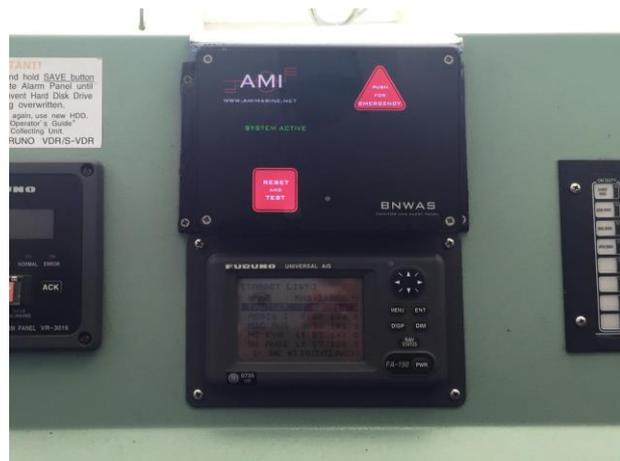
St. Gregory was fitted with an AMI marine KW810 BNWAS, in compliance with the above mentioned technical specifications & standards (Figures 4.4.4.3 / 1, 2 & 3).

Figures 4.4.4.3/1 & 2: St. Gregory's BNWAS as presented in its Operational Manual and as fitted on board the vessel.

However it was verified through the analysis of VDR recordings, that on the night of the marine casualty no audible alarm was sounded from BNWAS before the grounding. Additionally from the BNWAS data as recorded by the VDR it was revealed that the system was set to OFF mode, so the BNWAS was deactivated, despite the fact that the Autopilot was engaged. (see Figure 4.4.4.3/4). These information were verified after clarifications provided by the manufacture company of said BNWAS system, AMI MARINE (UK) LTD.
