**HELLENIC REPUBLIC  
HELLENIC BUREAU FOR MARINE CASUALTIES INVESTIGATION**

**MARINE CASUALTY SAFETY INVESTIGATION REPORT  
02/2020**

**July 2024**

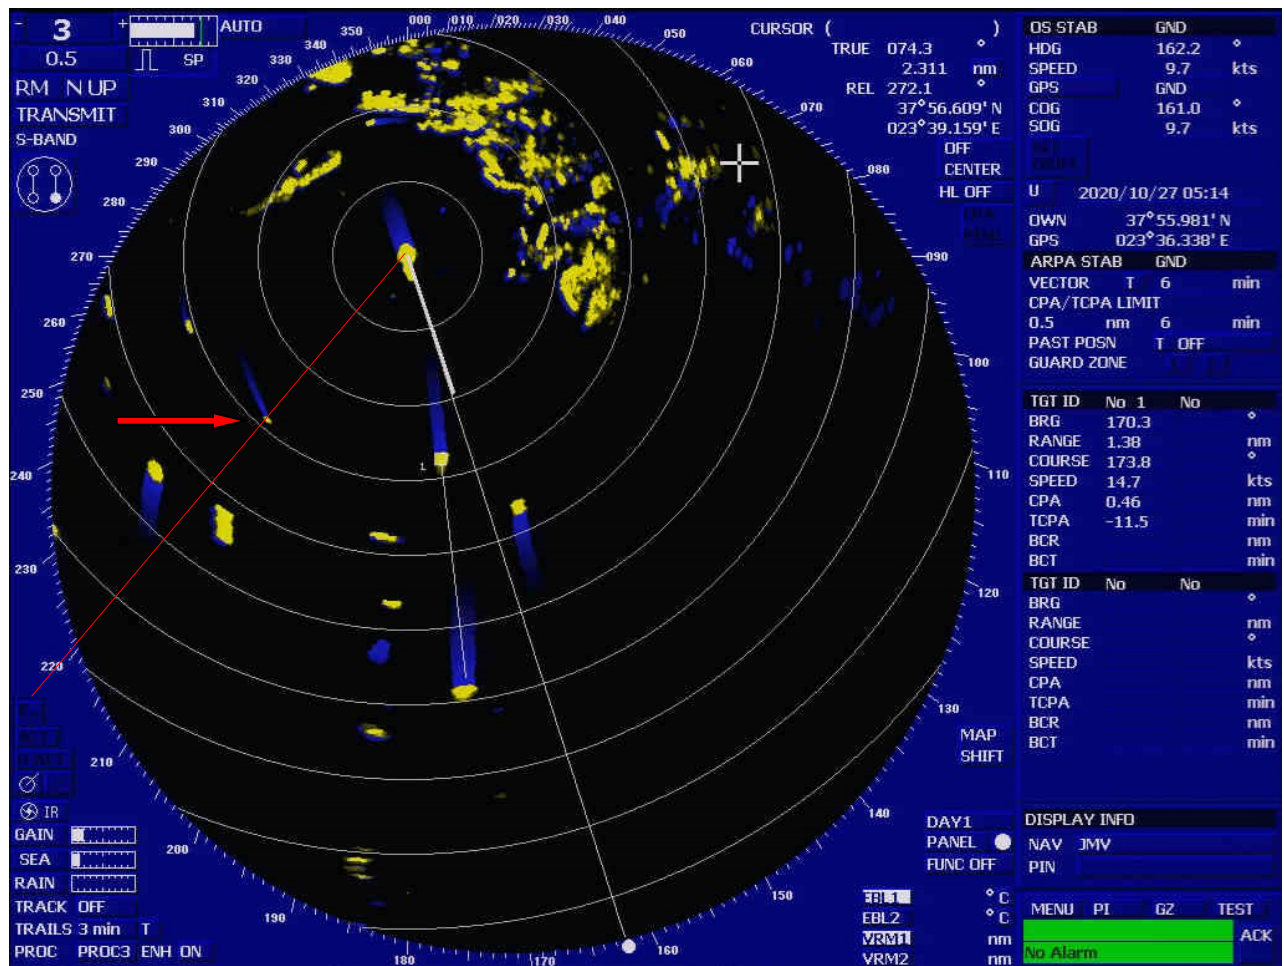
Figure 6. Depiction of S Band radar at time 07:14:51. The arrow indicates HS KALLISTO and the red line was drawn to indicate the bearing from MAERSK LAUNCESTON.

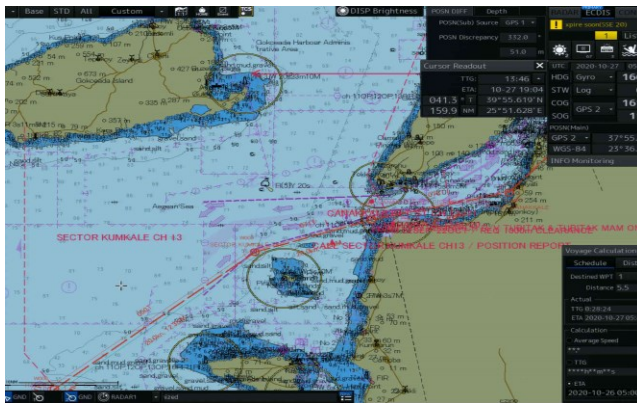
Furthermore, the Master, who was the only one on the bridge, operated the ECDIS on the sea area of Canakkale Turkey in order to check the planned voyage and other navigational details. More specifically, according to the VDR data from 07:17:33 until 07:19:33 the ECDIS screen was displaying the CANAKKALE entrance area (Figures 7,8).

Figure 7. Depiction of ECDIS screen at time 07:17:33.

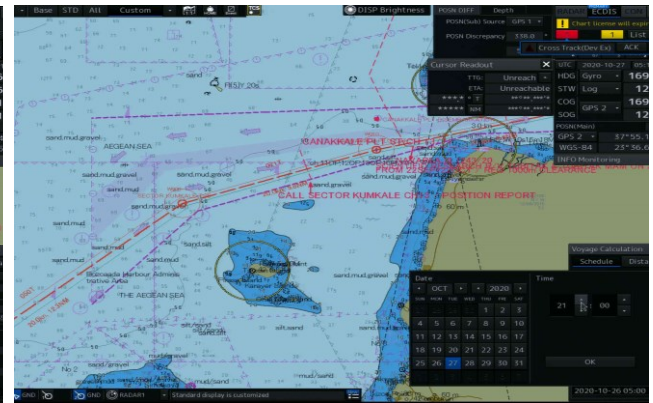
Figure 8. Depiction of ECDIS screen at time 07:19:33.

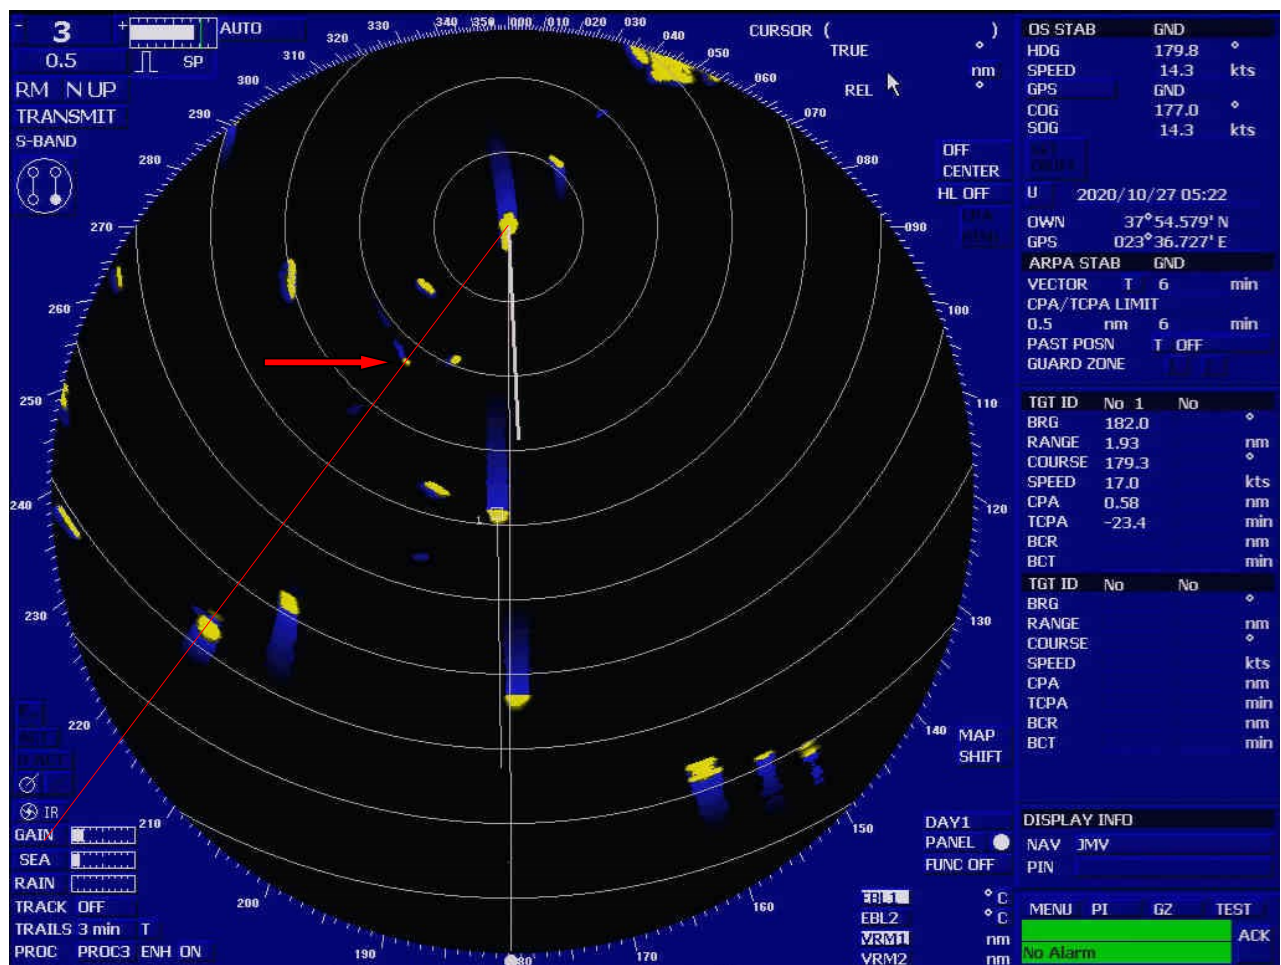
- to increase the range of the S Band radar from 3 nm to 6 nm at approximately 07:22:06. At that time HS KALLISTO was at a distance of approximately 1,1 nm and at a bearing of 217° (Figure 9) and
- to acquire two more targets on the ARPA at approximately 07:23:51 which were two vessels also heading towards TSS and were in front of the already acquired Container vessel. At that time HS KALLISTO was at a distance of approximately 1 nm and at a bearing of approximately 217° (Figure 10).

Figure 9. The last depiction of S Band radar at 3nm range at time 07:22:06. The arrow indicates HS KALLISTO and the red line was drawn to indicate the bearing from MAERSK LAUNCESTON.

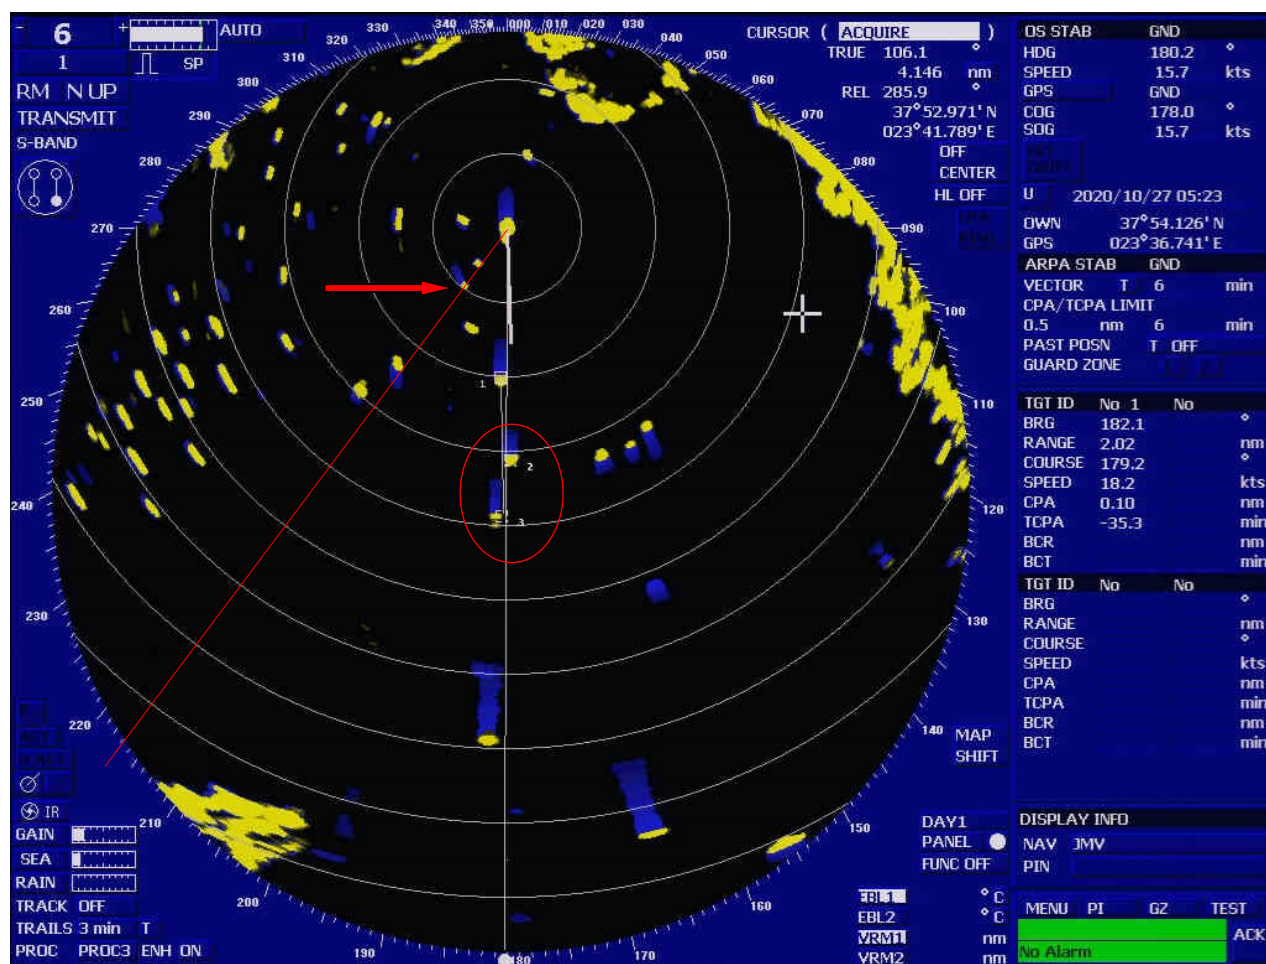
Figure 10. Depiction of S Band radar at 6nm range at time 07:23:51, indicating the acquired targets No 2,3. The arrow indicates HS KALLISTO and the red line was drawn to indicate the bearing from MAERSK LAUNCESTON.

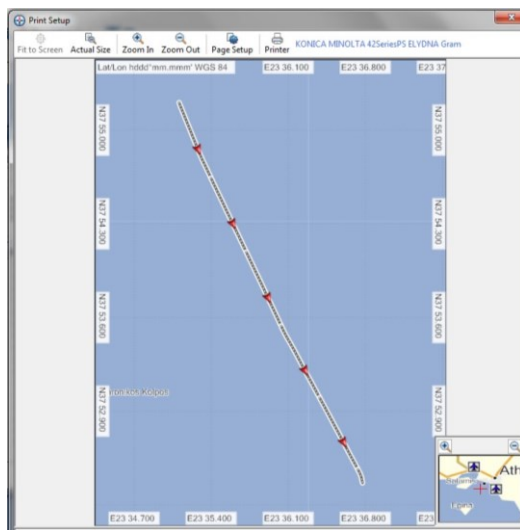
In light of the above data it can be deduced that the HS KALLISTO while navigating towards the TSS did not proceed to any considerable alteration of her course and speed. Her almost steady course is also depicted by the plotting of the recorded positions to the GPS manufacturer's application (Figure 13).

**Figure 13.** The extracted positions of HS KALLISTO's GPS plotted on the manufacturer's application (Garmin HomePort).

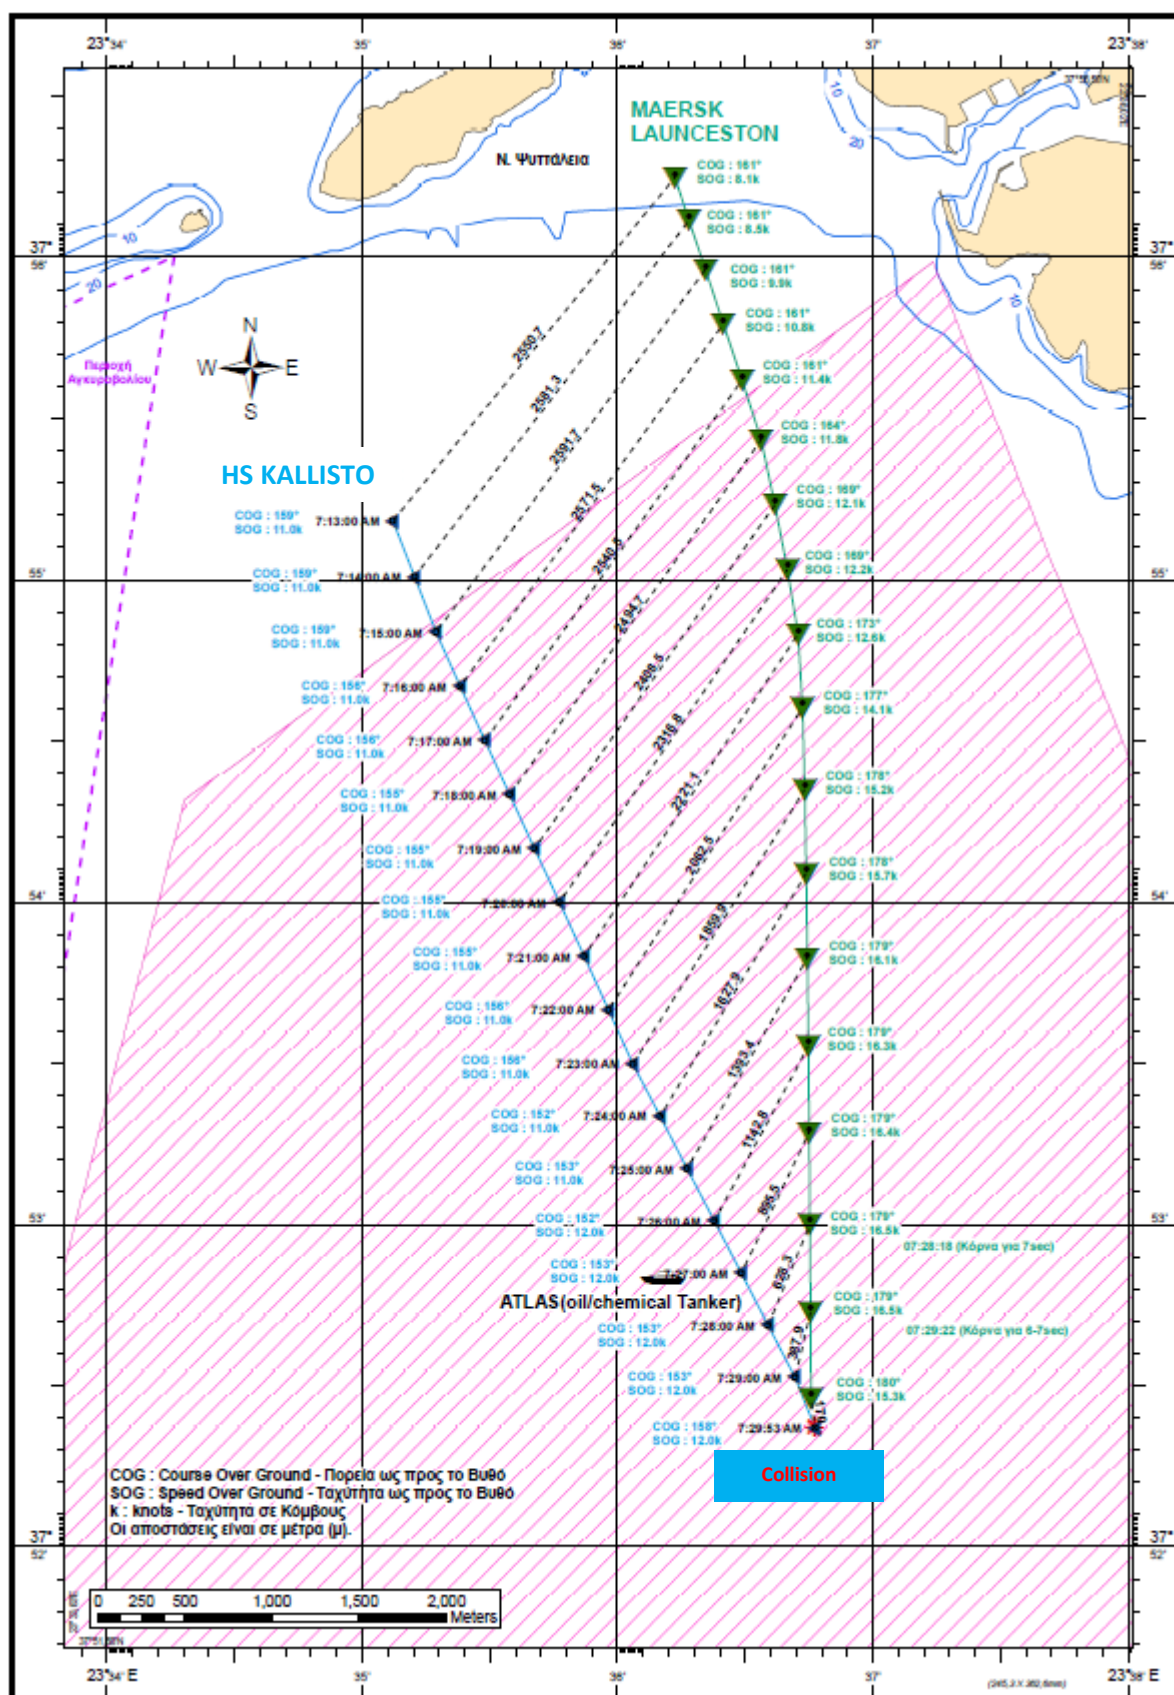
Based on the available navigational data of the two vessels while they were navigating towards Piraeus TSS a correlation of their plotted courses was depicted (Figure 14).

Figure 14. Correlated courses plotted according to the positions of HS KALLISTO from table 2.

As depicted in Figures 6,9,10,14 and 15, while the two vessels were steaming towards Piraeus TSS they were "in sight of one another", as per COLREGs, Rule 3, par. (k). During that time, the bearings of HS KALLISTO were ranged between 210° and 221°, which correspond to directions between 30° to 41° abaft the beam of HS KALLISTO.
