HELLENIC REPUBLIC  
HELLENIC BUREAU FOR MARINE CASUALTIES INVESTIGATION

MARINE CASUALTY SAFETY INVESTIGATION REPORT  
03/2014

EXPLOSION ON BOARD M/V "NAKHODKA"

September 2016

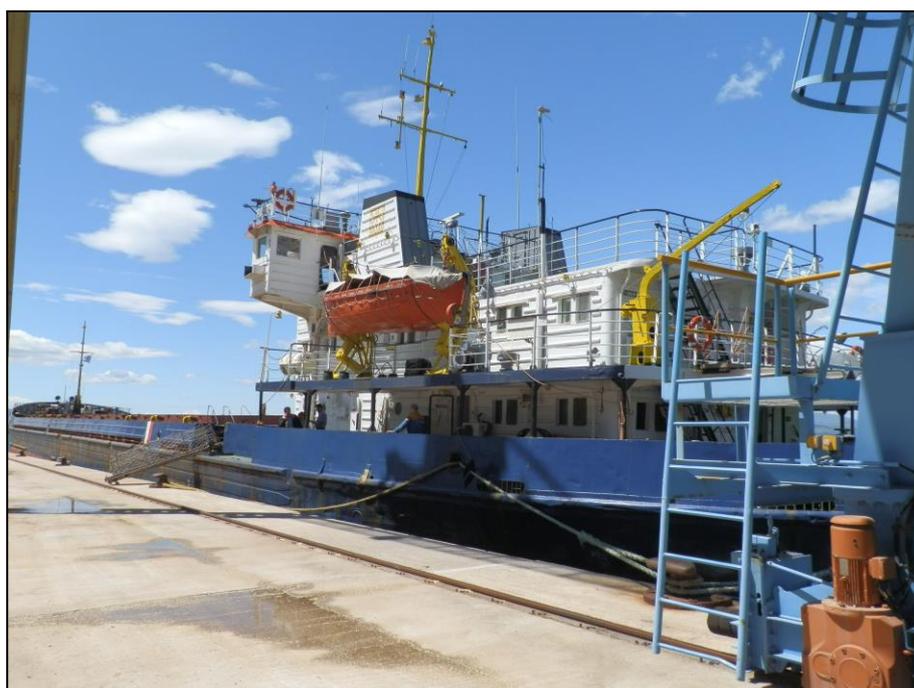
Figure 1: M/V NAKHODKA berthed at the port facility of LOULIS MILLS, at Amaliapolis.

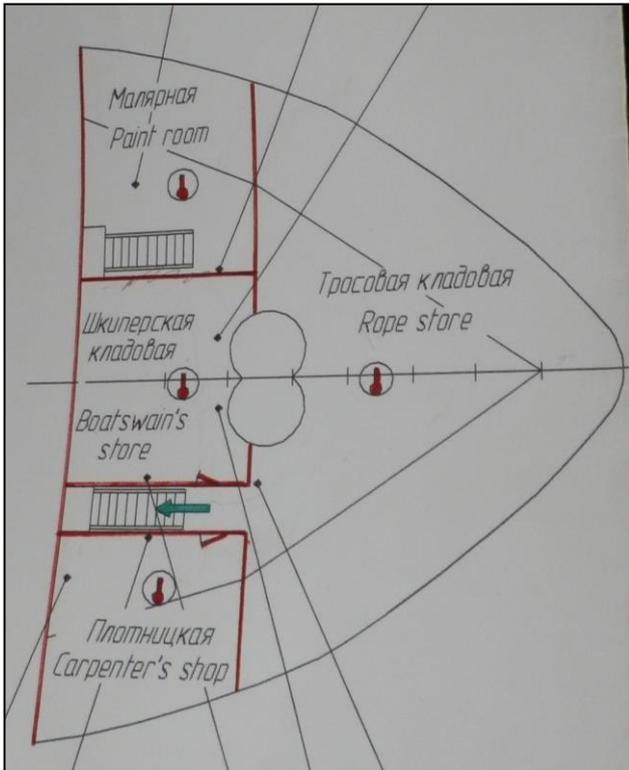
In the morning hours of the 26 April 2014, the Chief Engineer along with the 3<sup>rd</sup> Engineer went to the forecastle of the vessel for repairing a steel pipe of the vessel's diesel generator engine which was leaking. The repair work would be carried out at a work bench situated at the port side of the Rope Store inside the forecastle as there was no workshop at the vessel's engine room (figure 2). It is noted that during the interview process, the crew members of NAKHODKA could not provide any information with regard to the working process for the repairing of the pipe and whether hot works were to be carried out by the two engineers.

**Figure 2:** The interior of the forecastle. The mending of the pipe would be carried out by the Chief and 3<sup>rd</sup> Engineer inside the rope store. (Source: M/V NAKHODKA's Fire Control Plan, No:53025)

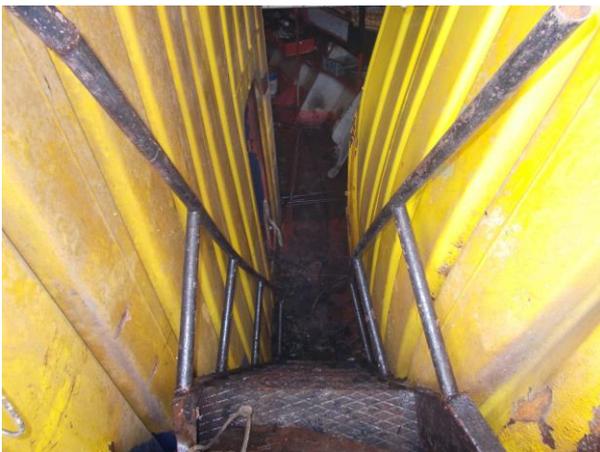
**Figure 3:** The companion way ladder leading from the starboard watertight door of the forecastle to the internal passageway.

The Rope Store was accessible through a watertight door at the starboard side of the forecastle's aft bulkhead and through a companion way ladder leading to a passageway between the Carpenter's Shop and the Boatswain's Store (Figure 3).

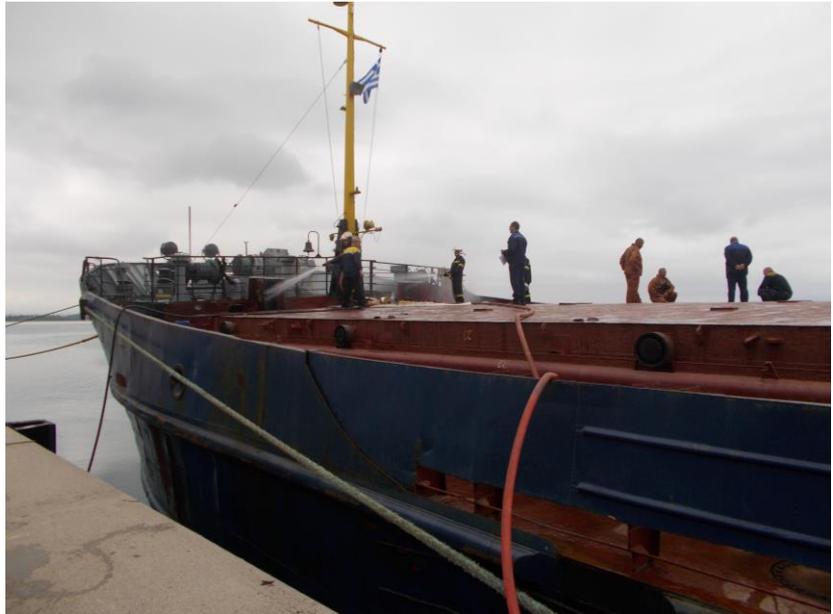
**Figure 8:** Photo of the cooling process after the extinguishing of the fire on board NAKHODKA by the Fire Brigade.

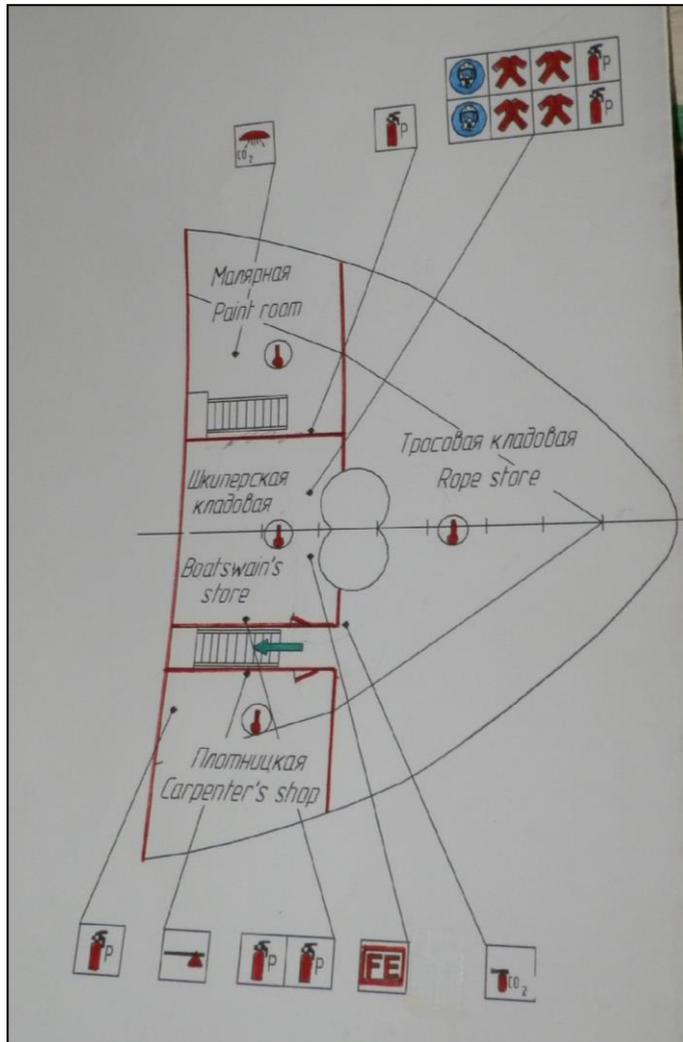
The forecabin area comprised four separate spaces (see Fig.9). The Paint Room was situated at the aft port side and it was accessed through a watertight door and a companion way ladder. The Paint Room was equipped with a fixed CO<sub>2</sub> fire extinguishing system. The two CO<sub>2</sub> cylinders were located on the main deck, at the starboard side of the Paint Room door.

**Figure 9:** The forecastle area as presented by the vessel's Fire Control Plan (No 53025)

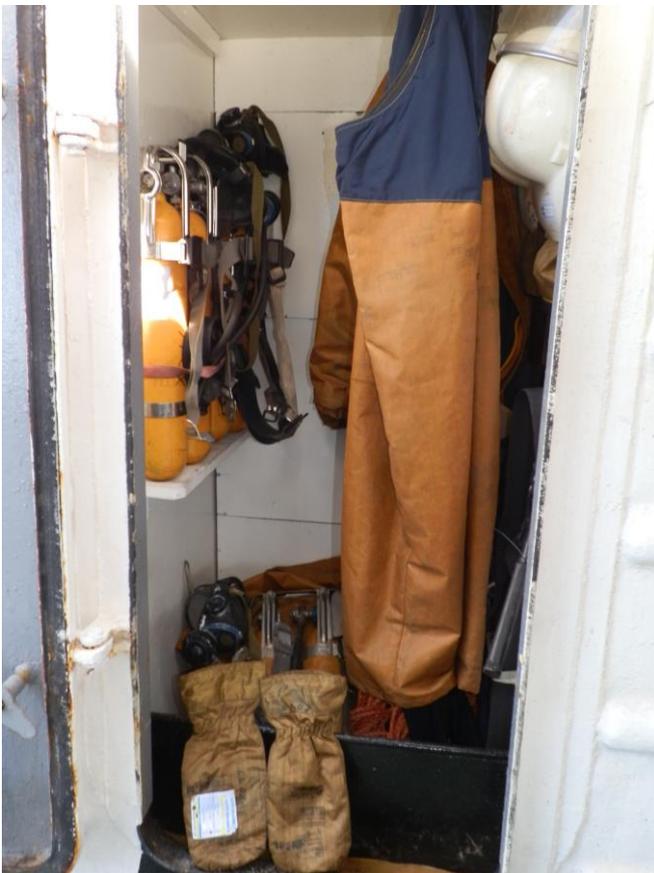
**Figure 20:** The fireman's outfit stored in the fire locker at the port side of the Accommodation.

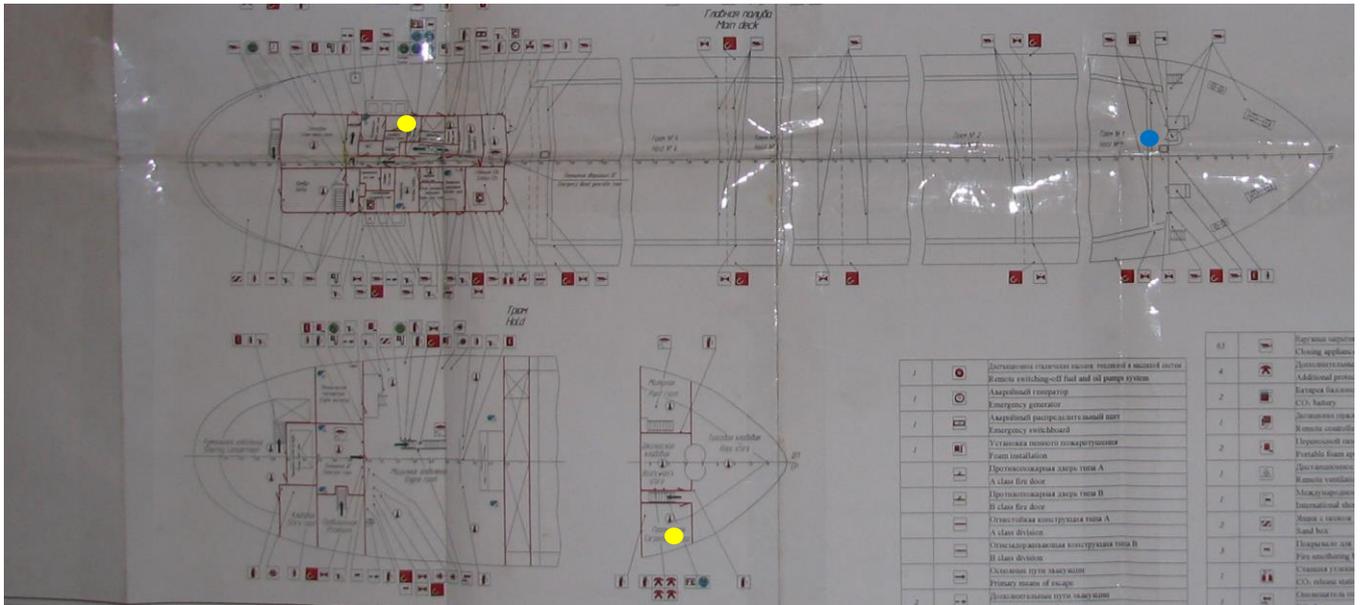
**Figure 21:** The locations of the Fire Lockers (yellow dots) and the location of the Paint Room fixed CO<sub>2</sub> firefighting system (blue dot).

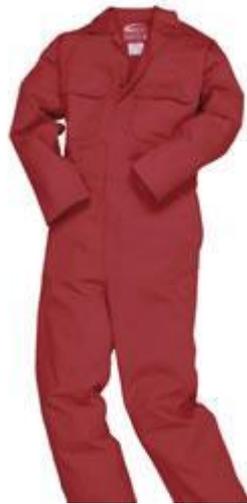
FLAME RETARDANT  
COVERALL

The performance requirements set out in this standard are applicable to protective clothing which could be worn for a wide range of end uses, where there is a need for clothing with limited flame spread properties and where the user can be exposed to radiant or convective or contact heat or to molten metal splashes.

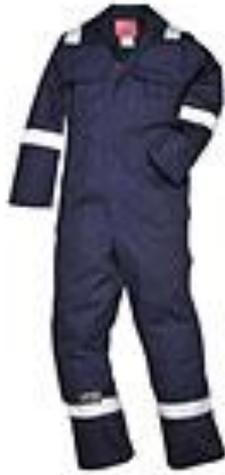
**FLAME RETARDANT  
COVERALL**

This type of protective clothing is intended to protect the wearer against spatter (small splashes of molten metal), short contact time with flame, radiant heat from an electric arc used for welding and allied processes, and minimizes the possibility of electrical shock by short-term, accidental contact with live electrical conductors at voltages up to approximately 100 V d. c. in normal conditions of welding. Sweat, soiling, or other contaminants can affect the level of protection provided against short-term accidental contact with live electric conductors at these voltages.
