HELLENIC REPUBLIC

**HELLENIC BUREAU FOR MARINE CASUALTIES INVESTIGATION
MARINE CASUALTY SAFETY INVESTIGATION REPORT
03/2020**

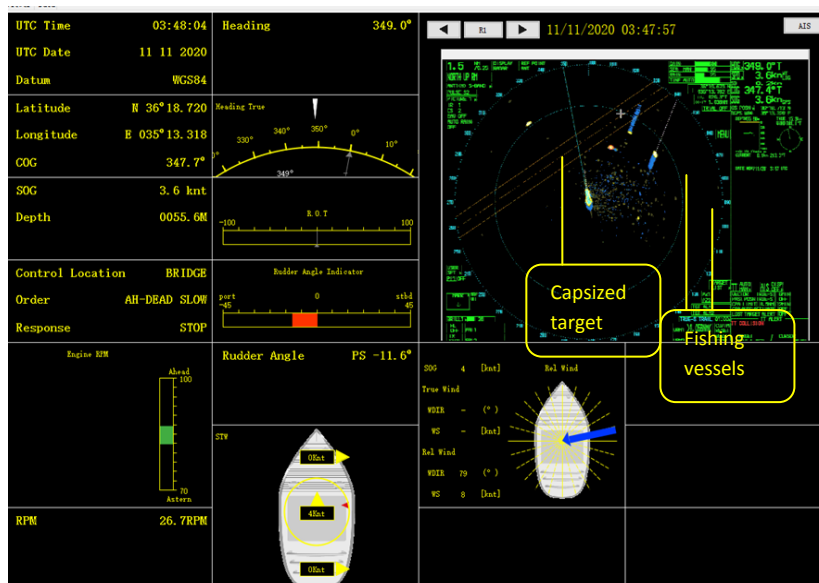
Figure 4: VDR coning recording at approximately 06:48 when the Second Officer spotted a capsized target. Targets on starboard side are assessed to be F/V MAHMUTCAN 1 and/or KUMRULAR 3.

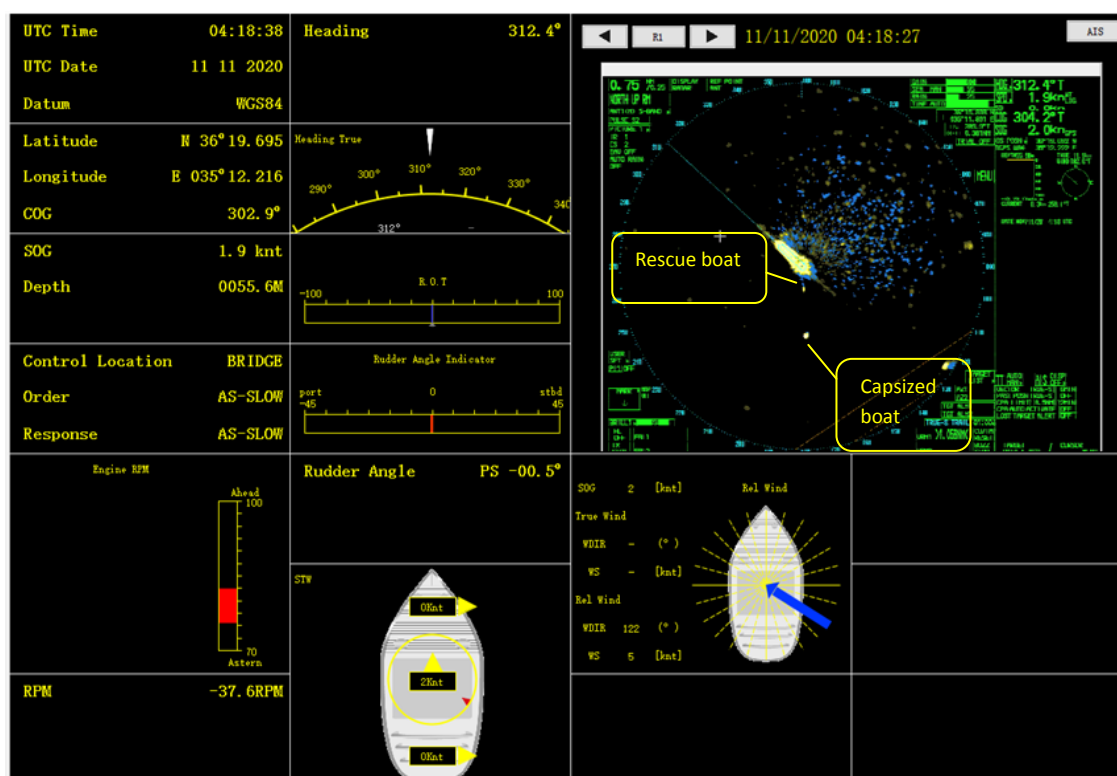
Figure 7 . VDR Coning recording at approximately 07:18 when EPHESOS reported to AKDENIZ VTS that the rescue boat is heading to the capsized boat. ARPA range to 0.75 nm. Target on starboard quarter is the capsized boat. Rescue boat is close to EPHESOS stern.

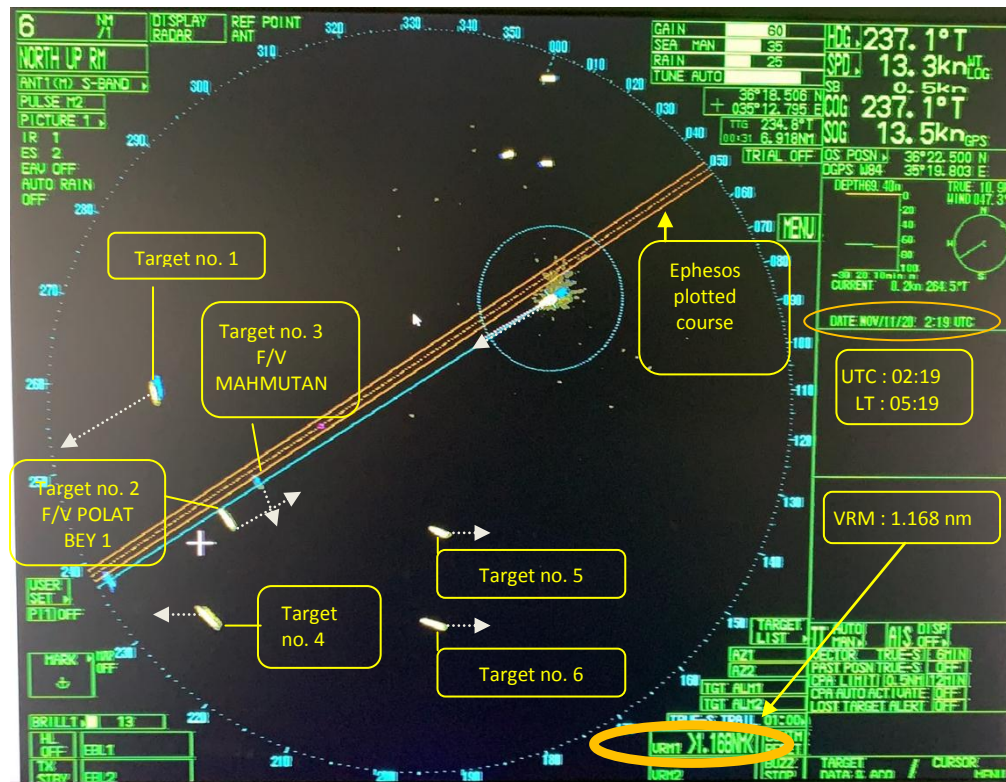
- d) one target (**no. 4**) was about 10° on EPHESES port side at approximately 6 nm. As per VTS recording, and based on the target's vector indication, it was probably drifting or sailing at low speed; and heading to about 250°.

- e) Two targets (**no. 5 & no. 6**) were both 40 - 50° on EPHESES port bow at 3 nm and 4 nm respectively. Based on the targets' vector indications their speed is estimated to approximately 3 knots. Due to their speed and steady course it is presumed that they were Trawlers engaged in fishing operations.

Figure 13: At 05:19 the marine traffic displayed on EPHESOS ARPA. Six targets are detected and displayed. VRM is set to 1.168. Targets' vectors are simulated.

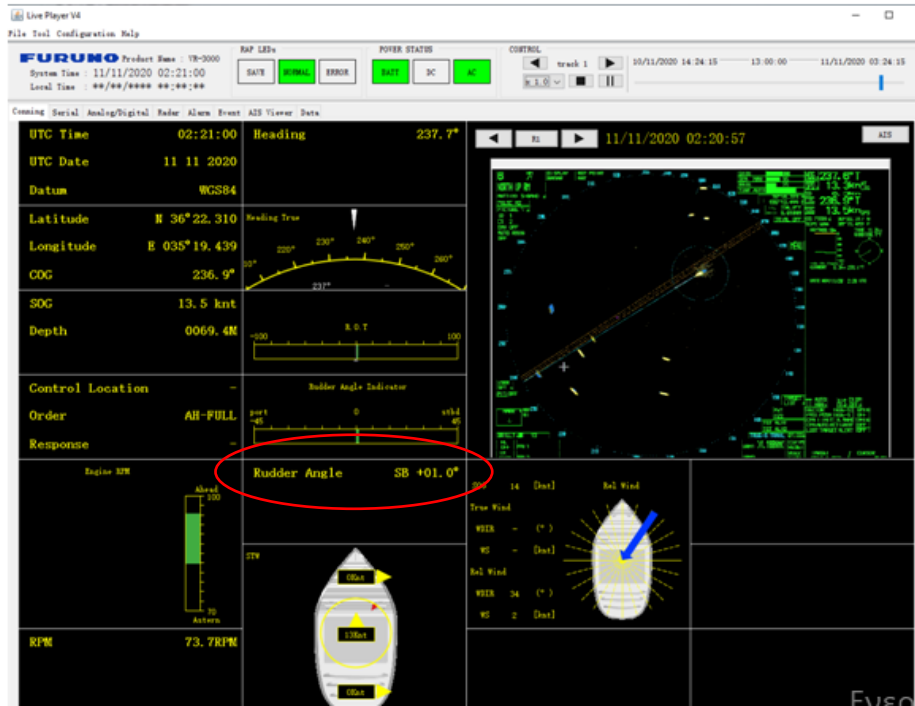
At approximately 05:20, as resulted from the data extracted from EPHESOS VDR (**Figure 15**), the OOW having evaluated the unfolding marine traffic on his port bow and more specifically the six targets displayed on ARPA decided to alter EPHESOS course to starboard in order to have a clear pass. He started altering her course gradually to starboard by adjusting the autopilot's course setting control.

Figure 15: At approximately 05:20 EPHEOS OOW started altering her course to starboard. Rudder is set 1° to starboard by the course setting control.

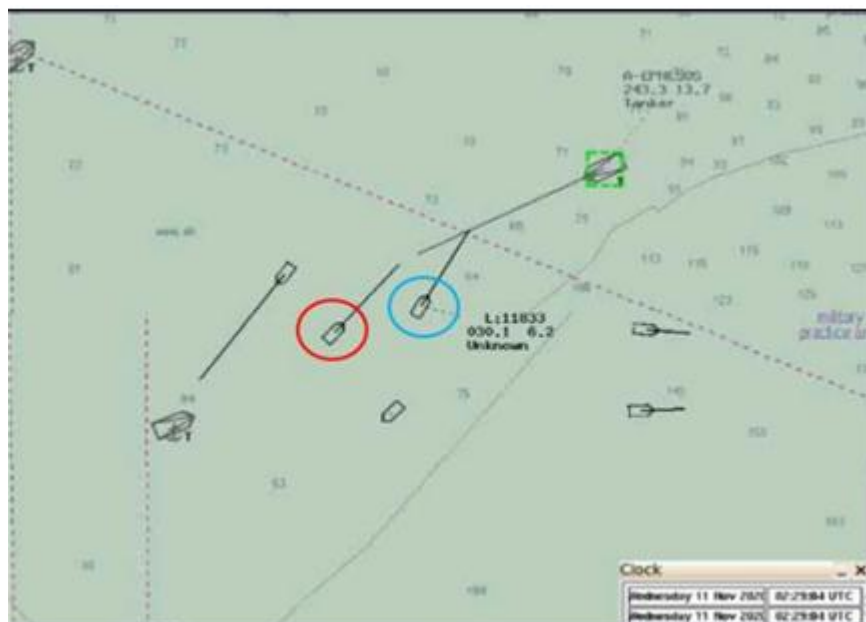
At 05:29:04 VTS captured EPHESOS navigating at 243.3° making 13.7 knots. The F/V MAHMUTCAN 1 (blue circle) was sailing at 030.1° and 6.2 knots. The F/V POLAT BEY 1 (red circle) was sailing at an estimated course of approximately 035° and speed of 6 knots. Additionally the target referred as no. 4 was apparently drifting away off EPHESOS navigating area. The two trawlers (targets no. 5 & 6) were recorded to sail more than 2.5 nm abeam off EPHESOS port side, running at approximately 3 knots. The trawlers speed indicated that they were engaged in fishing operations (see below **Figure 18**).

Figure 18: At 05:29:04 the situation recorded by VTS. POLAT BEY 1 (red circle), MAHMUTCAN 1 (blue circle)

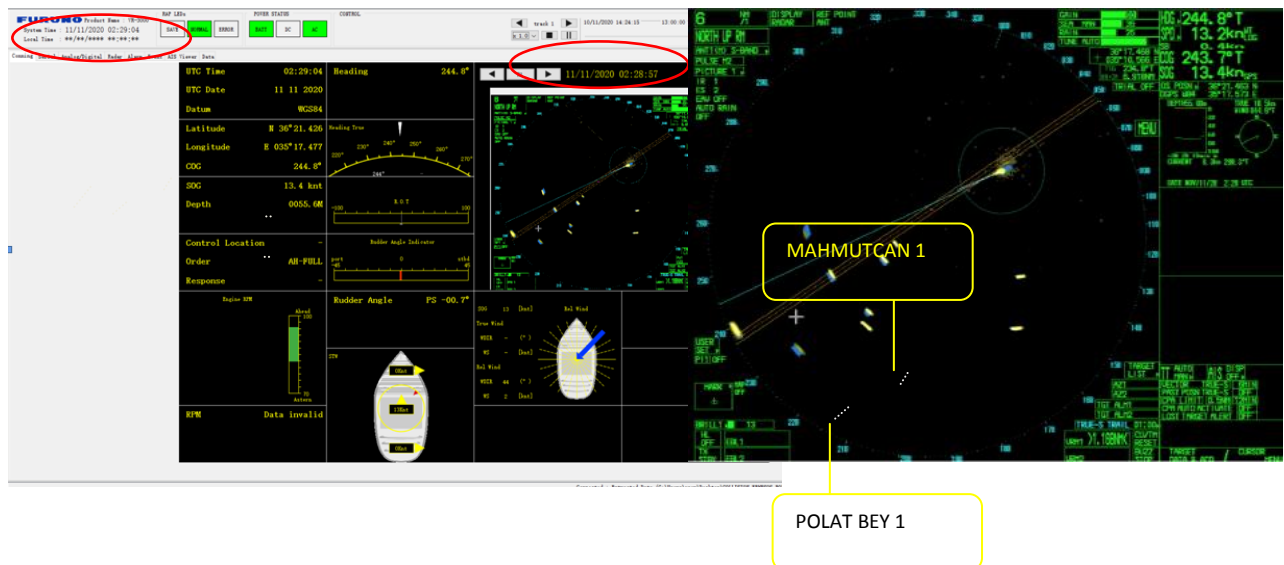
At the time VTS recorded the marine traffic, EPHESOS ARPA as extracted from VDR (see below **Figure 19**), displayed her heading at 244.8° and speed to 13.2 knots. MAHMUTCAN 1 was approximately 3 nm (estimated as 3 times the VRM range) off her

bow and 10° to port. POLAT BEY 1 was about 4 nm (estimated as 4 times the VRM range) off EPHESOS bow and 5° to port. Both F/Vs vectors' indicators were of the same length. MAHMUTCAN 1 speed was recorded at 6.2 knots. The estimated distance between the two F/Vs was approximately 1.2 nm.

Figure 19: EPHESOS ARPA displayed the navigating situation at about the same time it was recorded by Akdeniz sector. System's (VDR) time 02:29:04. ARPA time 02:28:57. A minor time difference of 7 seconds is observed between the time recording indications of the two devices. Targets' vectors are simulated.

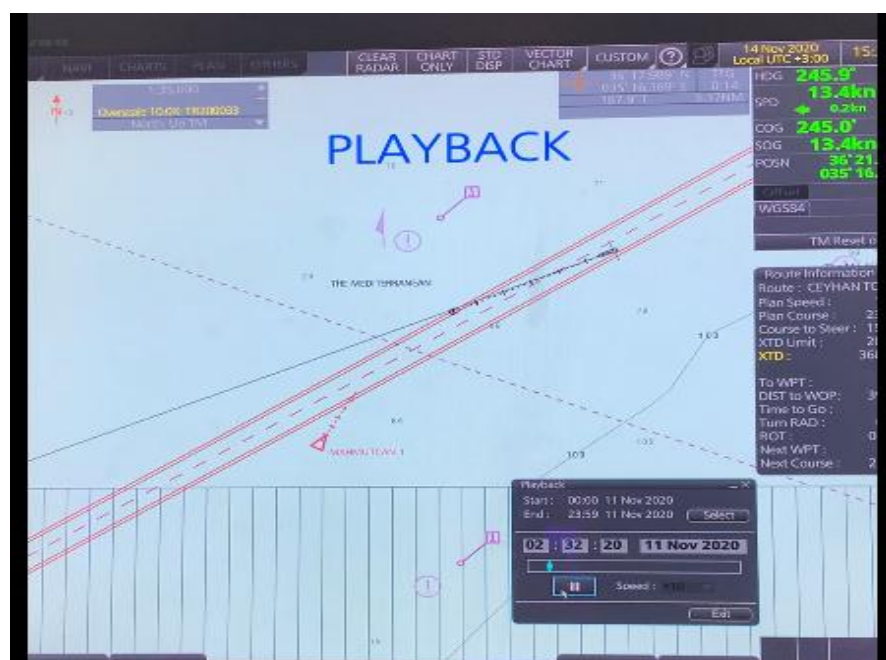
At 05:32:20, as per data extracted from EPHESOS ECDIS, while she was captured to navigate at 245.9° (COG 245°) and SOG 13.4 knots, MAHMUTCAN 1 was heading towards EPHESOS bow, steaming with an estimated course of 020° and speed close to 6 knots. At that time POLAT BEY 1 was not displayed (see below **Figure 20**).

Figure 20: MAHMUTCAN 1 heading towards EPHESOS bow, course 020°; speed about 6 knots

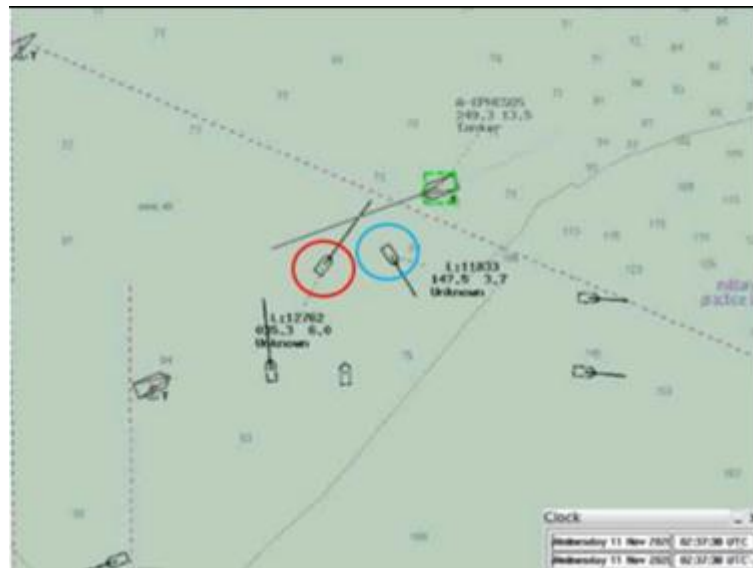
At 05:37:30 POLAT BEY 1 is recorded by VTS to have changed her course to starboard and more specifically to 035.3° maintaining the same speed of 6 knots. Her distance from EPHEOSOS was reduced to 2.67 nm; relative bearing close to 13° to port. (see following **Figure 31**).

Figure 31: VTS screenshot at 05:37:30. POLAT BEY 1 (red circle), MAHMUTCAN 1 (blue circle).

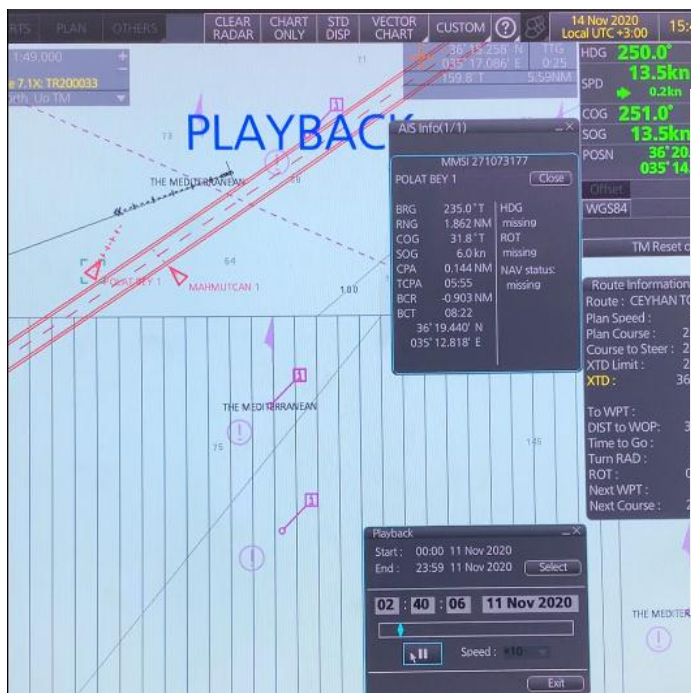
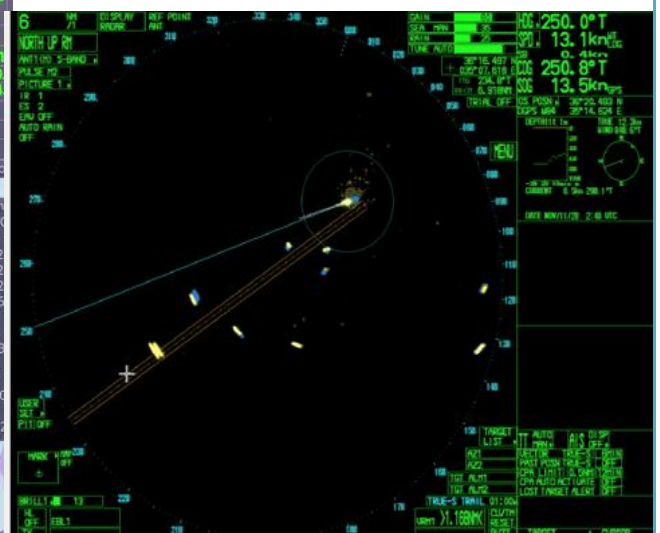
Figure 34: ECDIS data recorded at 05:40:06. **Figure 35:** ARPA recording at 05:40 ALDIS lamp signalling. CPA: 0.144 nm - TCPA: 05:55 - BCR: -0.903 nm

- EPHESOS was heading at 250° (COG 251°) and her speed was 13.5 knots.
- MAHMUTCAN 1 was about 1.3 nm off EPHESOS bow under course alternation to starboard. Her speed was close to 4 knots (as per her vector indication) and her distance from POLAT BEY was slightly less than 1 nm.
- At that time (05:40:06), POLAT BEY 1 was recorded to sail with course 031.8°, at the speed of 6.0 knots. She was 1.862 nm off EPHESOS port bow and relative bearing from EPHESOS port bow was approximately 15°. As per ECDIS plotted data, CPA was recorded at 0.144 nm with TCPA 05:55 minutes while the BCR indicated -0.903 nm, denoting that a cross heading situation was not anticipated.

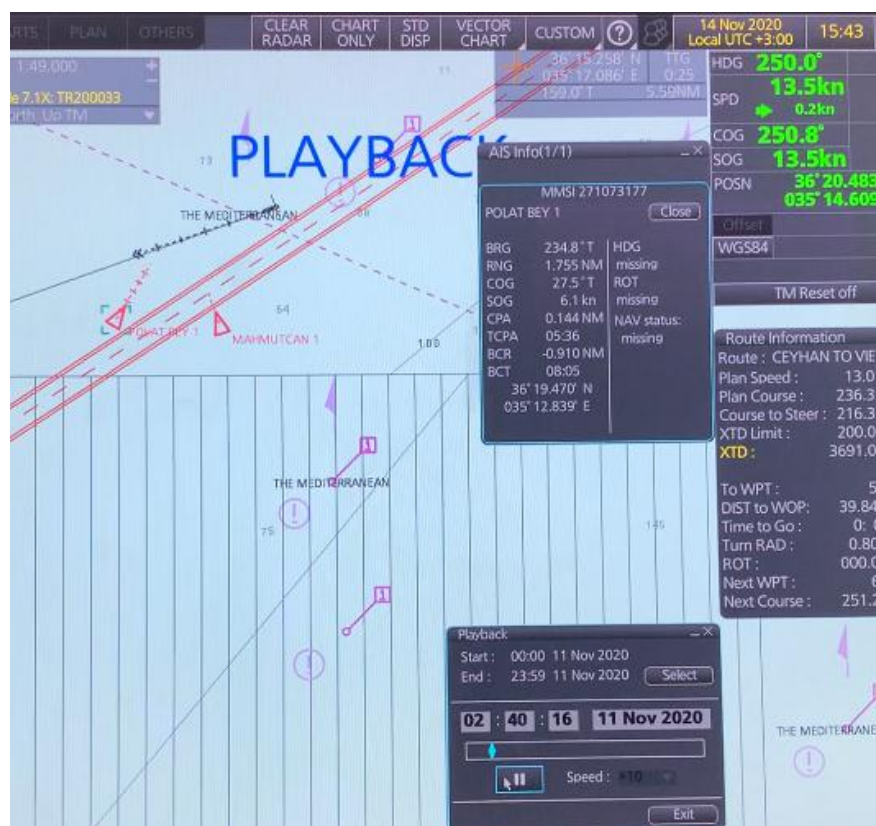
At 05:40:16 (see below **Figure 36**) POLAT BEY 1 was recorded to have altered her course to port, heading at 027.5°. The new course was almost 10° to port from the course at 05:37:56. She was 1.755 nm off EPHESOS port bow at about 13° to port.

- As per ECDIS plotted data, CPA was remained the same at 0.144 nm. TCPA was 05:36 minutes while BCR was -0.910 nm.
- MAHMUTCAN 1 was about 1.1 nm off EPHESOS port bow under course alternation to starboard. Her speed was close to 4 knots (as per her vector indication) and the distance between her and POLAT BEY was about 0.8 nm.

Figure 36: ECDIS data at 05:40:16. CPA: 0.144 nm; TCPA: 05:36; BCR: -0.910 nm.

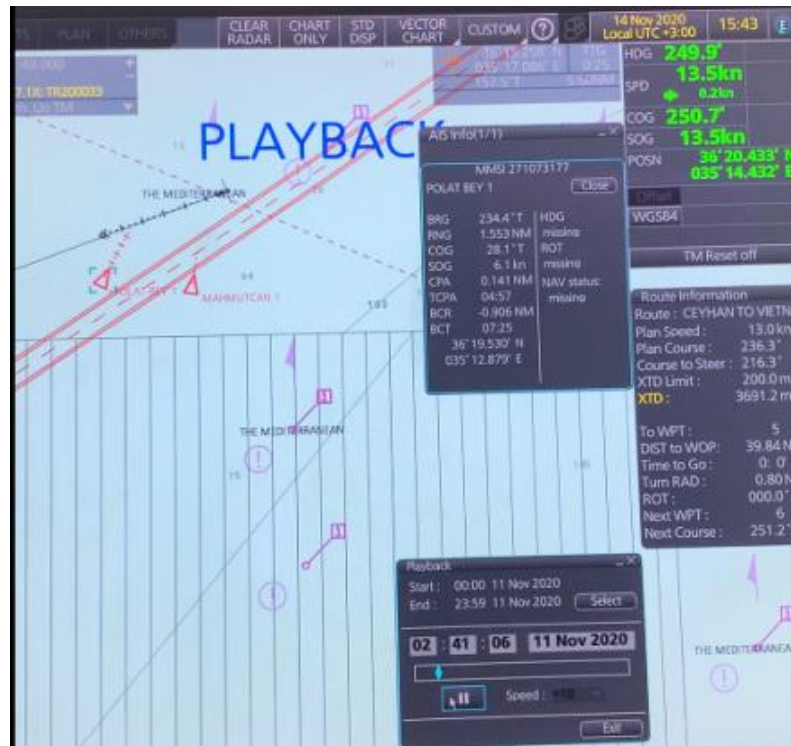
- EPHESOS was navigating with heading 249.9° (COG 250.7°) and SOG of 13.5 knots.
- MAHMUTCAN 1 was about 1.1 nm off EPHESOS bow under course alternation to starboard. She was about to complete a 360° maneuver with speed close to 4 knots (as per her vector indication). The 360° maneuver was resulting in position almost 50° abeam of EPHESOS port side.

- c) POLAT BEY 1 was recorded to sail with course 028.1° and speed of 6.1 knots. She was 1.553 nm off EPHESOS port bow at about 15° to port; CPA was 0.141 nm and TCPA 04:47 minutes. BCR was recorded to 0.906 nm.

Figure 37: ECDIS data at 05:41:06. CPA: 0.141 nm; TCPA:04:57; BCR: -0.906 nm

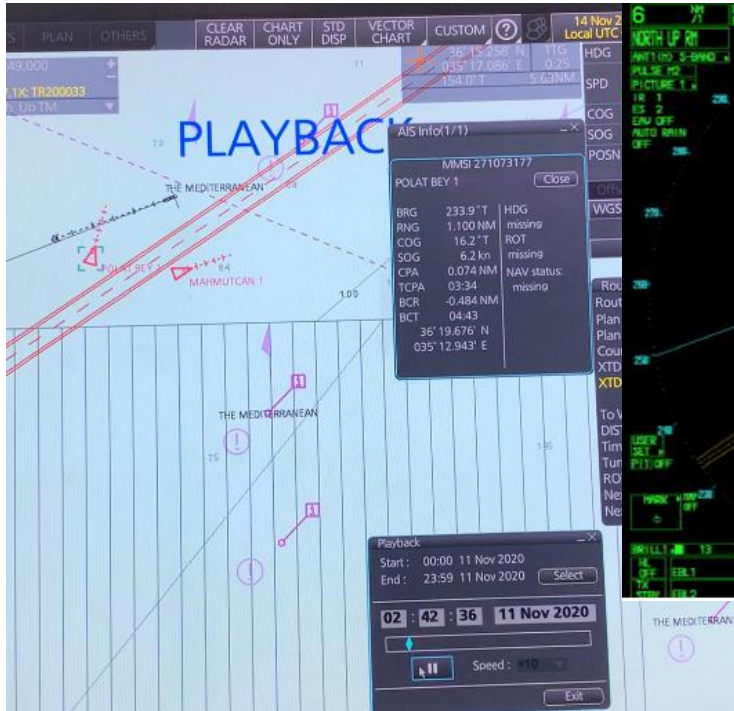
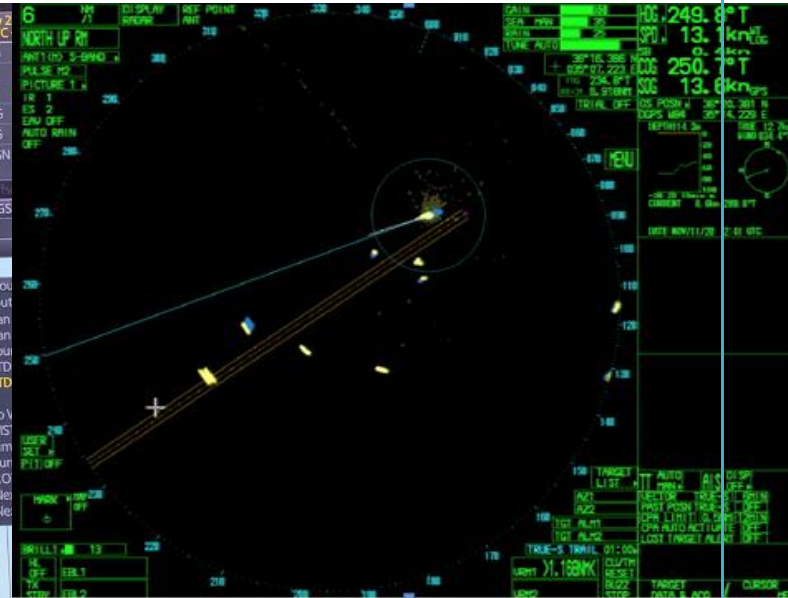
- EPHESOS was navigating at 249.5° (COG 250.8°) and SOG of 13.6 knots.
- MAHMUTCAN 1 had completed the 360° maneuver to starboard (bold alternation) and was recorded to head at approximately 080°. She was about 01 nm abeam of EPHESOS port side. Her bearing from EPHESOS was 75° to 80° to port, as estimated from her vector indication. She had increased her speed close to 6 knots (as per her vector’s indication). The distance from POLAT BEY 1 was estimated to about 0.7 nm.
- POLAT BEY 1 heading was recorded at 016.2°. Her course had altered within 30 seconds by almost 10° to port in relation to her previous course 027.5°. She was

running at 6.2 knots and her distance from EPHESES bow was 1.051 nm. Bearing was about 15° to port, CPA 0.074 nm and TCPA 03:34 min. BCR was recorded at -0.484 nm.

Figure 38: ECDIS data at 05:42:36 **Figure 39:** APRA recording at 05:42
CPA:0.071 nm; TCPA:03:25 min; BCR: -0.484 nm

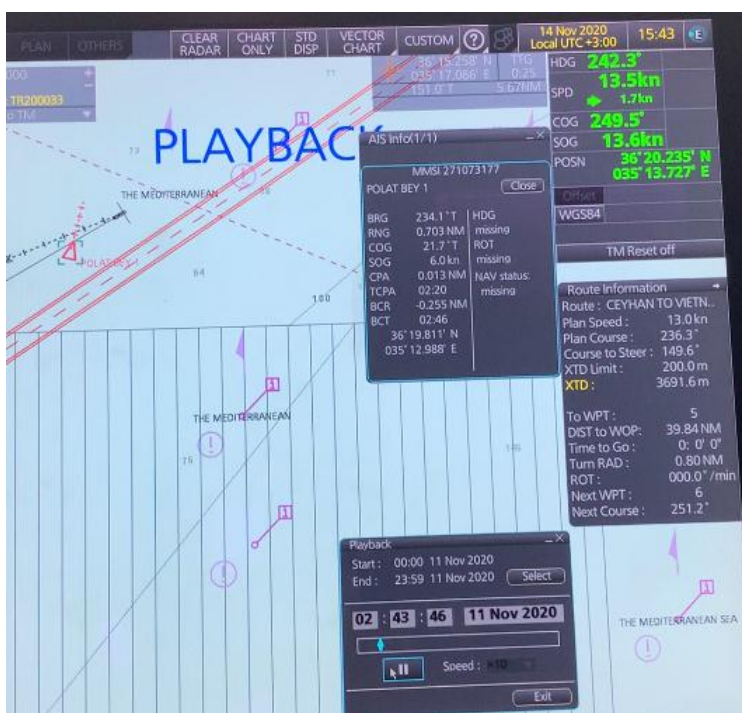
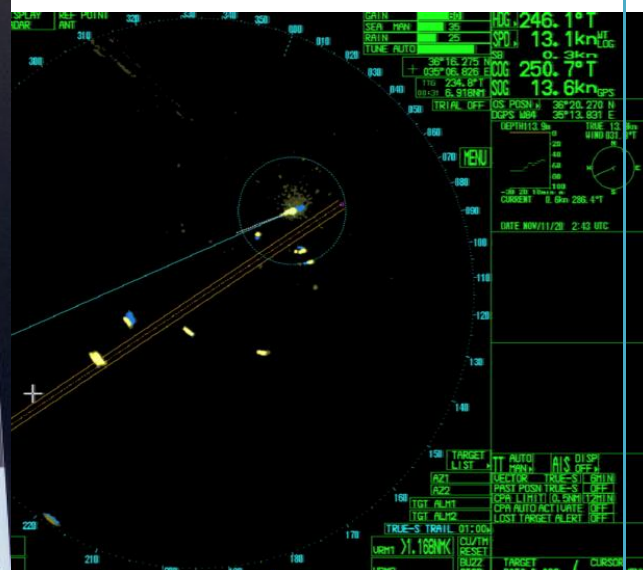
- EPHESOS course was altering to port, recorded at COG 242.3°. SOG to 13.5 knots.
- MAHMUTCAN 1 was recorded turning to starboard and navigating to approximately 170° maintaining a speed of approximately 6 knots, as per her vector indication length that is almost equal in length with POLAT BEY vector’s indication.
- POLAT BEY was sailing at 021.7°, about 5° to starboard from previous course. Speed was at 6 knots. Her distance from EPHESOS was reduced to 0.703nm and bearing was close to 5° to port. CPA was 0.013 nm and TCPA 02:20. The Bow Crossing Range indicator recorded to - 0.255nm.

At that time, POLAT BEY 1 was approximately 1 nm off MAHMUTCAN 1 starboard quarter, which was heading SSE.

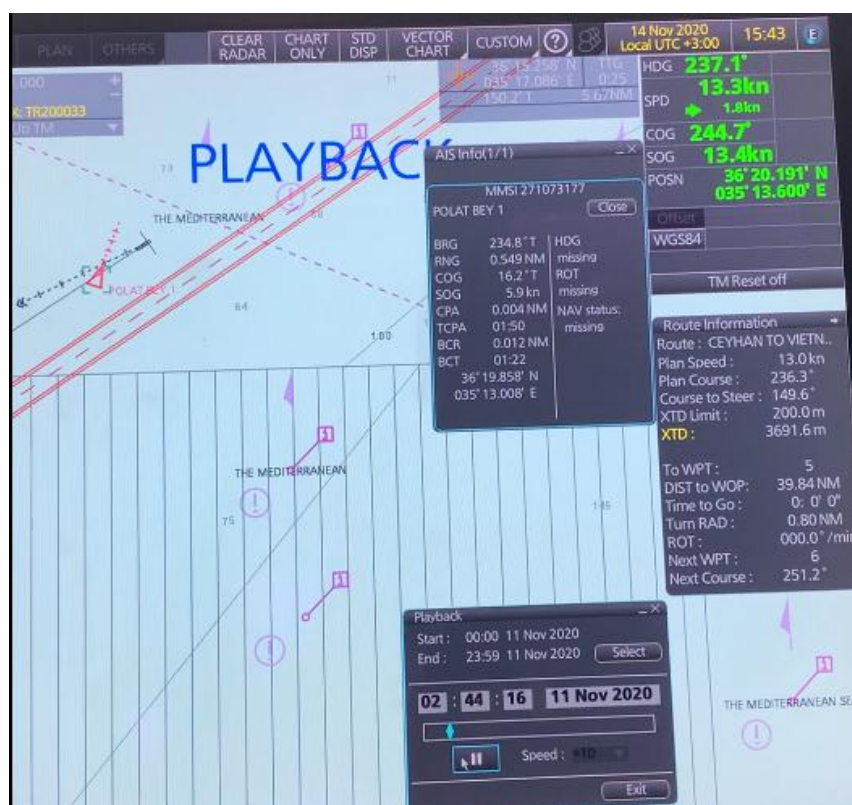
- a) EPHESES was altering her course by 15° to port. Her heading was recorded at 237.1° (COG 244.7°) and speed at 13.3 knots. POLAT BEY 1 was navigating 0.549 nm off her bow with course at 016.2° and speed at 5.9 knots.
- b) POLAT BEY 1 was heading at 016.2°. Her course had been altered to port by approximately 5° in relation to the course recorded at 05:43:46 (see **Figure 44**). CPA was reduced to 0.004 nm and TCPA to 01:50. BCR was recorded to 0.012 nm and Bow Crossing time (BCT) was captioned at 01:22 minutes, as POLAT BEY was about to cross the heading of EPHESES.

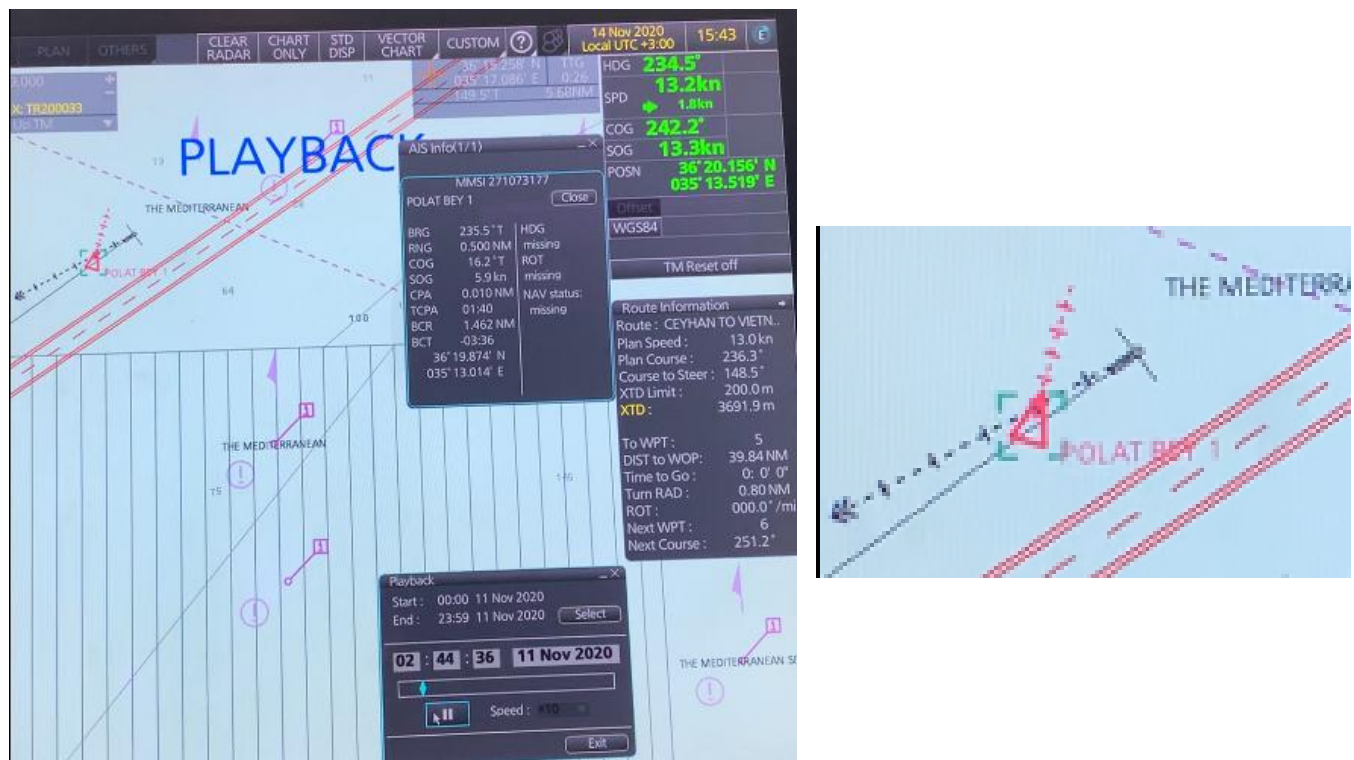
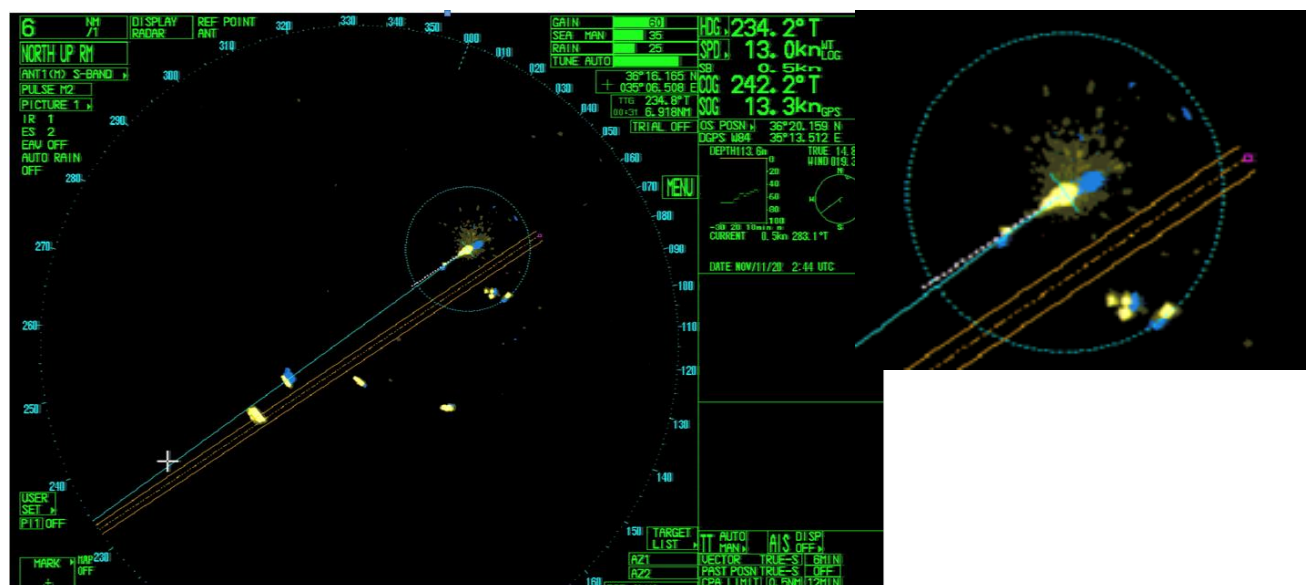
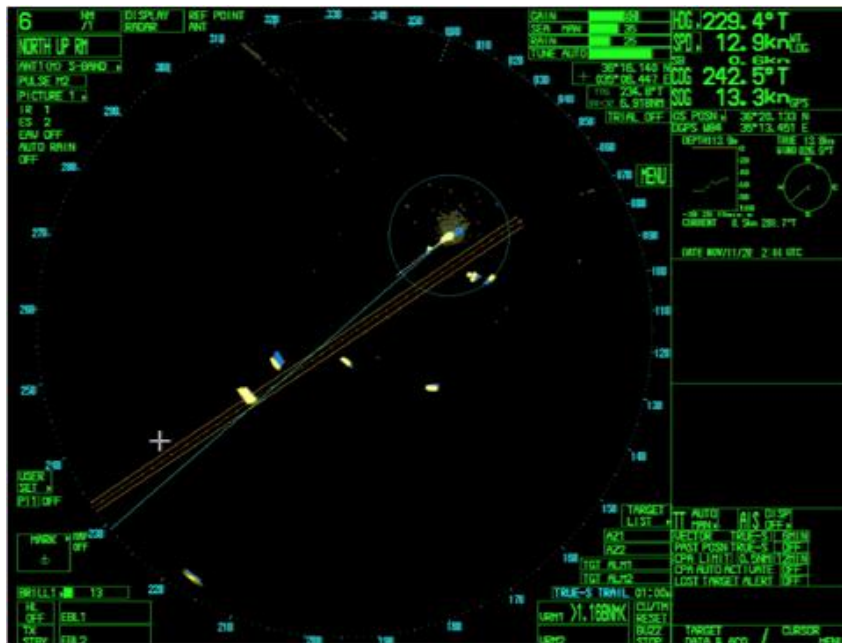
- a) EPHESES course was altering to port, captured at 234.5° (COG 242.2°) and SOG of 13.2.
- b) POLAT BEY 1 was navigating at 16.2° with speed 5.9 knots. She was 0.500 nm (926m) off EPHESES stem post. CPA was recorded at 0.010, BCR at 1.462 nm and BCT -03:36 min.
- c) Due to the fact that EPHESES was turning to port by setting the rudder “20° to port” and POLAT BEY 1 had crossed her heading and had passed to her starboard side heading NNE, it was deduced that the “crossing situation” had been cleared (BCT is negative) and the imminent danger of collision had been avoided.

Taking into account the electronic data obtained from ECDIS and VDR as well as VTS recordings, EPHESOS was under a continuous course alteration to starboard from 05:20 until the next 15 minutes, based on the marine traffic situation in the navigating sea area to clear off the fishing vessels at her port bow that were evident not to be engaged in fishing (see **Figure 13**)⁷. At 05:25 POLAT BEY 1 was heading at an estimated course of 67⁰, that is almost a reciprocal course in relation to EPHESOS. During the development of the situation until POLAT BEY 1 crossed EPHESOS heading, at 05:44:36 (see **Figures 44, 45, 46**), she was following various courses from 067⁰ to 16.2⁰, with a speed almost to 6 knots.

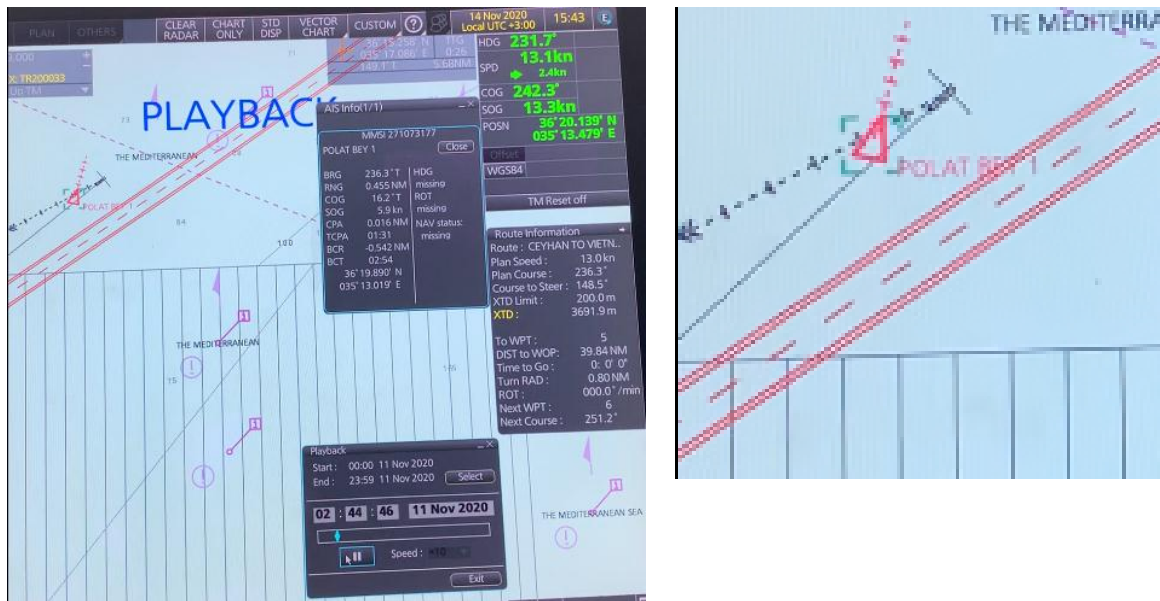
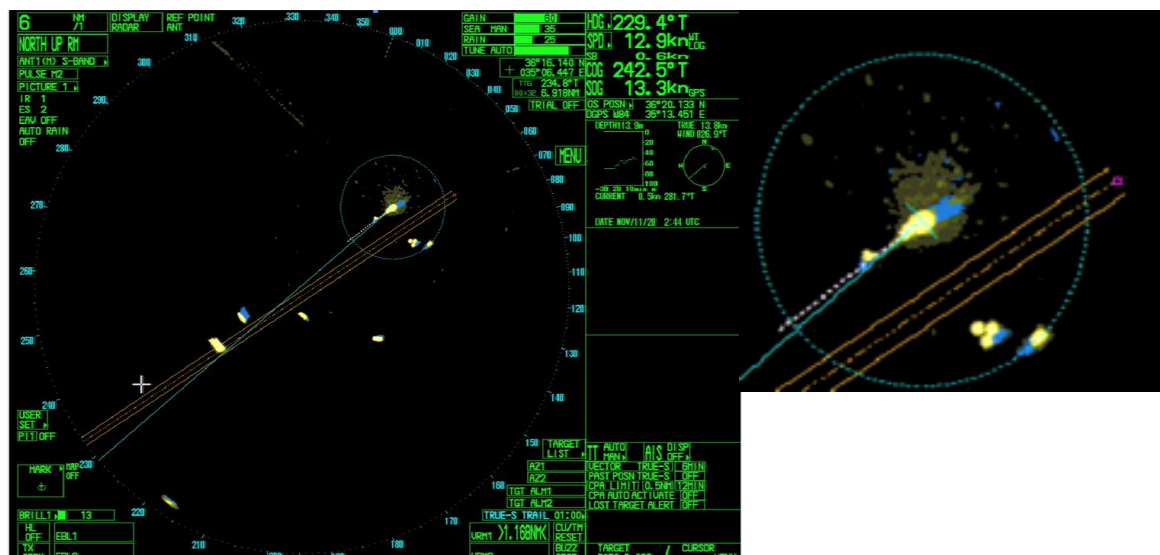
- EPHESOS rudder was set “20° to port” and she was on a continuous maneuver to port. Her heading was recorded at 231.7° (COG 242.3°) and speed 13.3 knots. Bow Crossing Range was recorded to -0.542 nm. The BCR indication denoted that the heading would not be crossed.
- POLAT BEY 1 was recorded to navigate at 16.2° under the speed of 5.9 knots. She had already passed EPHESOS stem post and was navigating clear on EPHESOS starboard bow quarter heading NNE.
- Due to the fact that EPHESOS was continuously altering her heading to port, as rudder was steel set 20° to port her projected course had been cleared off POLAT BEY 1 course.
- POLAT BEY 1 relative bearing from EPHESOS was close to 5.3° to starboard.

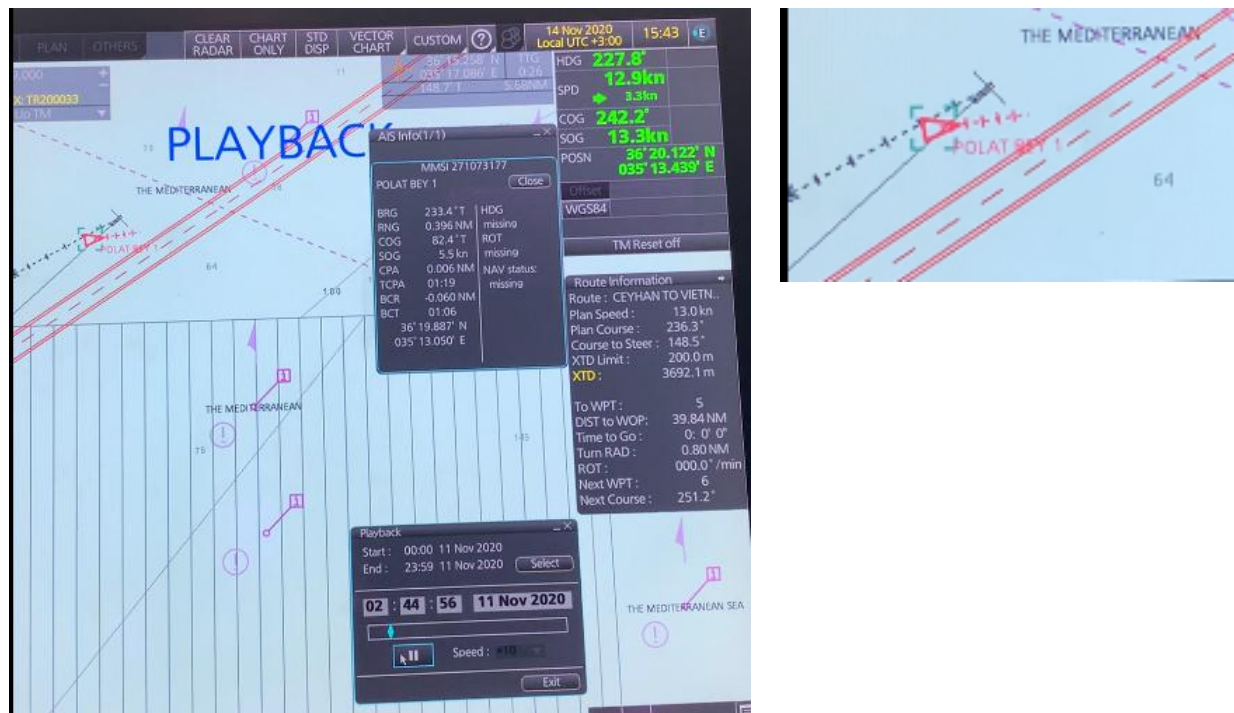
- At that time, EPHEOSOS was still altering her course to port, as rudder was set to 20° to port. Her heading was recorded at 227.8° (COG 242.2°) and SOG at 13.3 knots.
- POLAT BEY 1, having altered her course to starboard by 66.2° , was heading E with course at 82.4° and speed 5.5 knots. By that time ECDIS displayed that the distance from EPHEOSOS was 0.396 nm. Relative bearing was 5.6° to EPHEOSOS starboard bow, CPA of 0.006 nm, TCPA 01:19 minutes and BCR -0.060.

As resulted through the evidence obtained from EPHESOS VDR, the decision taken by the OOW to alter course to port to avoid the collision, given the circumstances at that time, was considered the most appropriate one as Rule 17 (c) stipulates. As it was proven it was also the most effective one, since POLAT BEY had already crossed the course of EPHESOS at 05:44:46, that was under collision avoidance maneuvering to port by 20° rudder set (see **Figures 47, 48**). It was also derived that EPHESOS maneuvering to port, were large enough and in ample time according to Rule 8(e). EPHESOS maneuvering to port gave sea room and allowed POLAT BEY 1 to cross her heading despite the fact that she was the “stand on” vessel. EPHESOS course was captured at 231.7° (COG 242.3°) and speed 13.3 knots. Bow Crossing Range was recorded to -0.542 nm, and the situation was cleared since POLAT BEY 1 had already passed EPHESOS stem post and was navigating clear on EPHESOS starboard bow quarter heading NNE (see **Figure 49**).

Nevertheless it became alarming again at 05:44:56 that was about 70 seconds before the collision, as per ECDIS data, due to the fact that POLAT BEY 1, unexpectedly made a large course turning to starboard by 66.2° (see **Figure 49**). It was apparent that the maneuvering actions by POLAT BEY 1 were unforeseen by the OOW and not compliant with the applicable COLREGs. Even at that time OOW counteracted and apart from the fact that he called POLAT BEY 1 on VHF and signaled with the ALDIS, ordered 30° to port, as a last action to avoid collision in compliance with Rule 17(a) (ii) and 17 (b).

At that time reducing speed could have been an option for the OOW, however due to the evolving situation and the distance between the vessels (0.396nm-as shown in Figure 49), steering maneuvering was seen as a best option to avoid collision, considering the emergency slowing down and stopping characteristics of EPHESOS. It is noted that according to EPHESOS emergency stopping characteristics with a speed of 13,6 knots in loaded condition, if the engines was set from full ahead to stop, the distance to stop would be 2nm. If the engine was set from full ahead to full astern, the stopping distance was estimated to 1.8nm.

However at 05:44:56, as recorded in ECDIS, POLAT BEY 1, despite the fact that had passed clear off EPHESOS stem post and heading, navigating at approximately 16.2° (NNE), suddenly altered her course to starboard and started heading to 82.4° (see **Figure 49**). The alteration of course to starboard side by POLAT BEY 1 after crossing EPHESOS course, instead of the port side is considered to be one of the safety factors that caused the marine casualty.

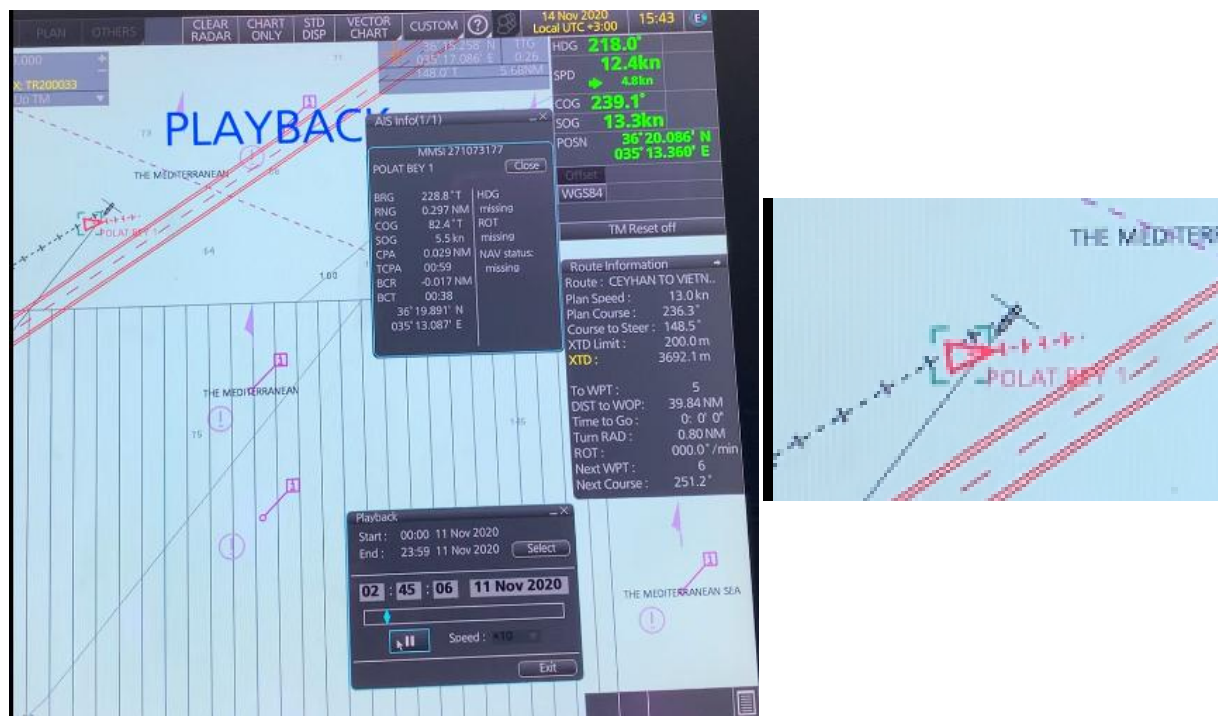
- EPHESES was under continuous maneuvering to port, as rudder was 20° to port. Her heading was recorded at 218.8° (COG 239.1 °) and SOG at 13.3 knots.
- POLAT BEY 1, was keeping the course of 82.4° running at and speed 5.5 knots. She was captured to be 0.297 nm off EPHESES bow on relative bearing 10.8° to EPHESES starboard bow, CPA at 0.029 nm, TCPA 00:59 seconds and BCR - 0.017.

- c) MAHMUTCAN 1 was recorded approximately 0.8 nm off EPHESOS port bow (correlation to VRM set at 1.168 nm); and was probably heading SSE.

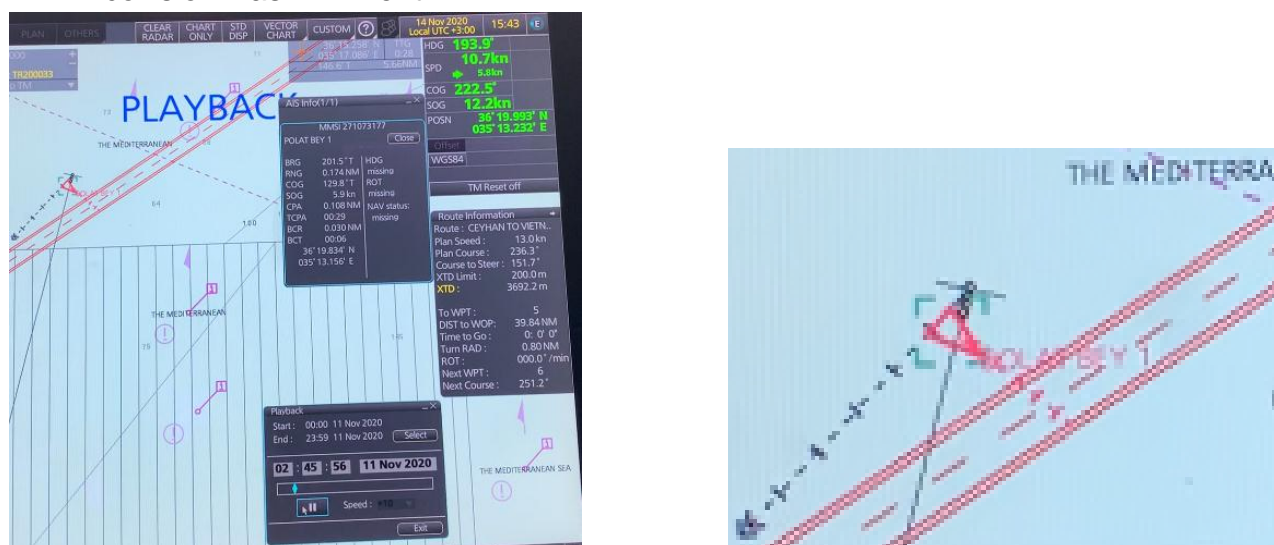
- a) EPHESES was under continuous maneuvering to port, rudder was set 30° to port. Her heading was recorded at 193.0° (COG 222.5°) and SOG at 12.2 knots (reduced due to continuous maneuver).

- b) POLAT BEY 1, was recorded to have altered her course to port by 13°. She was caught heading at 129.8° (previous heading at 116.6°, about 10 seconds before). Her speed was recorded at 5.9 knots. She was 0.174 nm off EPHESES bow; relative bearing of 7.6° to starboard of EPHESES. CPA was recorded the same 0.108 nm, TCPA 00:29, Bow Crossing Range (BCR) 0.030 nm and Bow Crossing Time (BCT) 00:06 showing that the collision was imminent.

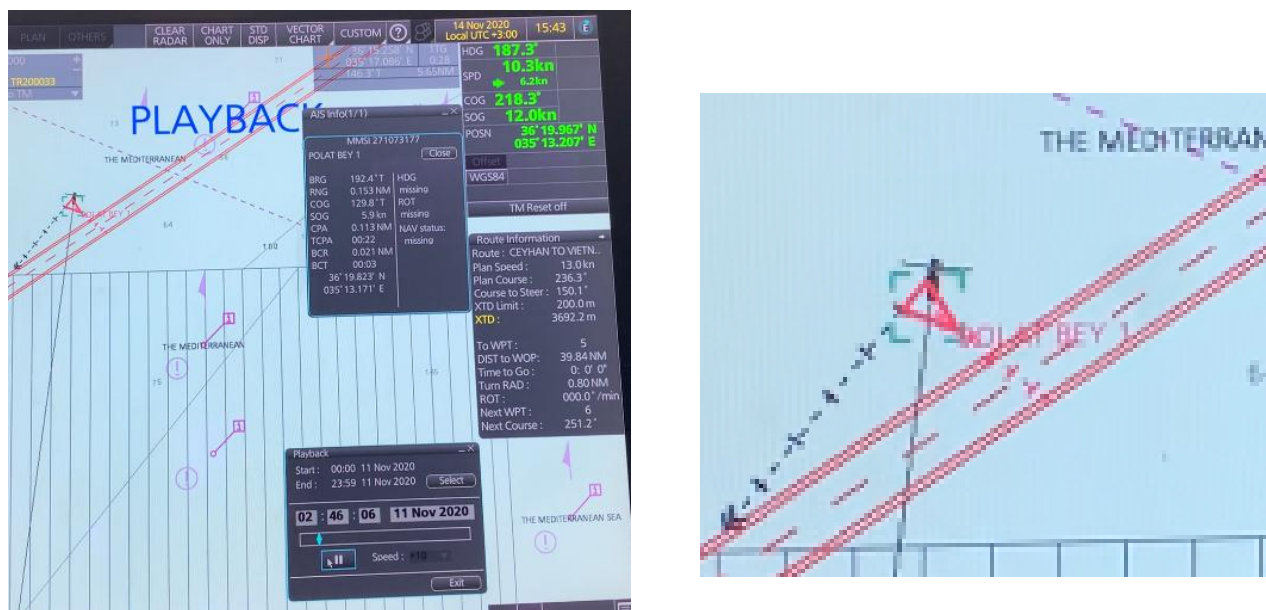
- EPHESES was under continuous maneuvering to port, rudder was set 30° to port. Her heading was recorded at 187.3° (COG 218.3°) and SOG at 12.0 knots (reduced due to continuous maneuver).
- POLAT BEY 1, was recorded to had the same course of 129.8° (as 14 seconds before) and speed 5.9 knots;

Her distance from EPHESES bow was recorded at 0.153 nm. Her relative bearing from EPHESES is estimated close to 4° to starboard. CPA was recorded the same 0.113 nm. TCPA 00:22sec, Bow Crossing Range (BCR) 0.021 nm and Bow Crossing Time (BCT) 00:03 sec. The OOW reported that he noticed the red light of the fishing vessel in front of EPHESES bow and then POLAT BEY 1 disappeared.

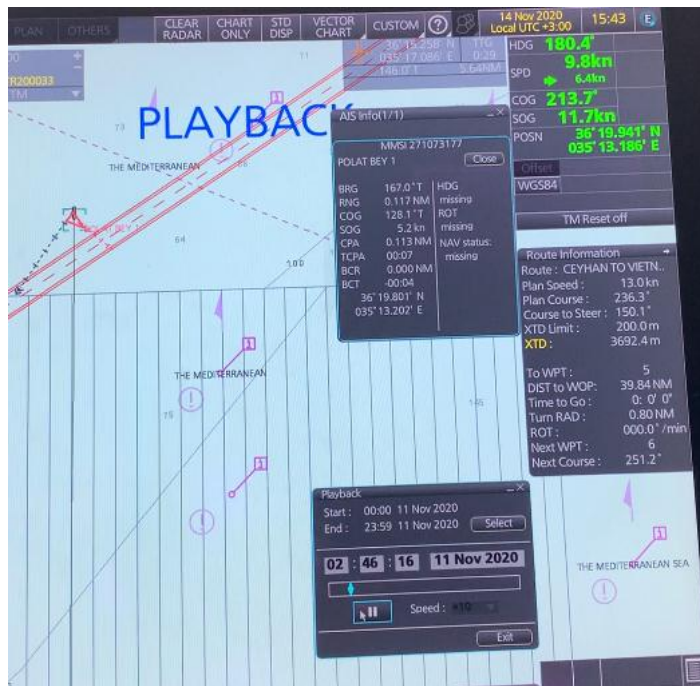
- EPHESES was still maneuvering to port, rudder was set 30° to port; her heading was recorded at 180.4° (COG 213.7°) and SOG at 11.7 knots (reduced due to continuous maneuver).
- POLAT BEY 1, was recorded to have the same course of 129.8° and speed 5.2 knots. CPA was recorded the same 0.113 nm. TCPA 00:07. Bow Crossing Range (BCR) 0.000 nm and Bow Crossing Time (BCT) -00:04 (BCR and BCT figures leads to the conclusion that the collision had occurred).

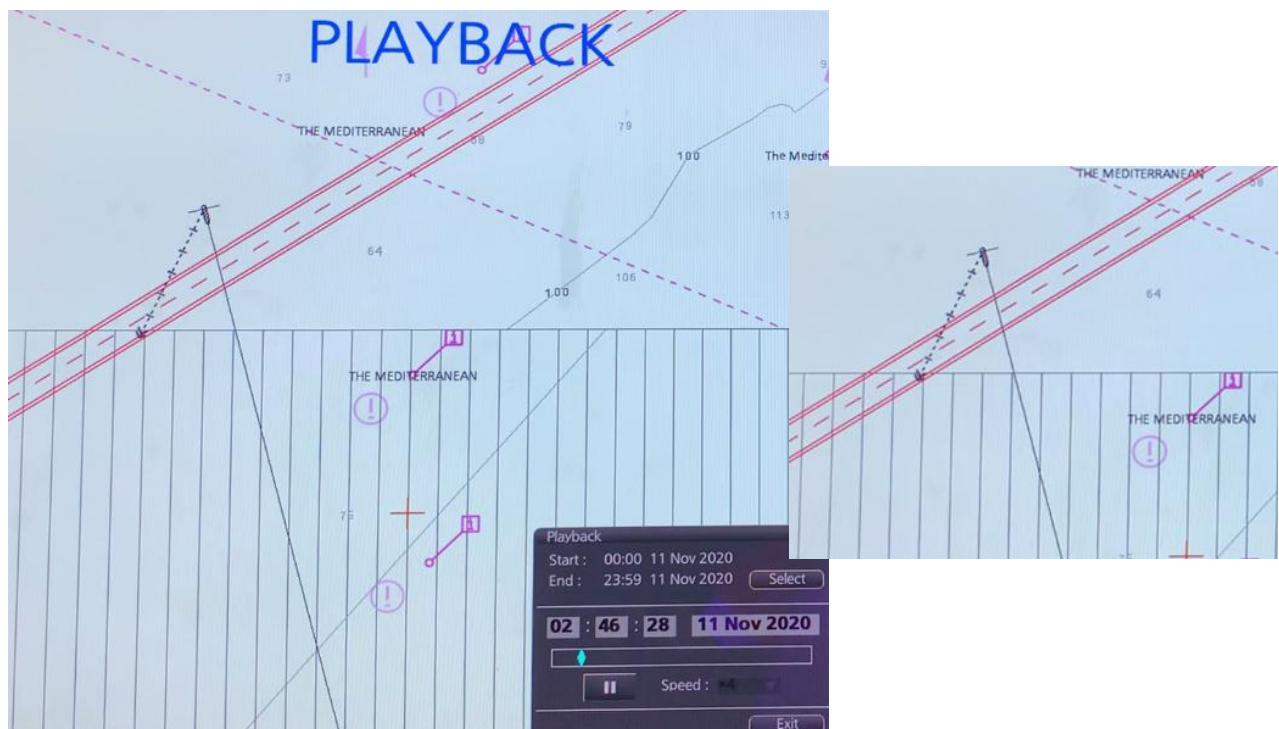
At 05:46:27 the Helmsman said: “Have fishing here Second”. It is presumed that he was referring to MAHMUTCAN 1. At 05:46:28 POLAT BEY 1 AIS and ARPA info disappeared from ECDIS display (see below **Figure 60**).
