HELLENIC REPUBLIC

**HELLENIC BUREAU FOR MARINE CASUALTIES INVESTIGATION
MARINE CASUALTY SAFETY INVESTIGATION REPORT
03/2020**

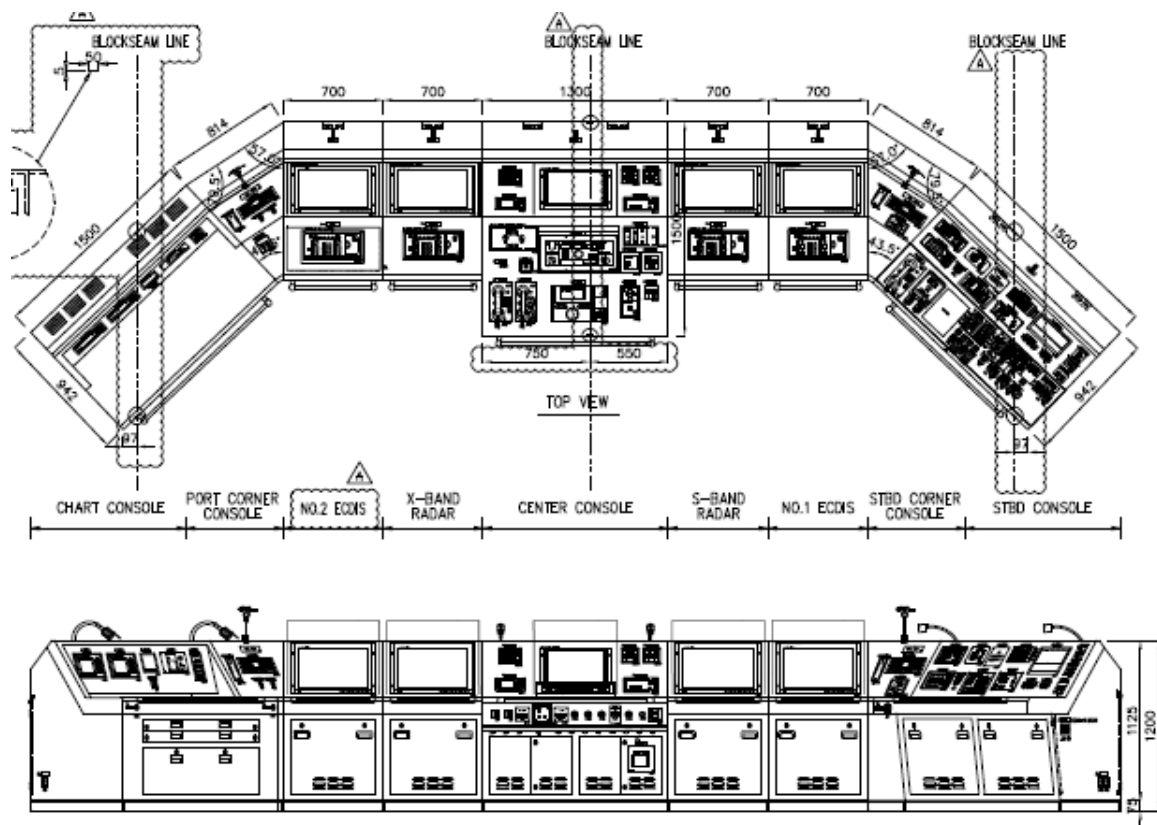
Figure 64. EPHESOS bridge arrangement.

EPHESOS bridge was also fitted with two radars. One S-Band radar (3GHz) fitted with an automatic radar plotting aid (ARPA) was mounted at the starboard of the center console and one X-Band (9 GHz) radar fitted also with ARPA was located at the port of the center console. (see **Figure 64**).

Two GPS were installed at the port corner console, next to the chart console³.

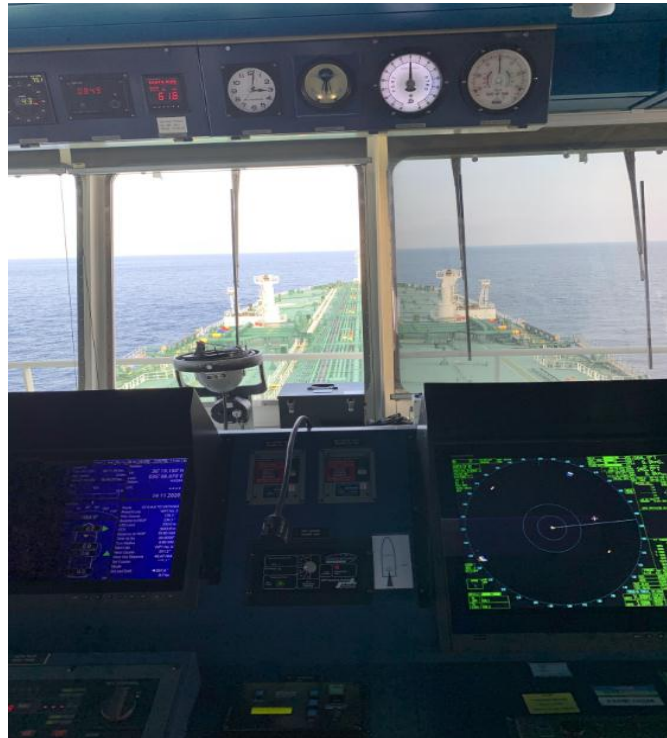
Figure 65. *EPHESOS's bridge horizontal field of vision.*

EPHESOS wheelhouse structural arrangement offered a very good horizontal field of vision from the conning position to the navigated sea area ahead (see **Figure 65**).

The OOW could maintain a very good visual contact and monitoring of head on vessels with reciprocal or crossing courses on her port bow or abeam.

In the view of the above the OOW could observe and monitor MAHMUTCAN and POLAT BEY 1 crossing courses on EPHESOS port bow at all times before the collision.
