**HELLENIC REPUBLIC  
HELLENIC BUREAU FOR MARINE CASUALTIES INVESTIGATION**

**MARINE CASUALTY SAFETY INVESTIGATION REPORT  
06/2015**

**Grounding and foundering of  
M/V Kerem S at Levitha Island, Greece.**

**May 2017**

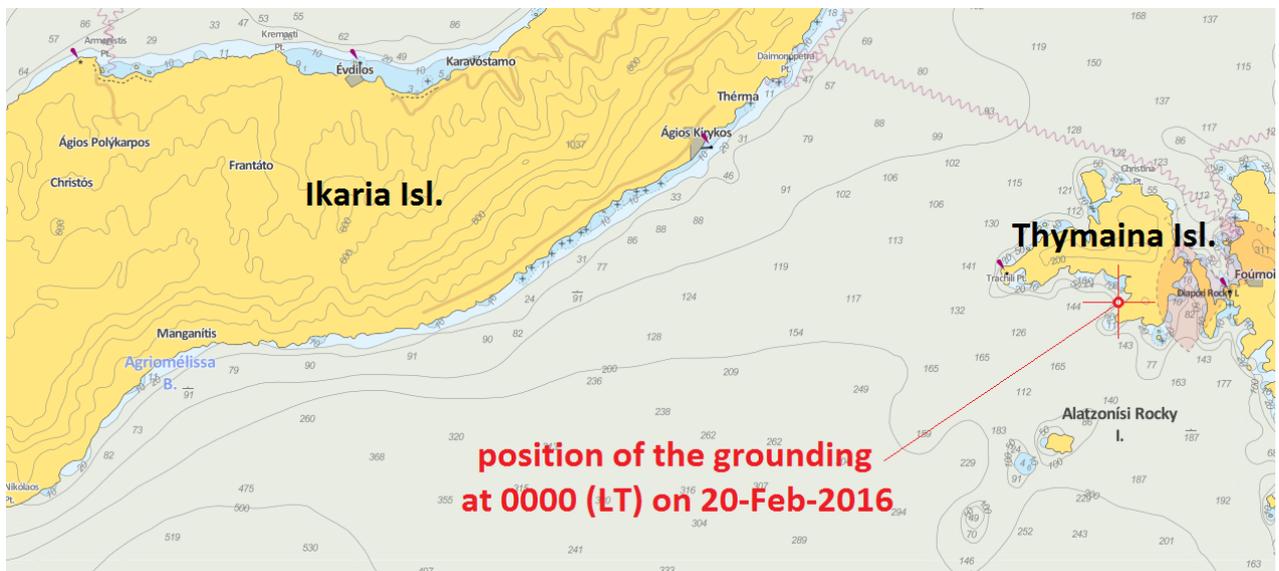
Figure 3.1/1. Extract of electronic chart HNHS<sup>2</sup> 422

After almost one hour Kerem S anchored south of Thymaina with four shackles<sup>1</sup> of chain cable paid out. The Master had estimated that with a charted depth of approximately 50m, 02 shackles would remain on the seabed to increase the anchor holding power. However, after three attempts of dropping the anchor the vessel could not hold on to it due to the high waves and the strong winds of force 7-8 Bft with gales of 9 Bft acting on the vessel's exposed freeboard. The vessel kept dragging the anchor and drifting towards the coast where she grounded with her stern starboard side (**Figure 3.1/1**).

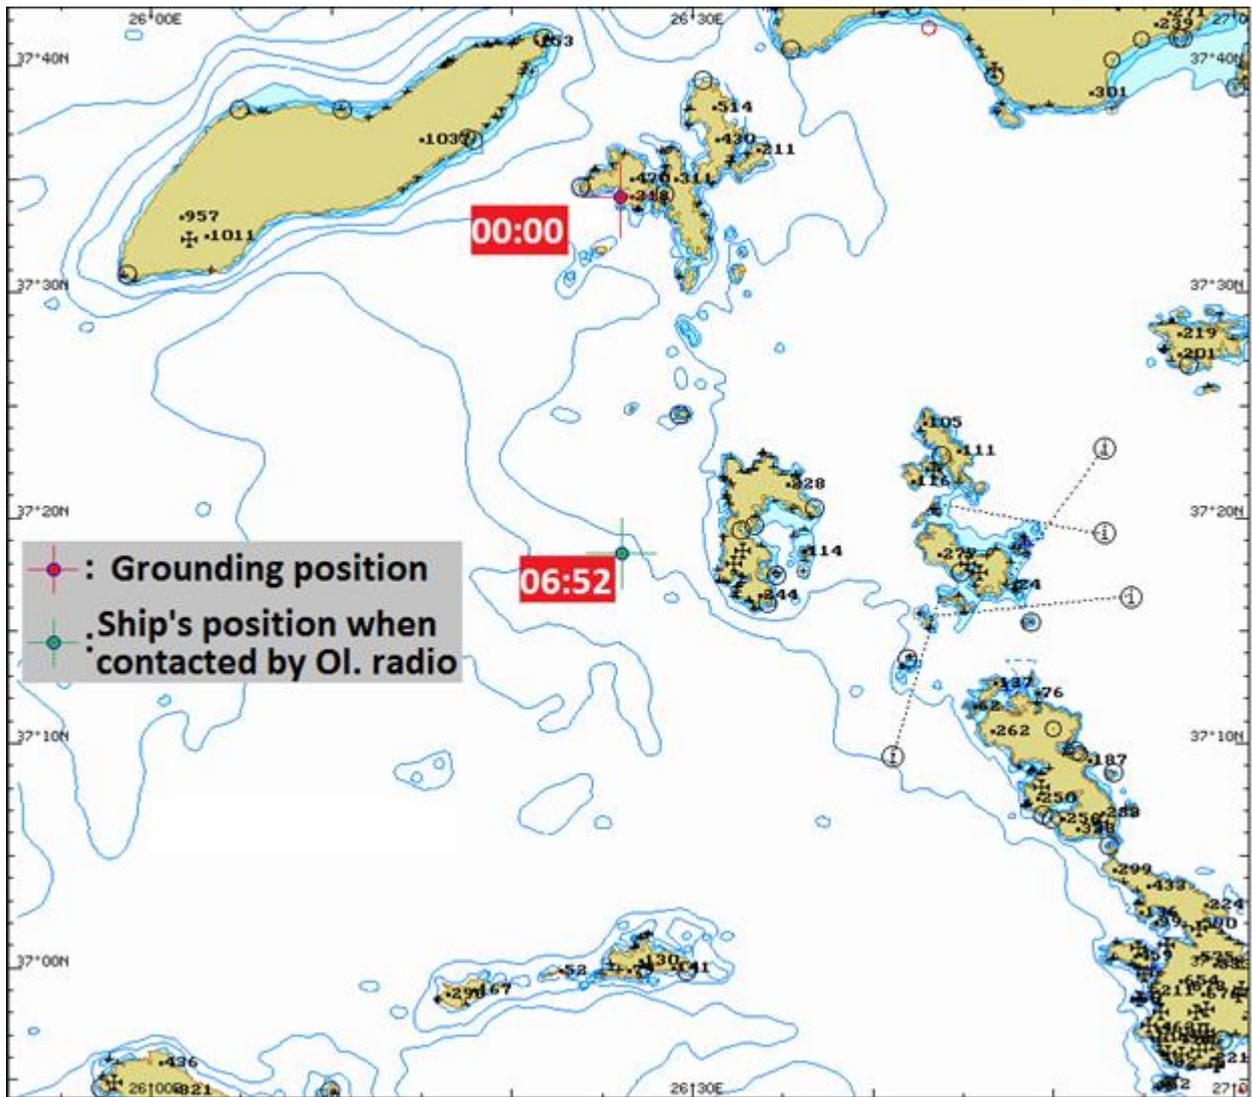
Figure 3.3/2. The position of Kerem S at 06:52 when Olympia Radio called her on the VHF.

At 06:52, almost 07 hrs after the casualty and while Kerem S was drifting west of Patmos island 15 nm south of the grounding position (**Figure 3.3/2**), Olympia Radio station called Kerem S via VHF and only then her Master reported that the ship was drifting not under command due to a mechanical failure. However, he did not provide any details regarding the actual condition of the ship and the sustained damages after the grounding and did not request any kind of assistance. Olympia Radio station reported the incident to Piraeus JRCC and a Pan Pan radio message was transmitted as appropriate.

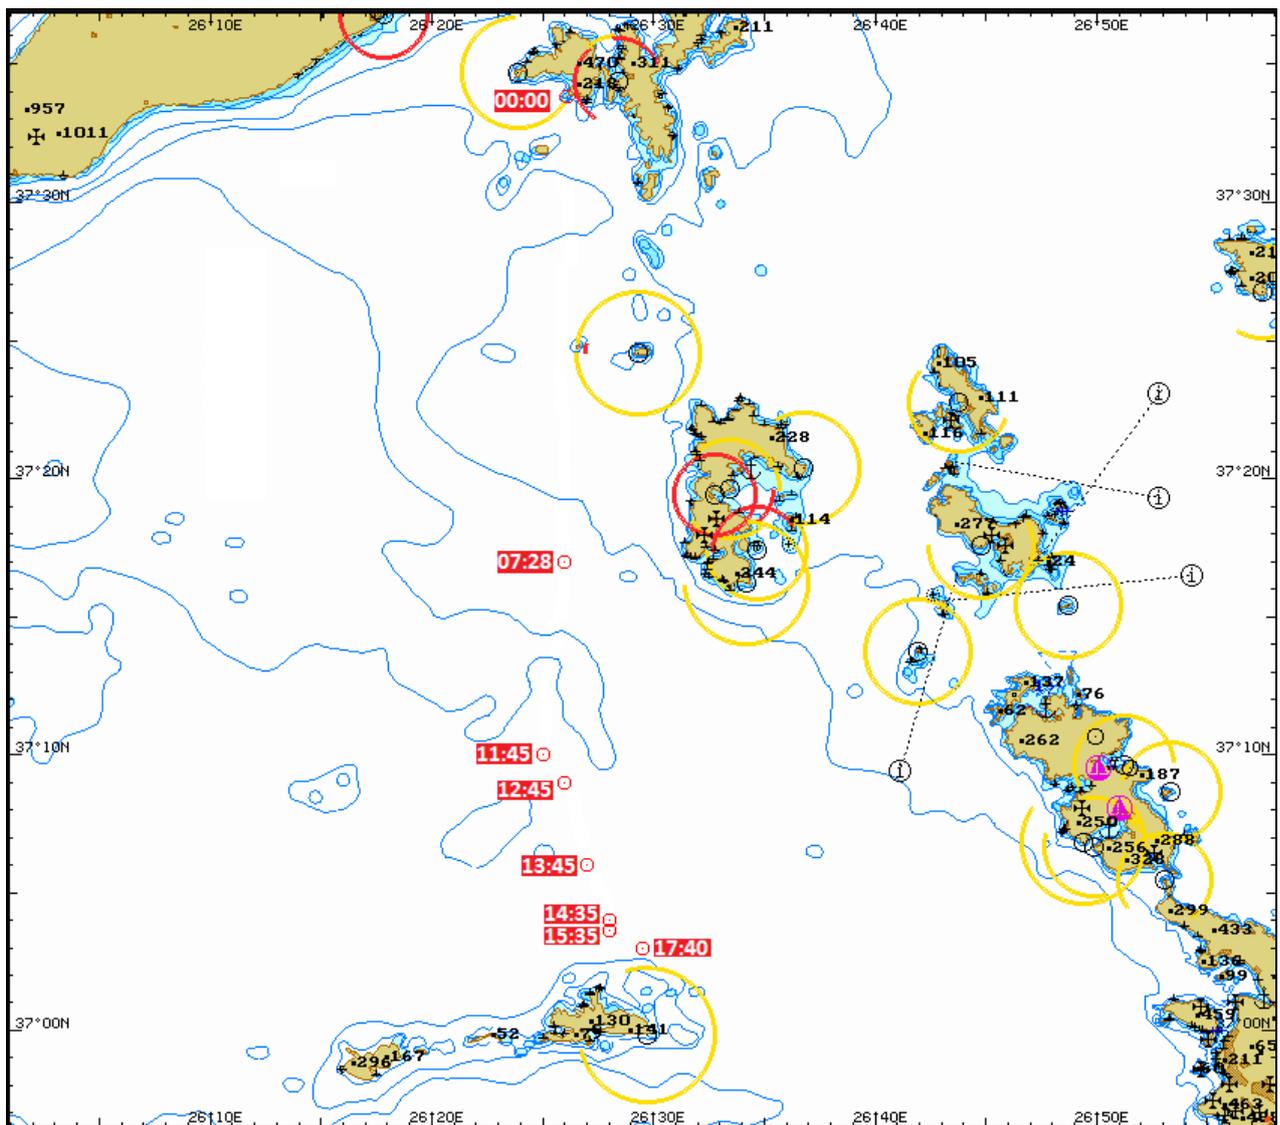
**Figure 3.3/3.** The positions of Kerem S while drifting, as monitored by JRCC Piraeus from 07:28 until 17:40.

At 11:05 the HCG SAR vessel arrived at the area and spotted Kerem S. The Master was reporting her position to Piraeus JRCC and her positioning during her drifting is depicted in **Figure 3.3/3**.

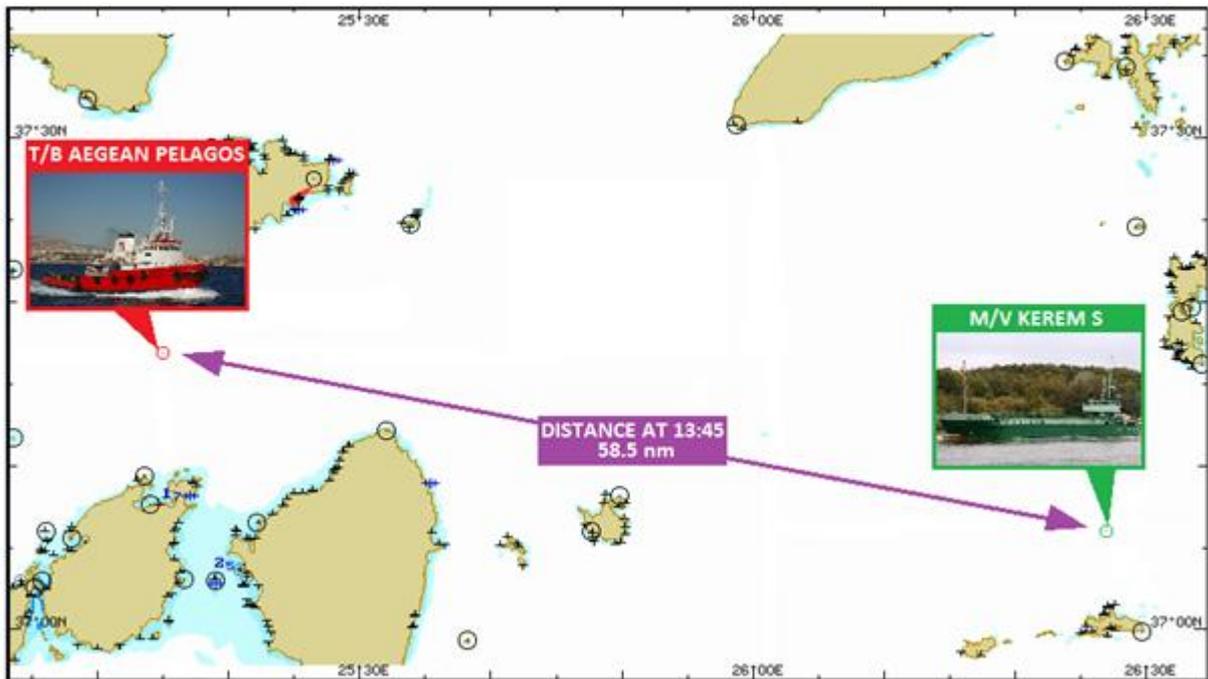
**Figure 3.3/4.** The distance between Kerem S and T/B Aegeon Pelagos at 13:45.

At 13:45 Kerem S was approximately 5.5 nm north of Levitha island drifting southerly at a speed of 1.5 - 2 knots and a course of  $162^{\circ}$ , whereas tug Aegeon Pelagos was more than 58 nm away sailing at a speed of 12 knots, and it was expected to arrive at the area approximately after almost 05 hrs (**Figure 3.3/4**).

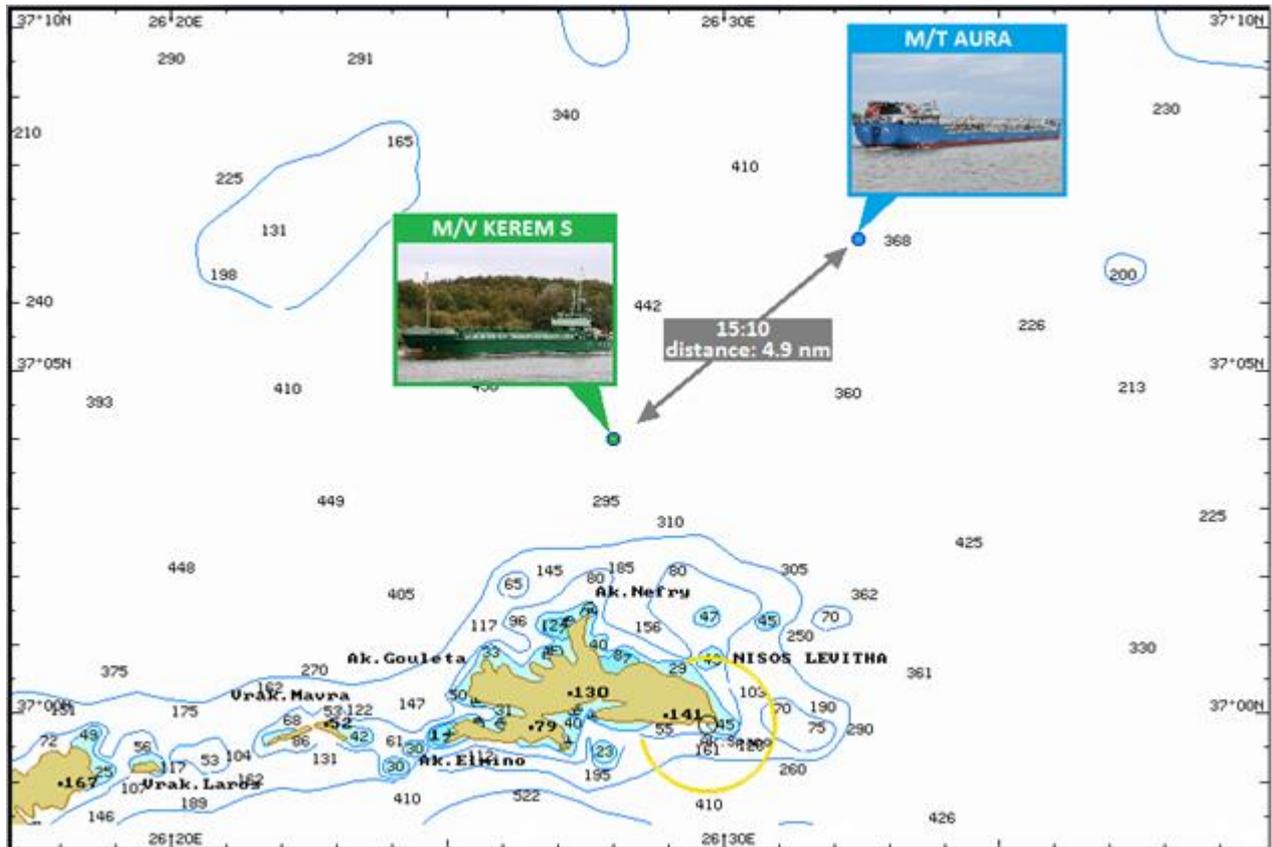
Figure 3.3/5. The distance between M/V Kerem S and M/T Aura at 1510.

At 15:05 Piraeus JRCC contacted with the Russian flagged M/T Aura that was sailing in the area so as to be engaged in case of emergency. At 15:10 M/T Aura contacted with the Master of Kerem S who stated once more that there was no need of assistance. At that time the distance of the two ships was approximately 4.9 nm as shown in **Figure 3.3/5**.

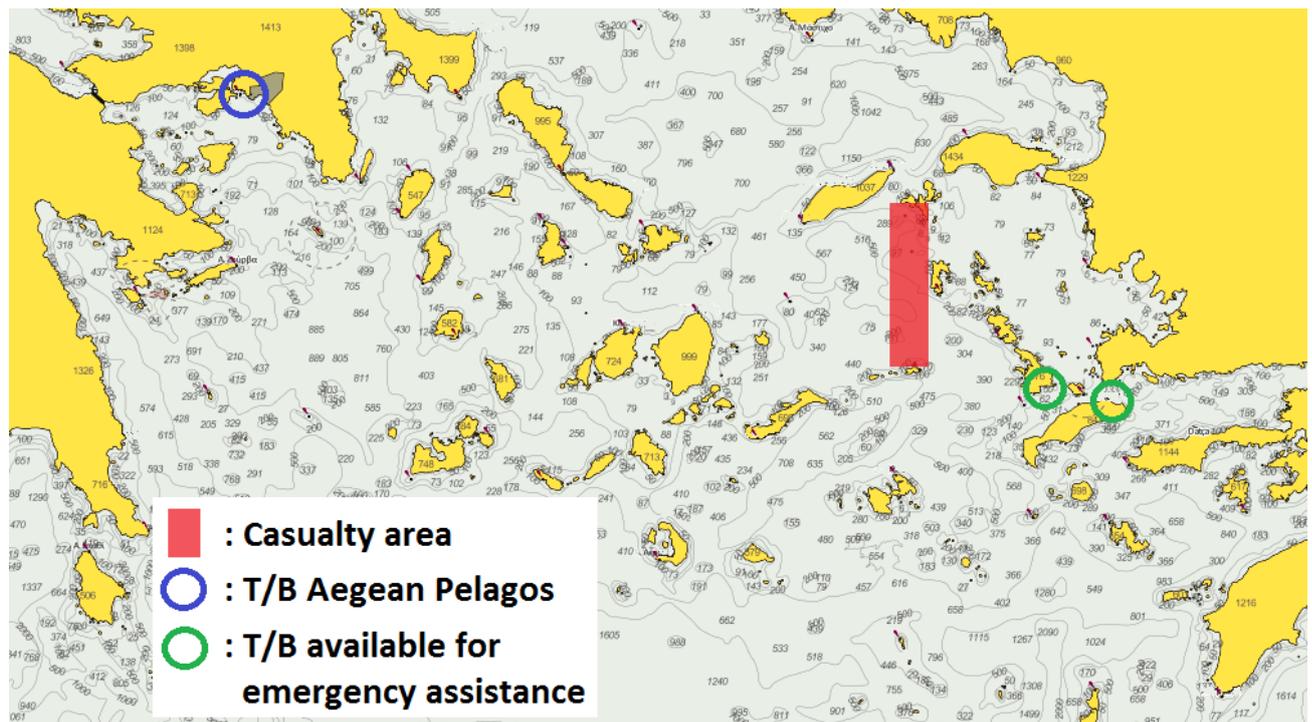
**Figure 4.4.2/1.** Overview of the positions of the available Tugboats for emergency assistance.

Considering the available time for the search of a competent tugboat from 01:00 when the Company was firstly alerted by the Master regarding the first grounding and the emergency situation, until the grounding at Levitha, as well as the estimated 14 hours that Kerem S would be drifting not under command into an area with scattered islands, it is inferred that no proper assessment of the emergency situation was conducted by the Company's Emergency Response Team during the casualty.
