INTERIM REPORT

MARINE CASUALTY SAFETY INVESTIGATION

FATAL INJURY OF A CREW MEMBER ON BOARD RO/PAX "AF-CLAUDIA "

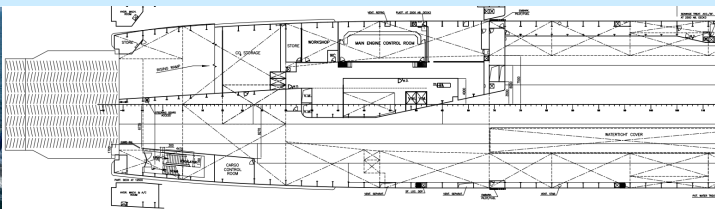
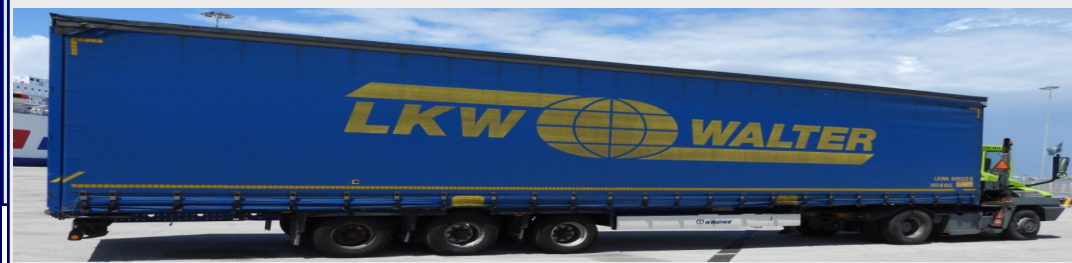
AF CLAUDIA Stern section of Deck 3

At approximately 00:38 hours, the casualty entered in Deck 3 garage space from the port side door situated at the middle of the deck in order to go ashore as the vessel would stay overnight in Patras port. At that time Deck 3 was completely empty. She walked in the garage space and stopped when she stepped onto the stern ramp. At that time the tugmaster tractor connected with a semi-trailer was moving in reverse from Deck 1 towards the exit, without guidance from deck crew involved to the uploading operation. The driver did not notice the crewmember who was on the stern ramp as she was standing in the blind sector of the vehicle's mirrors and was not visible. As a result, the truck struck and ran over the crewmember. The casualty was noticed by a Deck Officer who notified the Master. The local Authorities were notified and at approximately 02:00 hours her death was confirmed by the coroner who arrived on scene.
