Panama Maritime Authority
Directorate General of Merchant Marine
Maritime Affairs Investigation Department

M/V “NEW DIAMOND”

R-023-2021-DIAM

“EXPLOSION IN ENGINE ROOM”

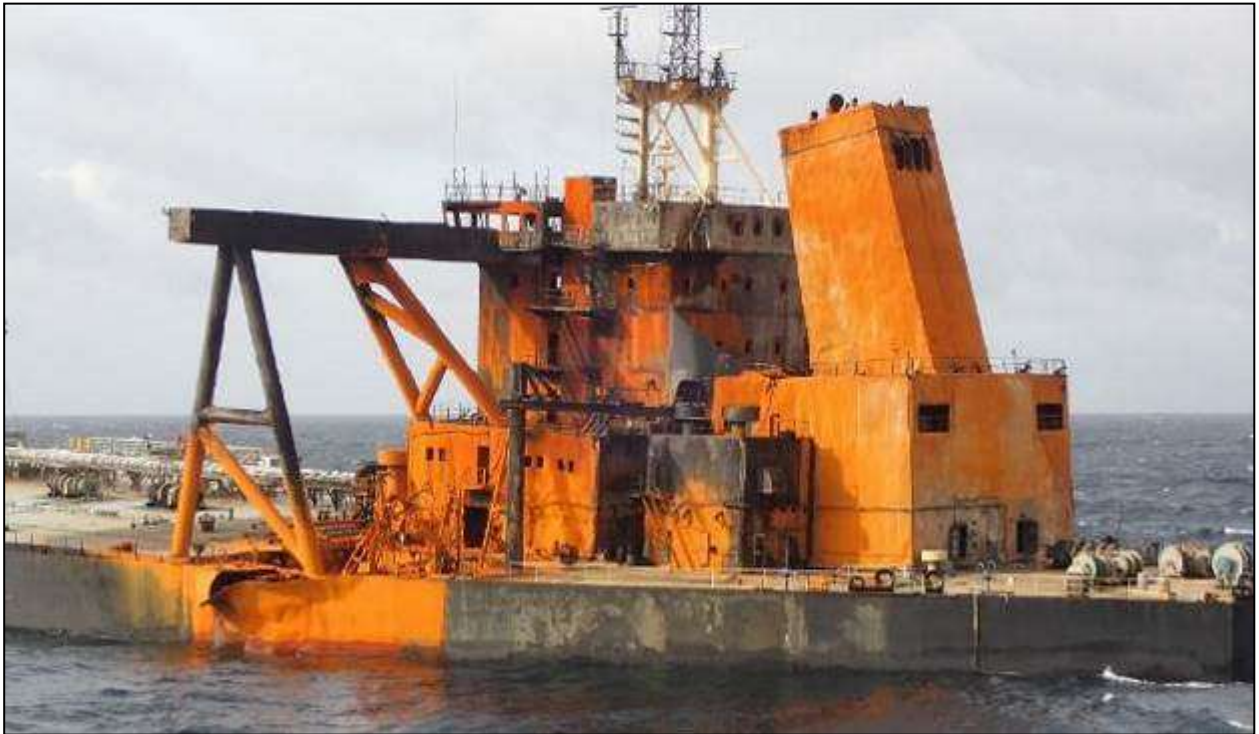
Port Quarter View

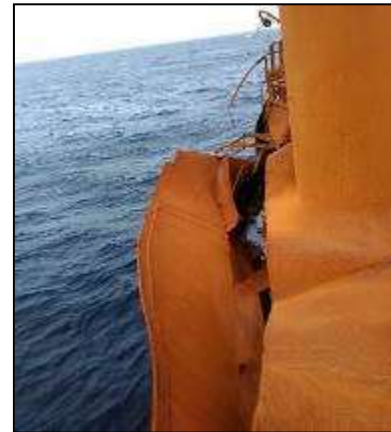
**Port side slop tank ship shell view
from aft looking forward**

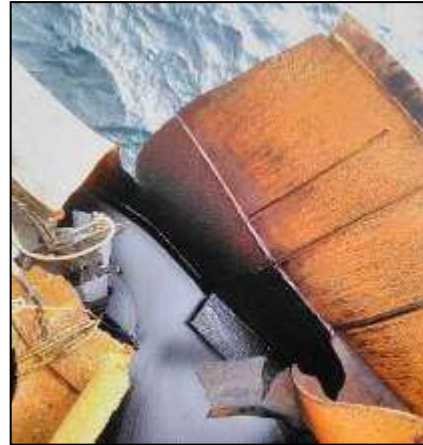
**STBD side shell ribbed from the deck down
at the forward edge of STBD tank no 2**

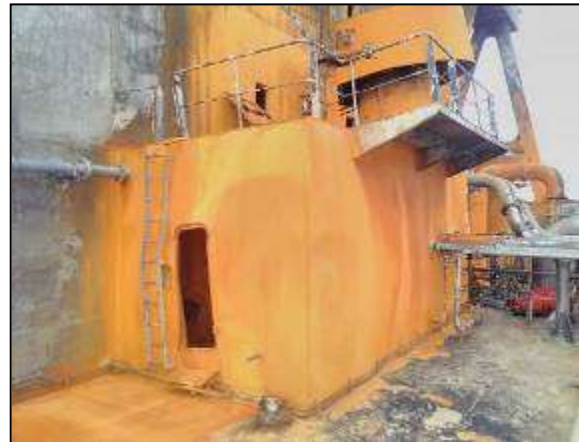
STBD side Pump Room entrance

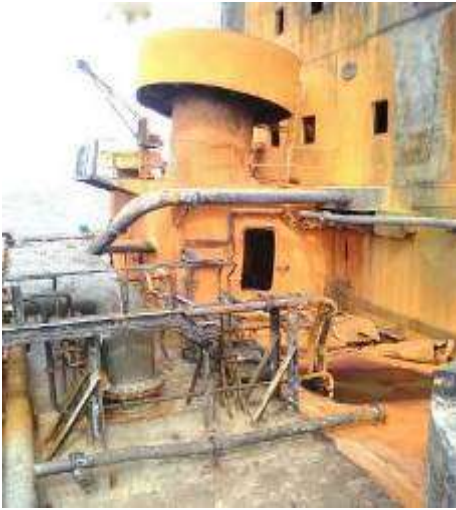
Port side Pump Room entrance

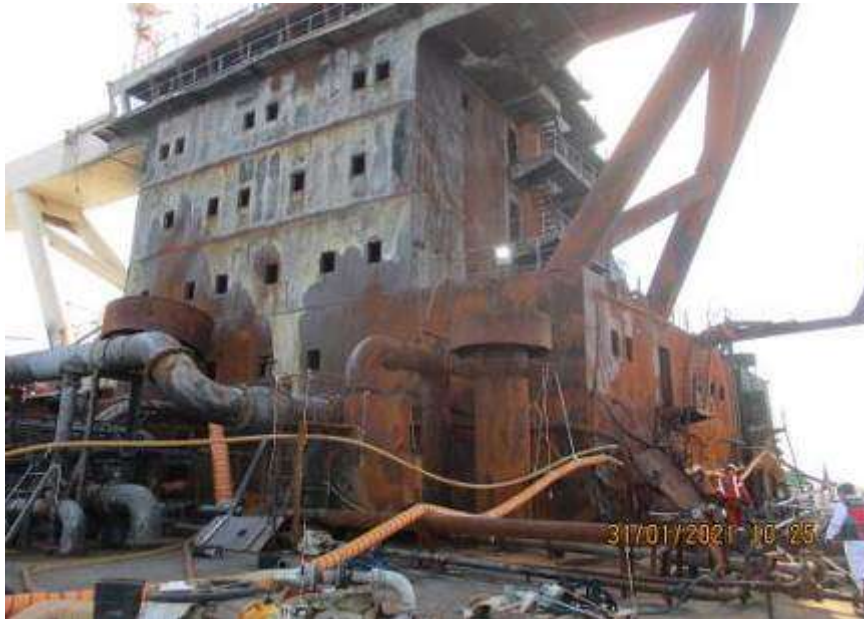
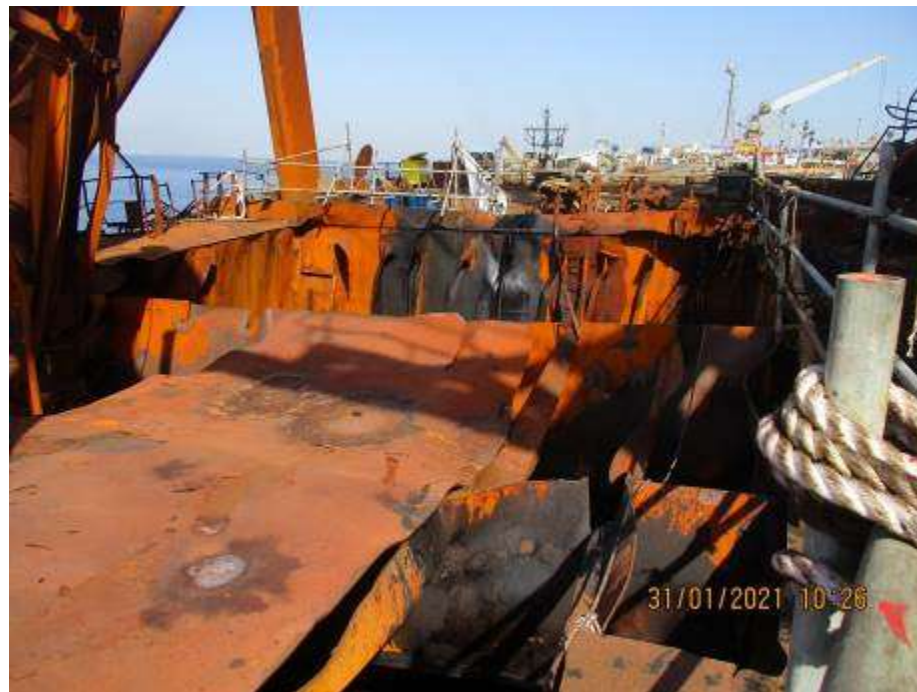
View from Port Side – F/O tanks

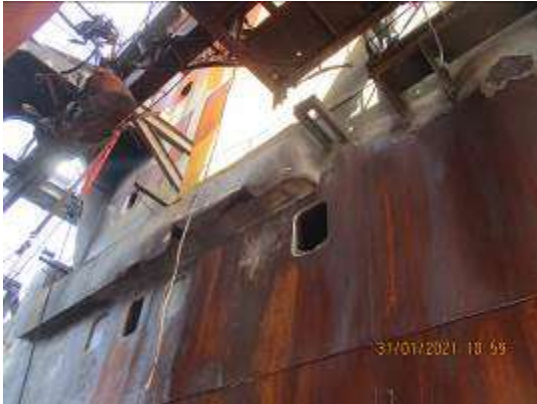
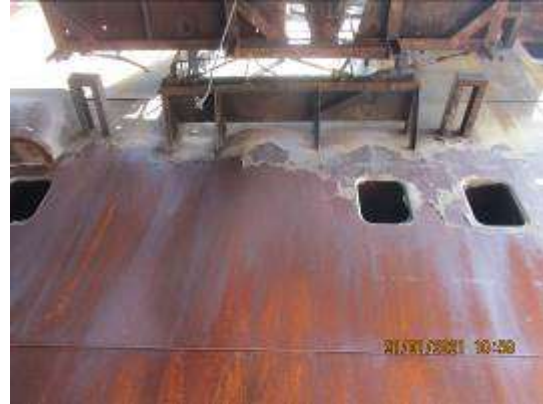
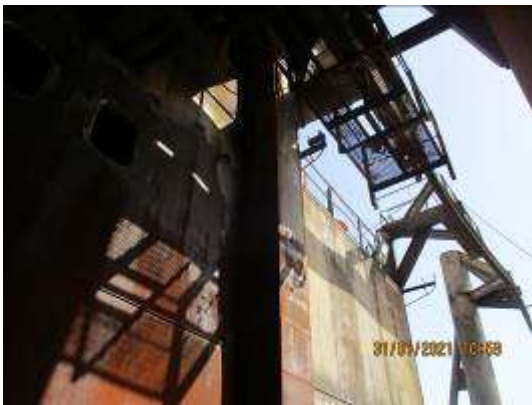
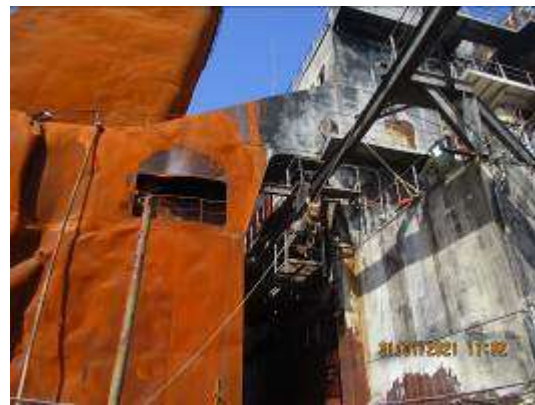
Broken and burnt out port holes on accommodation aft bulkhead and area around gantry crane above E/R sky light

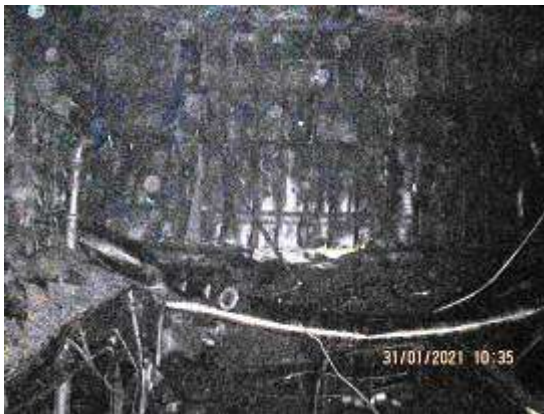
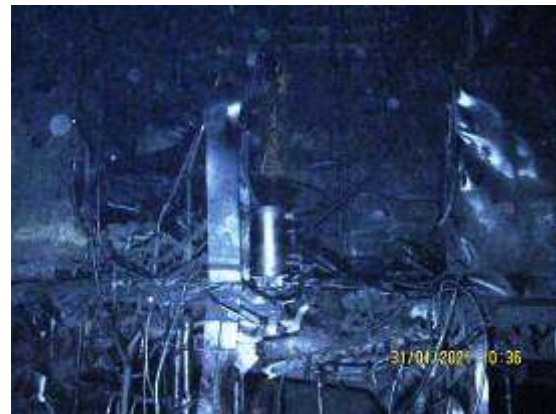
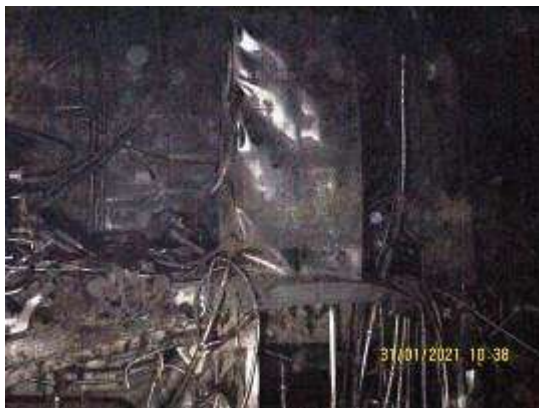
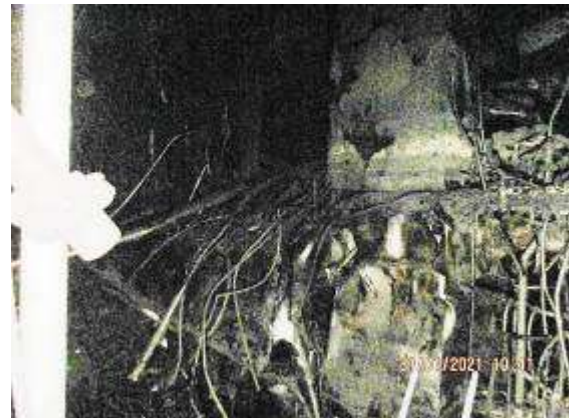
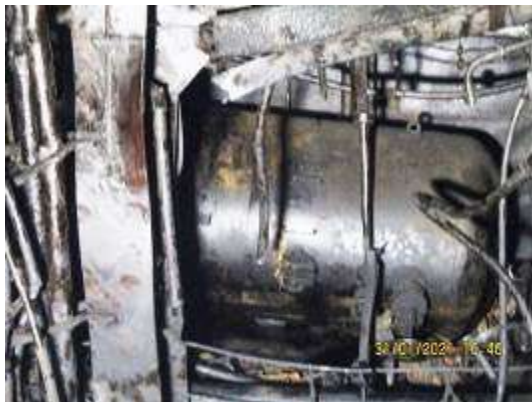
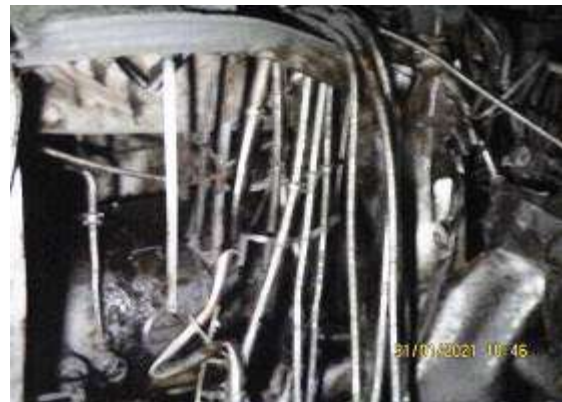
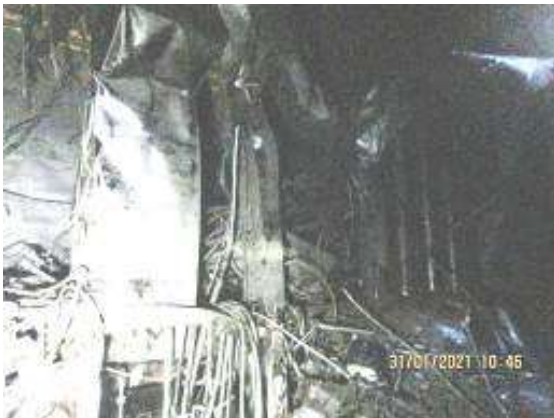
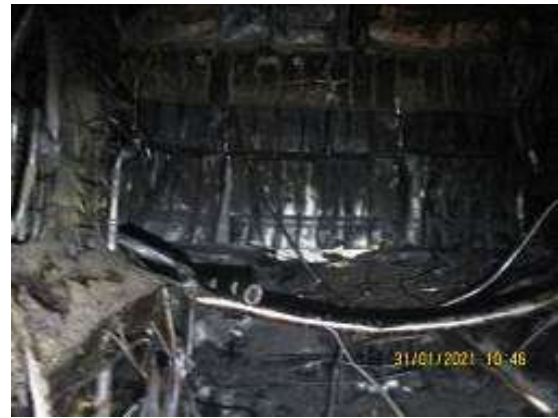
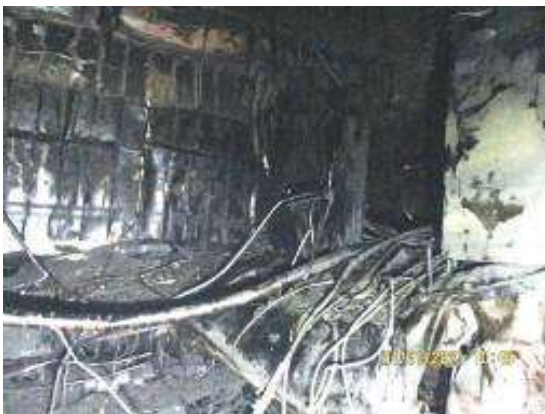
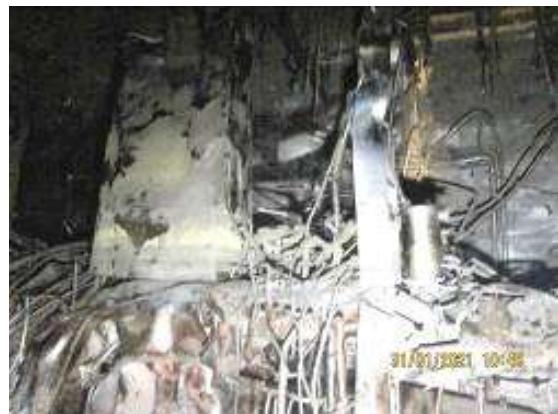
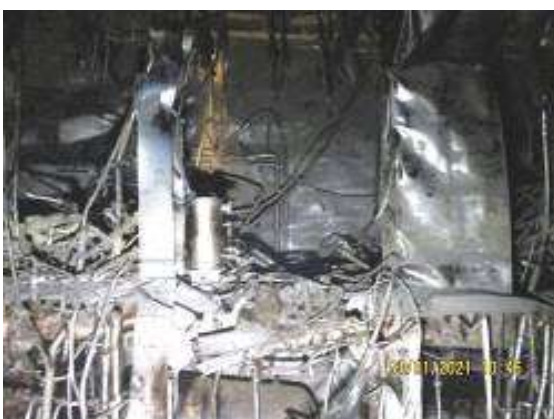
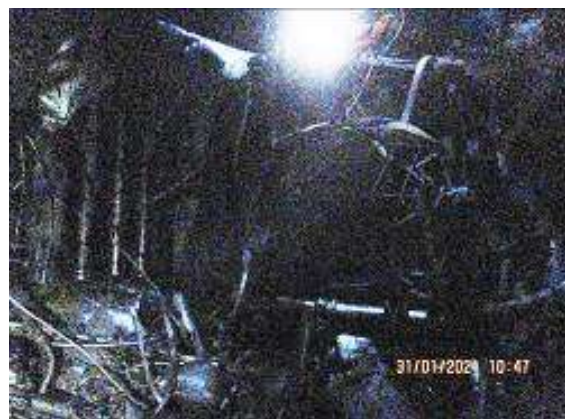
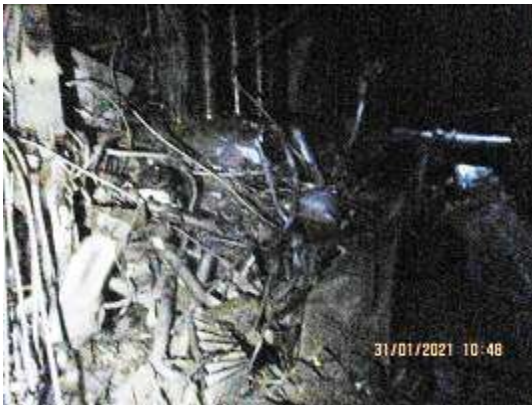
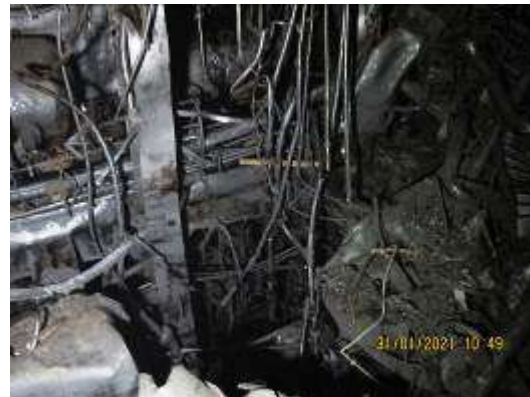
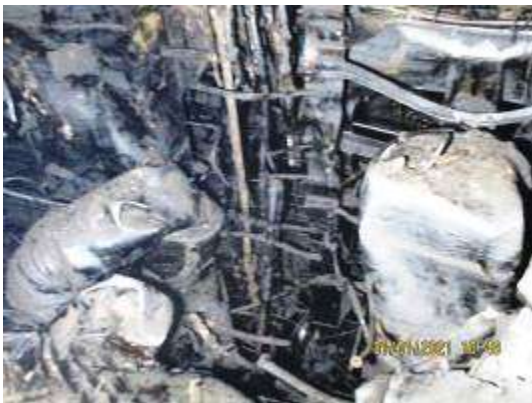
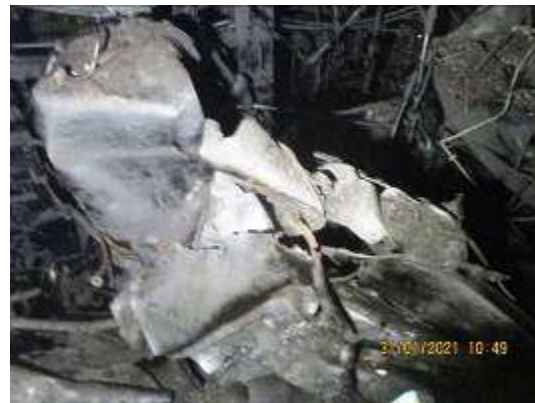
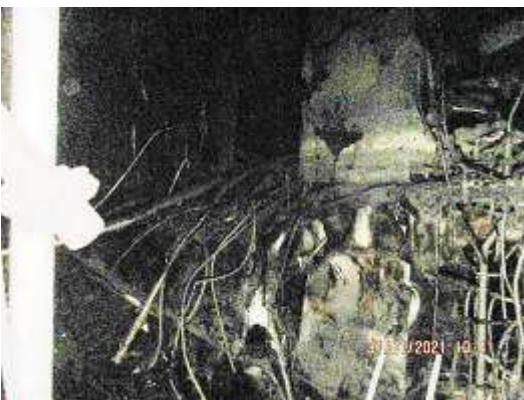
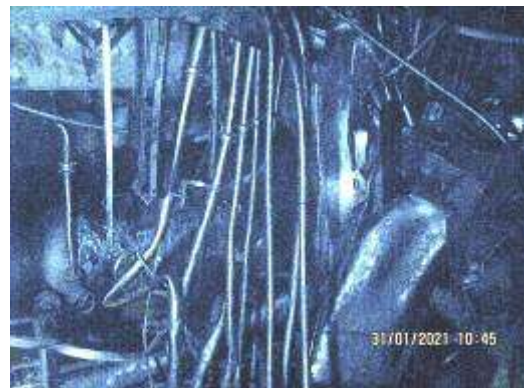
ENGINE ROOM 2ND DECK

Page 43 to 46 – Photos of debris and gutted down E/R machineries taken from staging rigged inside E/R in way of skylight

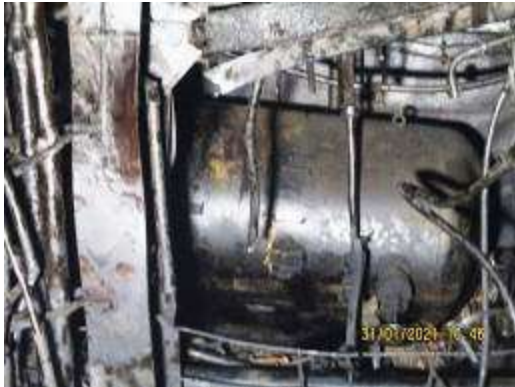
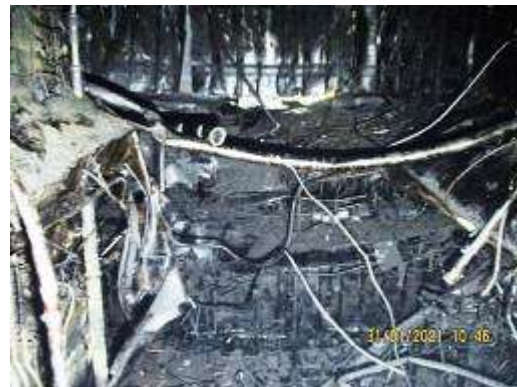
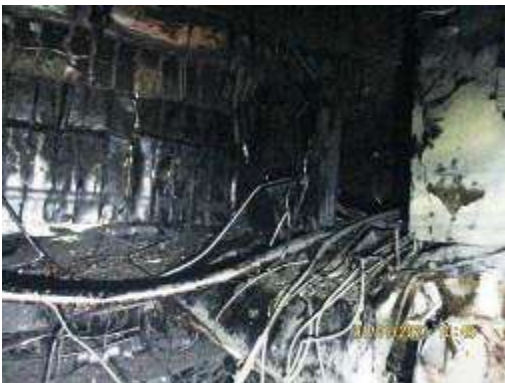
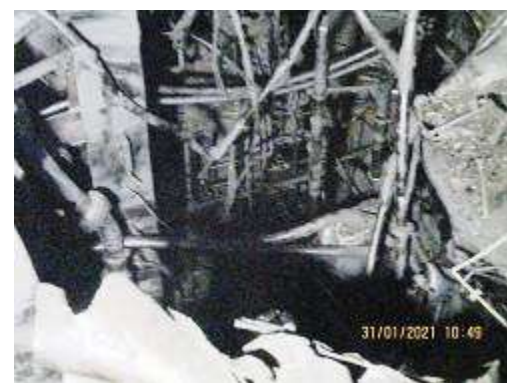
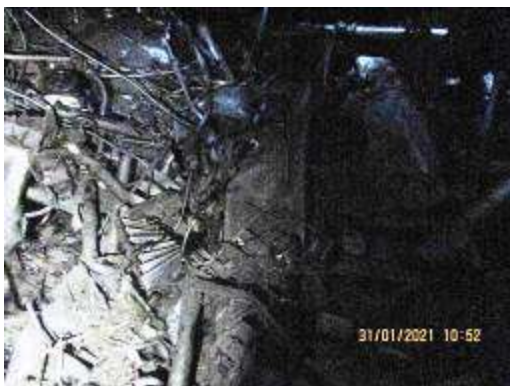
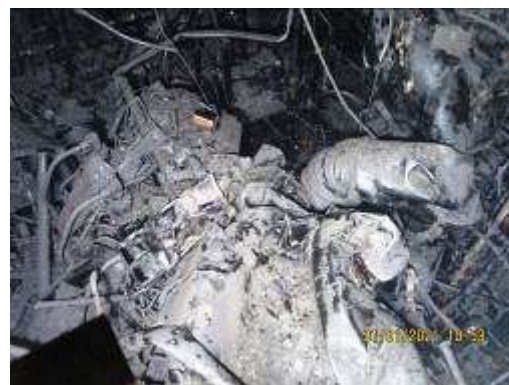
STERRING COMPARTMENT

Entry to 3rd Deck from Steering Compartment

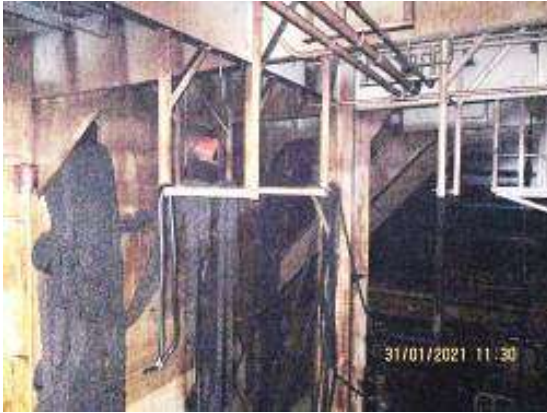
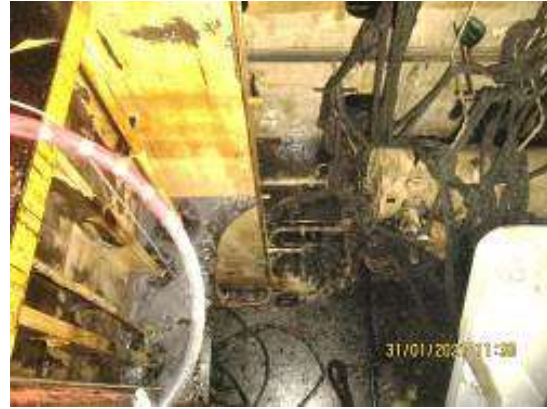
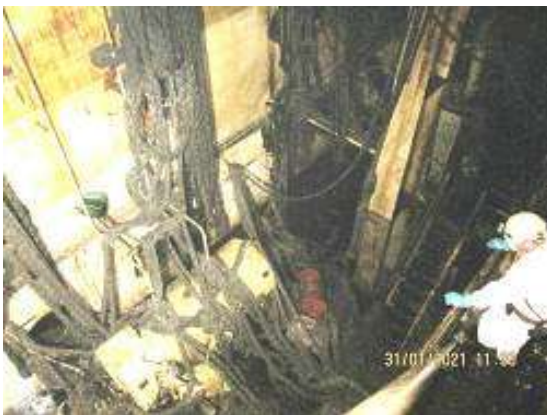
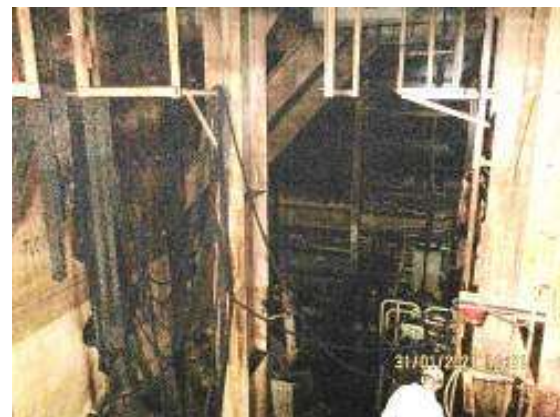
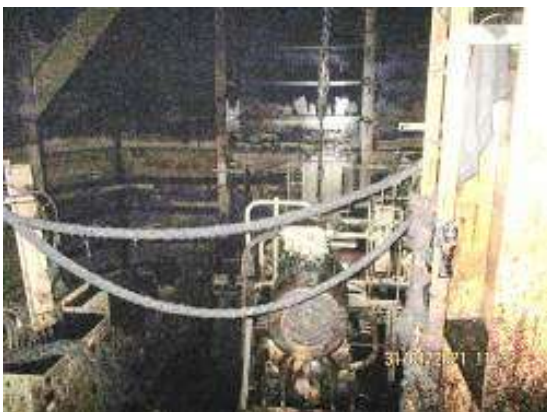
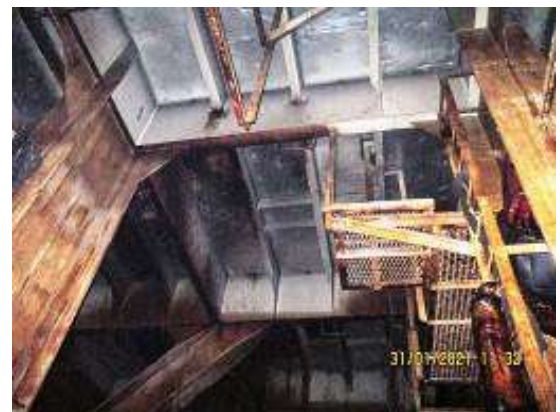
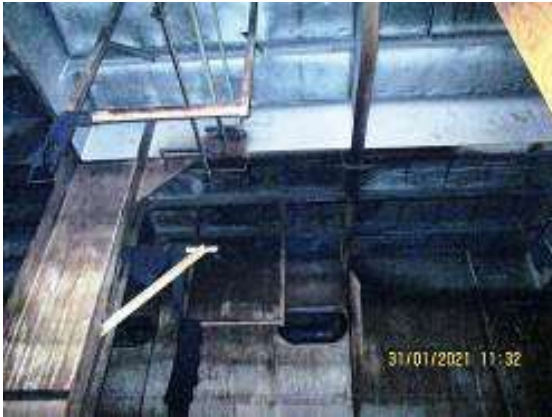
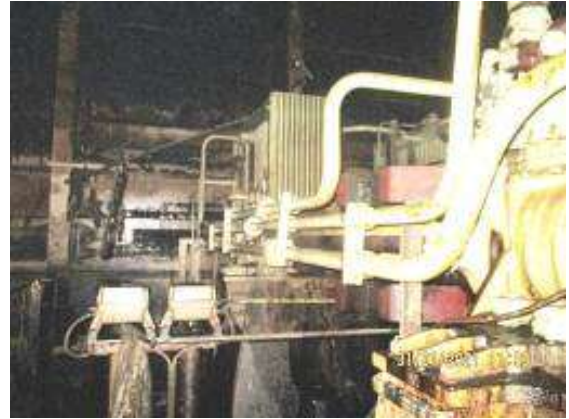
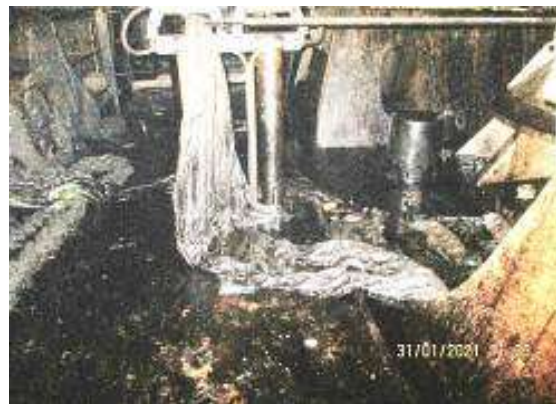
Engine room 3rd deck view from steering compartment

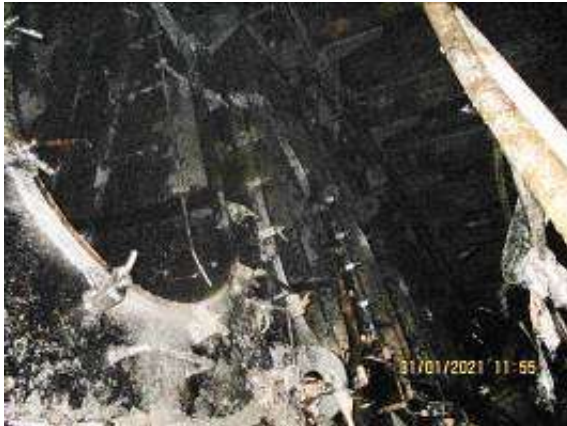
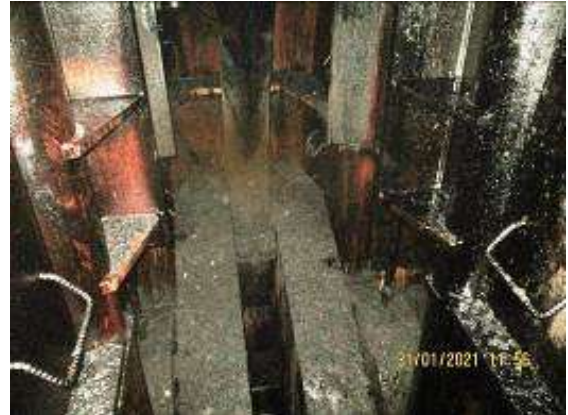
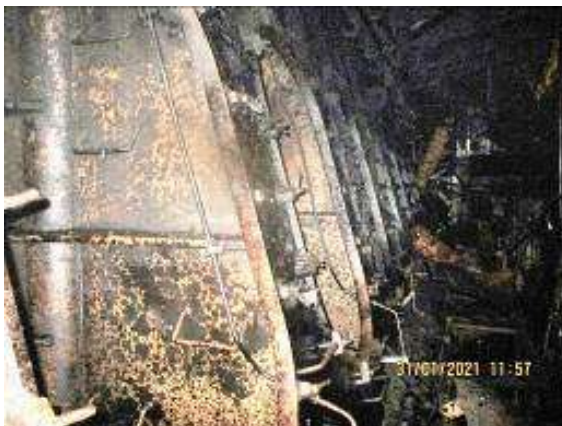
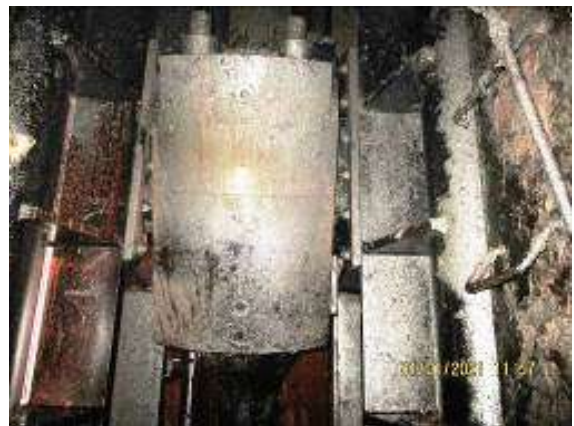
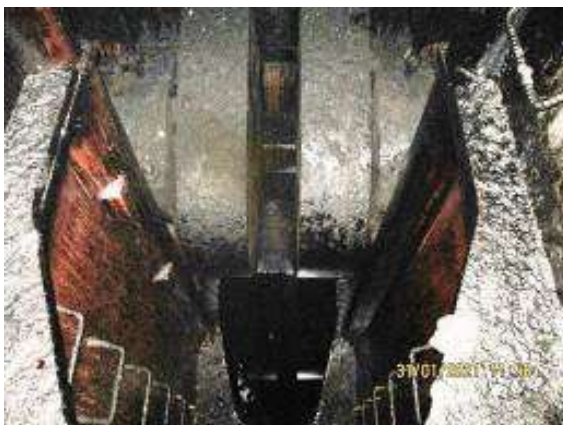
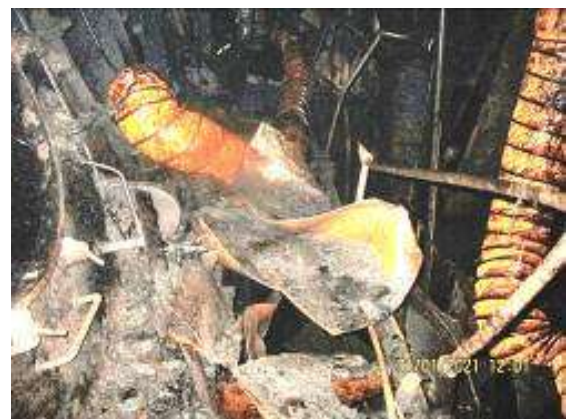
M/E crankcase and area around it

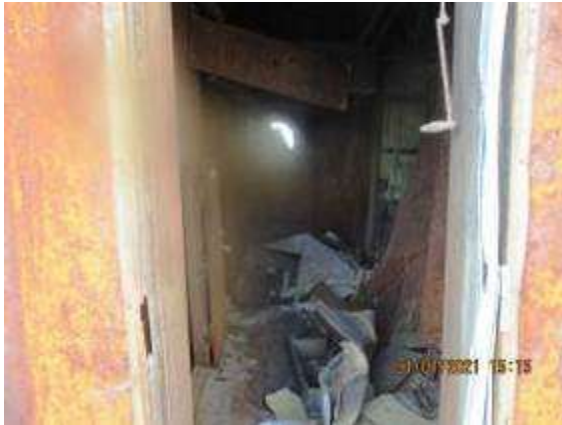
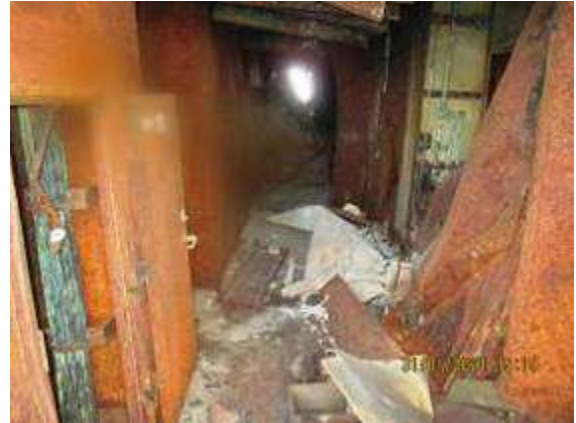
C Deck

Engine room casing and funnel deck badly buckled, tilted forward due to fire heat

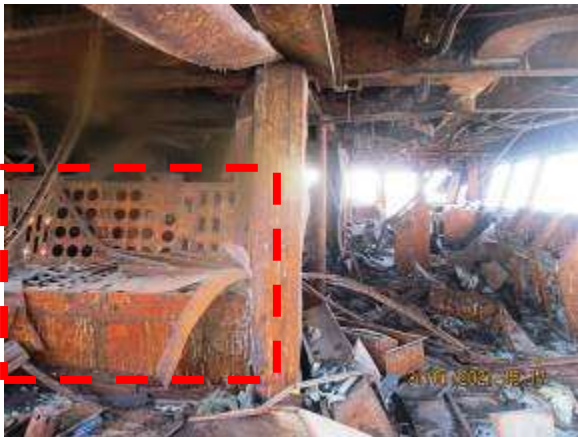
NAVIGATION DECK

View from STBD to Port
CCR Panel on aft STBD side in wheel house

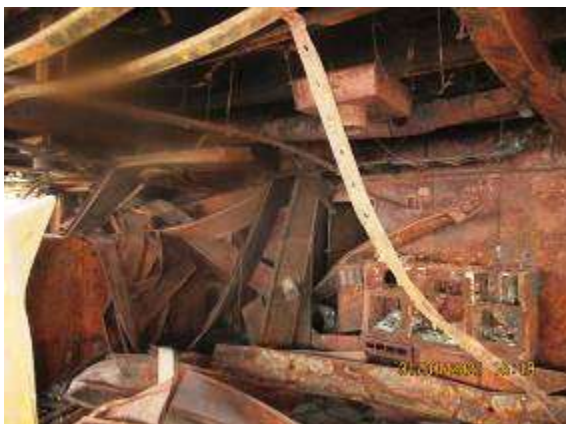
ECR Console of aft port wheel house

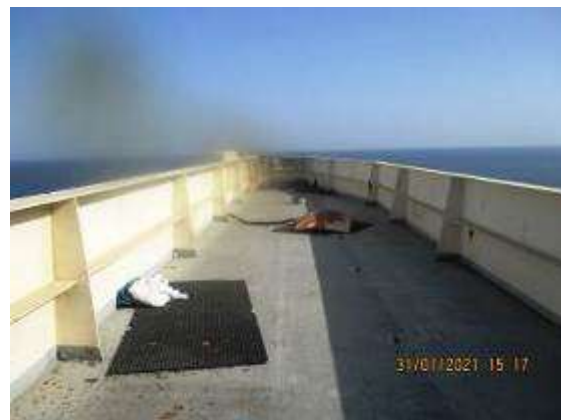
STBD side Bridge Wing
